# MIDDLE CREEK DAM

## GEOTECHNICAL INVESTIGATION

MIDDLE CREEK DAM  
GEOTECHNICAL INVESTIGATION

February 1984  
8M087.113/0611H

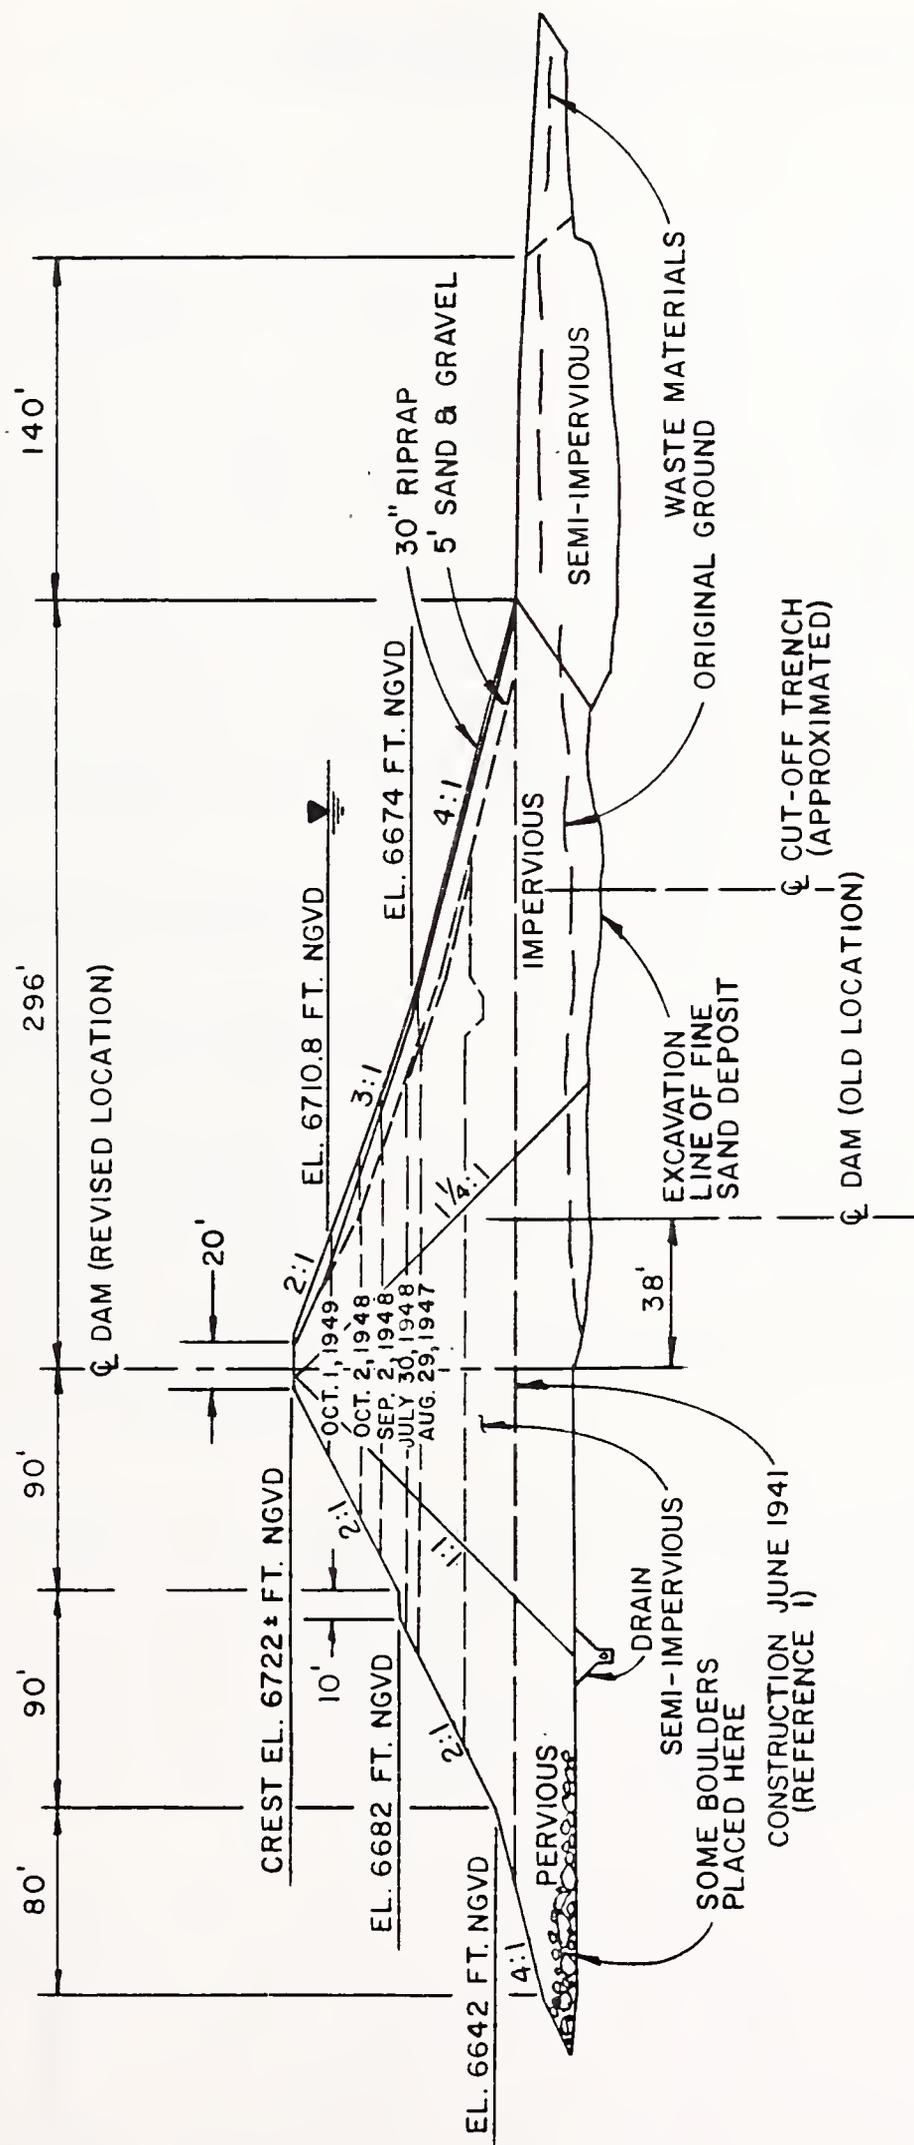
FIGURE 1

NGVD : National Geodetic Vertical Datum  
 Source : Reference 22

**MIDDLE CREEK DAM**  
**DAM EMBANKMENT CONSTRUCTION HISTORY**  
 (CUTOFF CONFIGURATION IS UNKNOWN)

Figure 1 summarizes the construction progress by date and embankment configuration. The embankment was raised in horizontal lifts and compacted using sheepfoot rollers.

Information from the Construction Progress Reports in the design files (Ref. 22) suggest that a rock fill was placed in the lower elevations of the previous fill section as depicted on Figure 1.

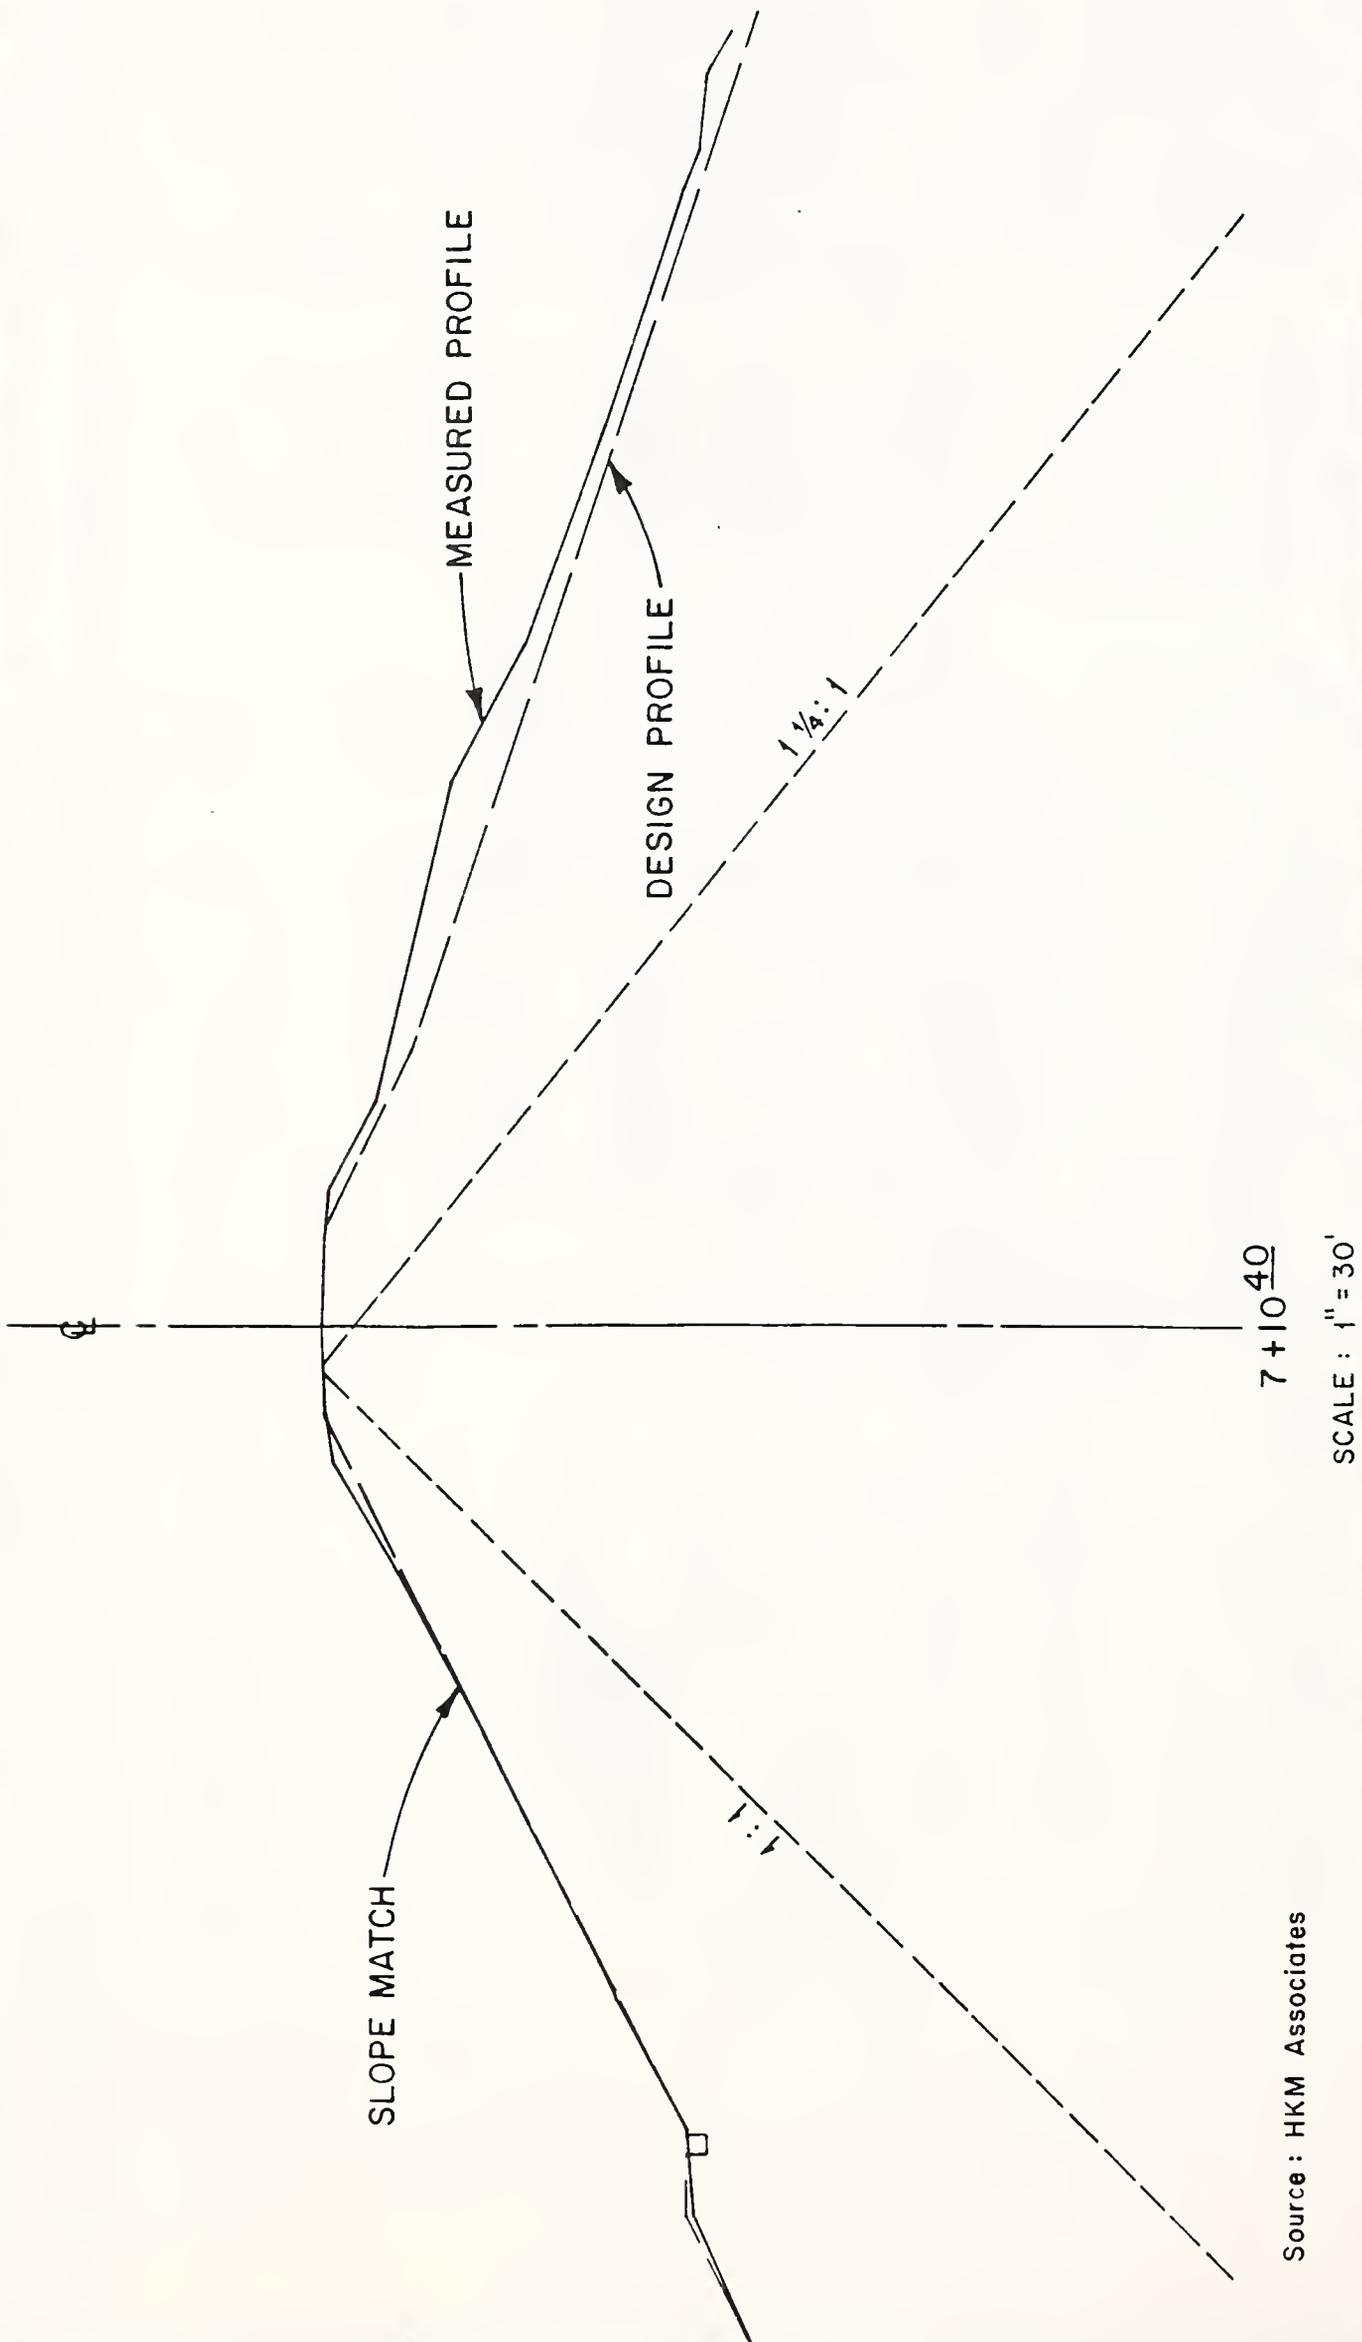
FIGURE 2  
**HKM ASSOCIATES**  
 ENGINEERS — PLANNERS

MIDDLE CREEK DAM  
**MEASURED VS. DESIGN PROFILE**  
 FEBRUARY 1984

Four embankment profiles were surveyed for the purpose of establishing a cross section and to compare the existing embankment with the design drawings. Figure 2 shows the measured profile superimposed on the configuration presented on the design drawings. The existing embankment generally conforms to the design drawings. The measured crest is wider than the design crest. This appears to be a change from the design drawings. Because of this wider crest, it appears that the upstream slope was moved upstream just slightly. It is also possible that this is an overbuild. The crest appears slightly wider on the downstream side due to traffic and road maintenance grading.

The riprap has slid down the slope, away from the crest, in some places, however, the riprap protection appears adequate. At some locations the riprap appears considerably thicker than 2.5 feet. A general profile of the riprap face is shown on Sheet 3 in Appendix A and on Figure 2.

As discussed previously in Section II.C., Figure 2 has been prepared to show the difference between the measured profile of the embankment and the design drawings. These findings indicate that crest width is about 6-8 feet wider than the

design drawing and some overbuild appears on the upstream slope. Apparently, there was a small runoff collection trench constructed on the berm on the downstream slope (See Figure 2). Since construction, the trench has filled with slough. There are no physical features of this trench visible today.

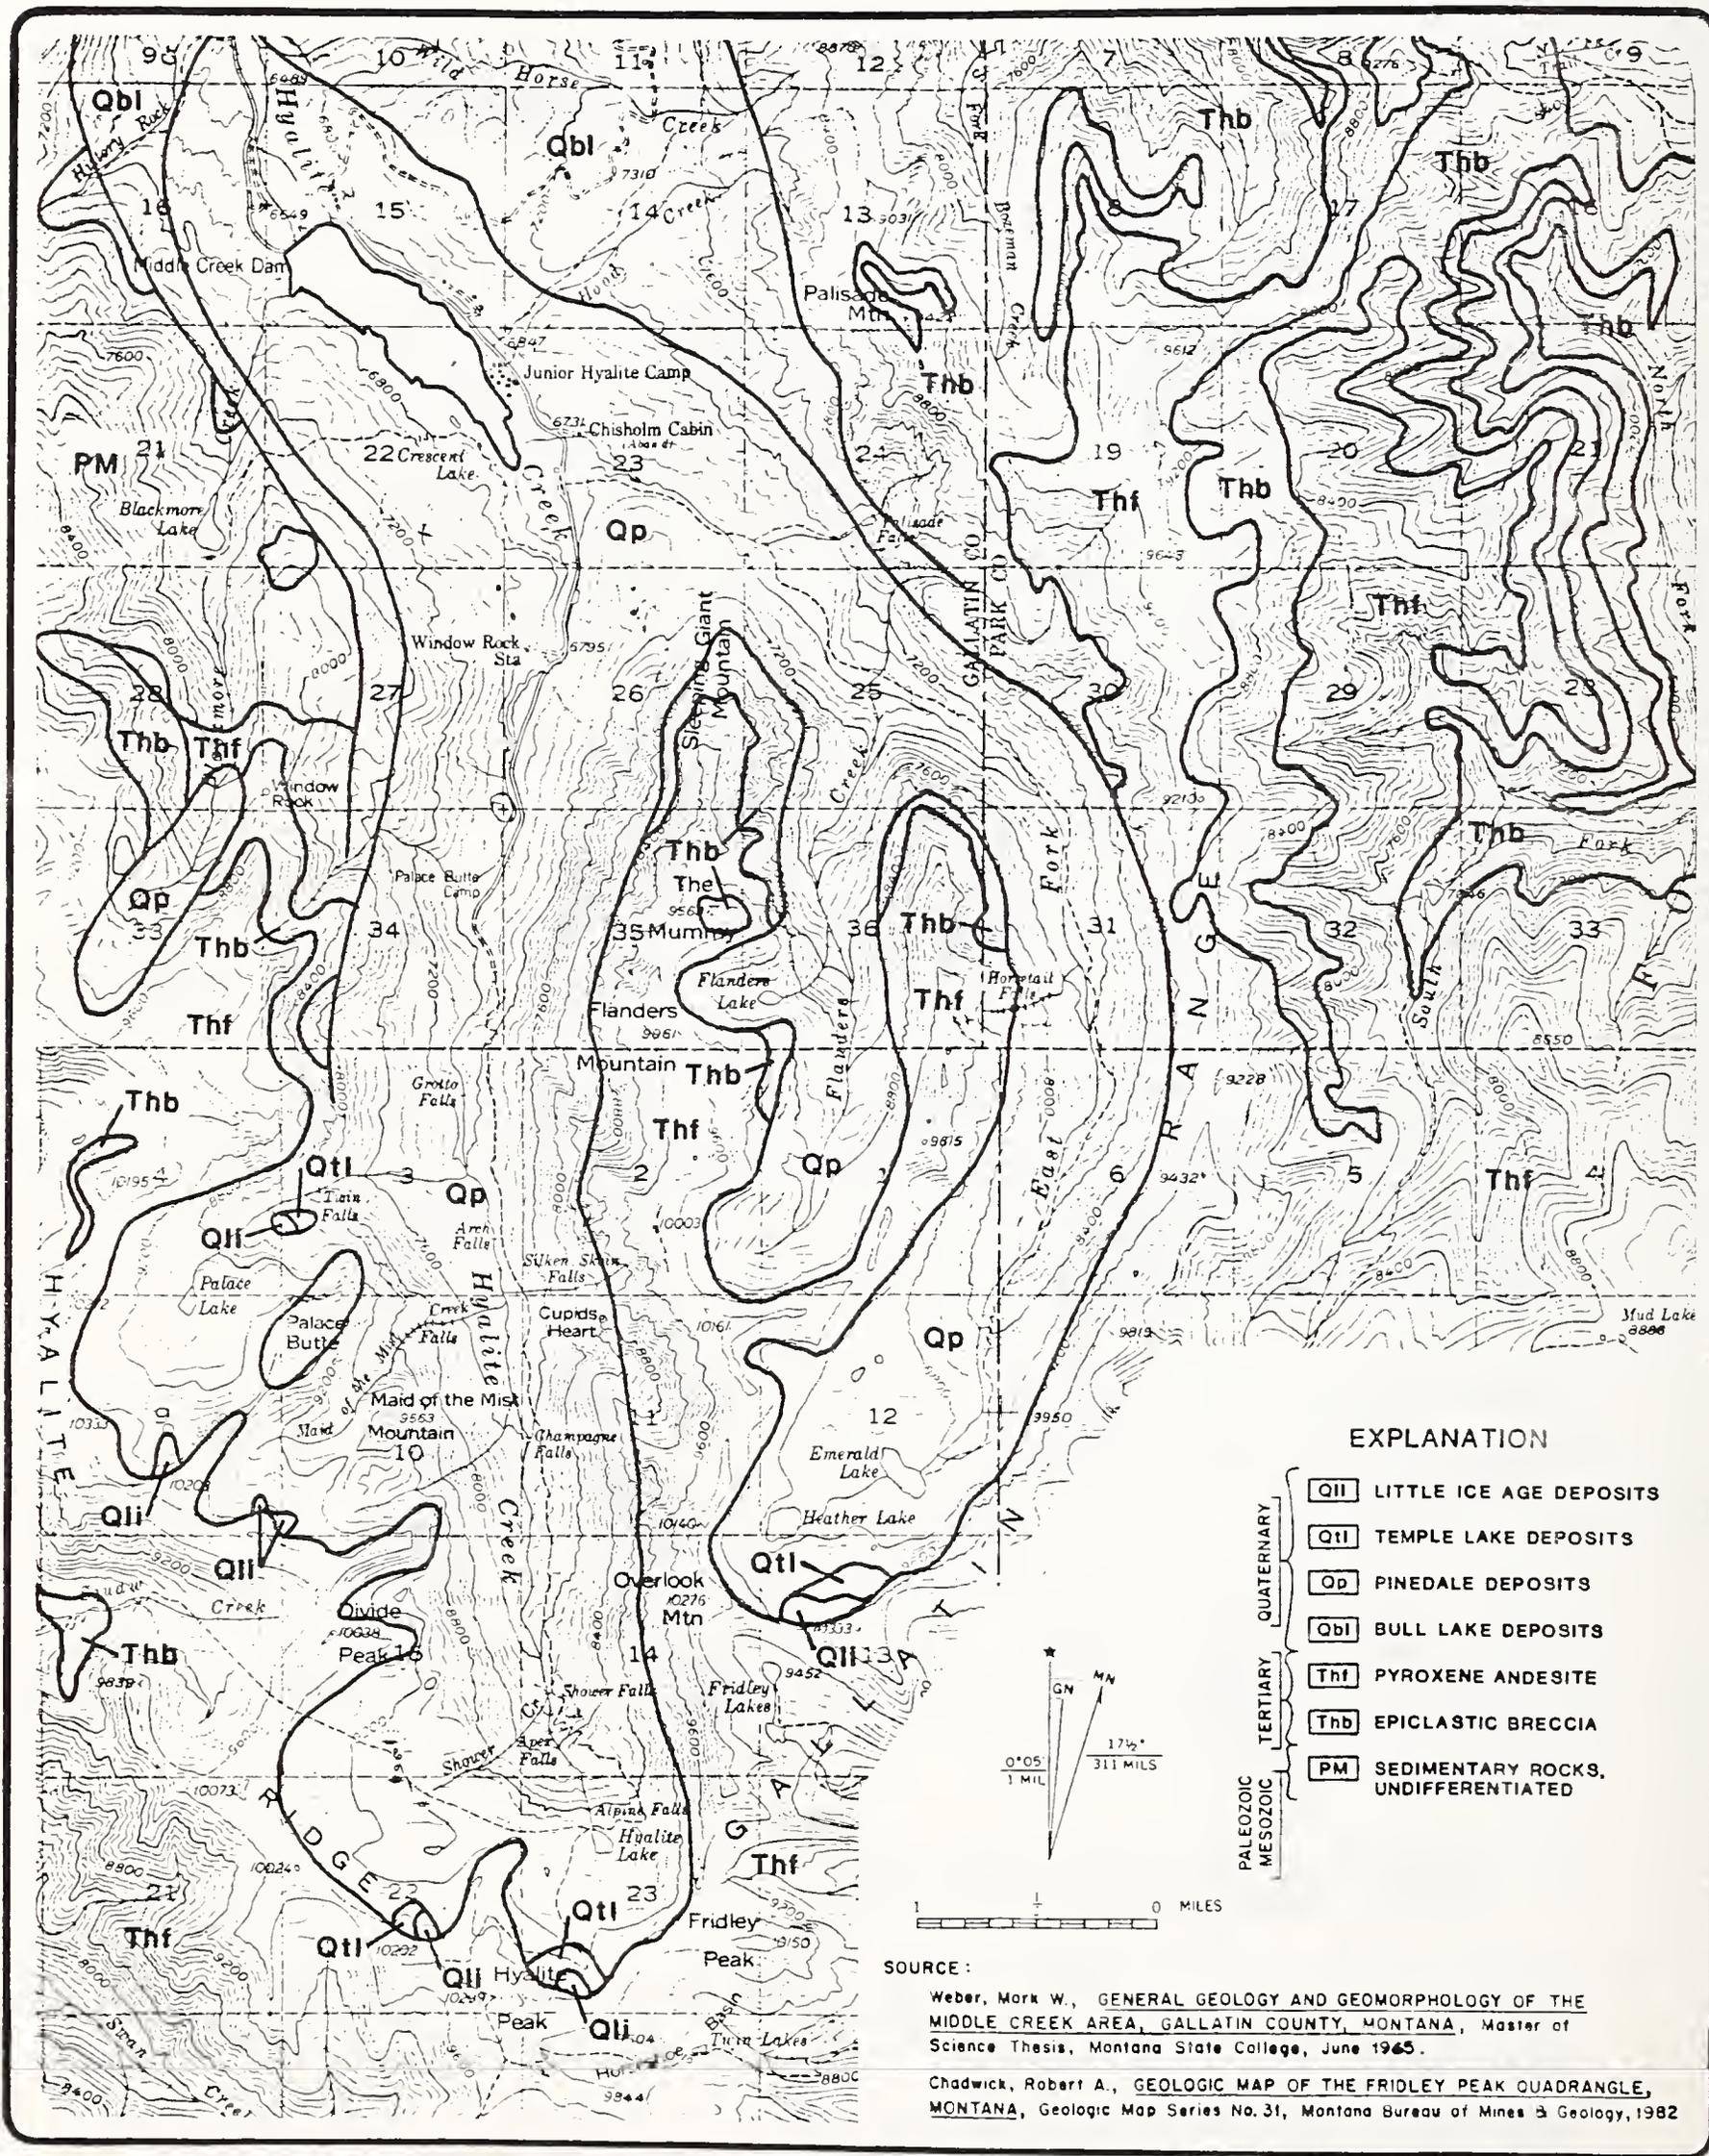
**FIGURE 4**

**MIDDLE CREEK DAM  
 GEOMORPHIC AND GEOLOGIC MAP**

Figure 4 is a geologic and geomorphic map of Middle Creek Reservoir and surrounding area that was adapted from the available geologic literature (Refs. 7 and 32). The topography

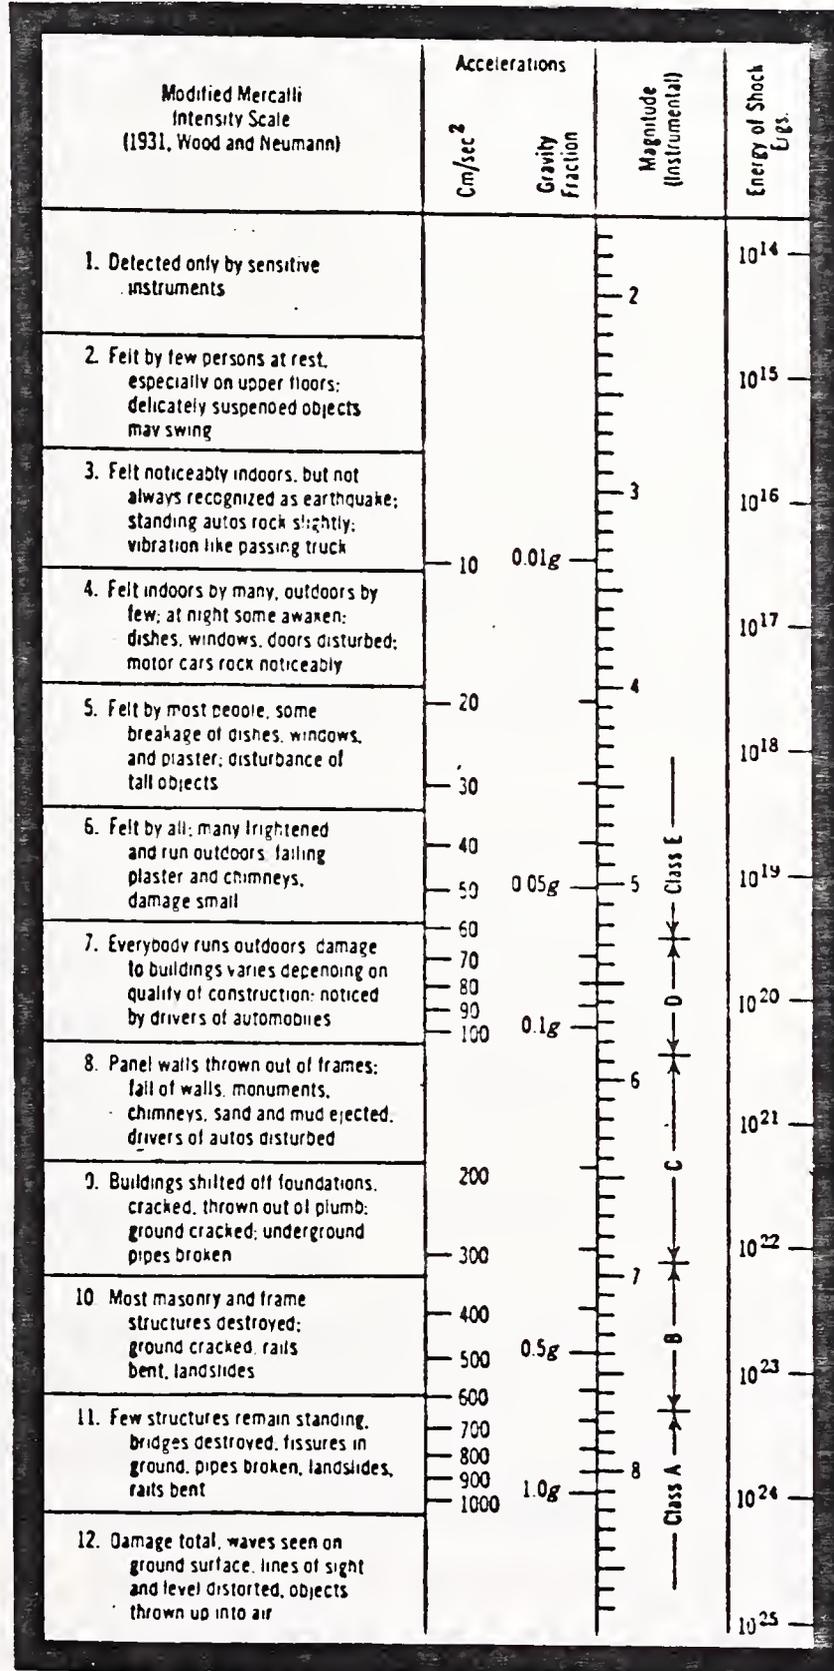
MIDDLE CREEK DAM  
 APPROXIMATE RELATIONSHIP, EARTHQUAKE  
 INTENSITY, ACCELERATION AND MAGNITUDE  
 8M087.113  
 FEBRUARY 1984

1. Selected Design Earthquake Magnitude = 6.5. Applicable earthquake magnitudes range from 6.0 to 7.0. Upper and lower magnitude values were obtained based on the methods proposed by Bonnilla (Ref. 3) assuming fault rupture along the entire fault, which is extremely unlikely, and fault rupture along one-half the length of the fault. During the Hebgen earthquake of 1959, fault rupture occurred along about one-half of the Hebgen Fault. Fault displacement values were based upon fault type and length. A median magnitude value of 6.5 was selected as the design value for the Deep Creek-Luccock Park Fault complex.
2. Intensity IX. Intensity was developed in relation to magnitude as proposed in Krinitesky and Marcuson (Ref. 18) and as correlated in Figure 5.

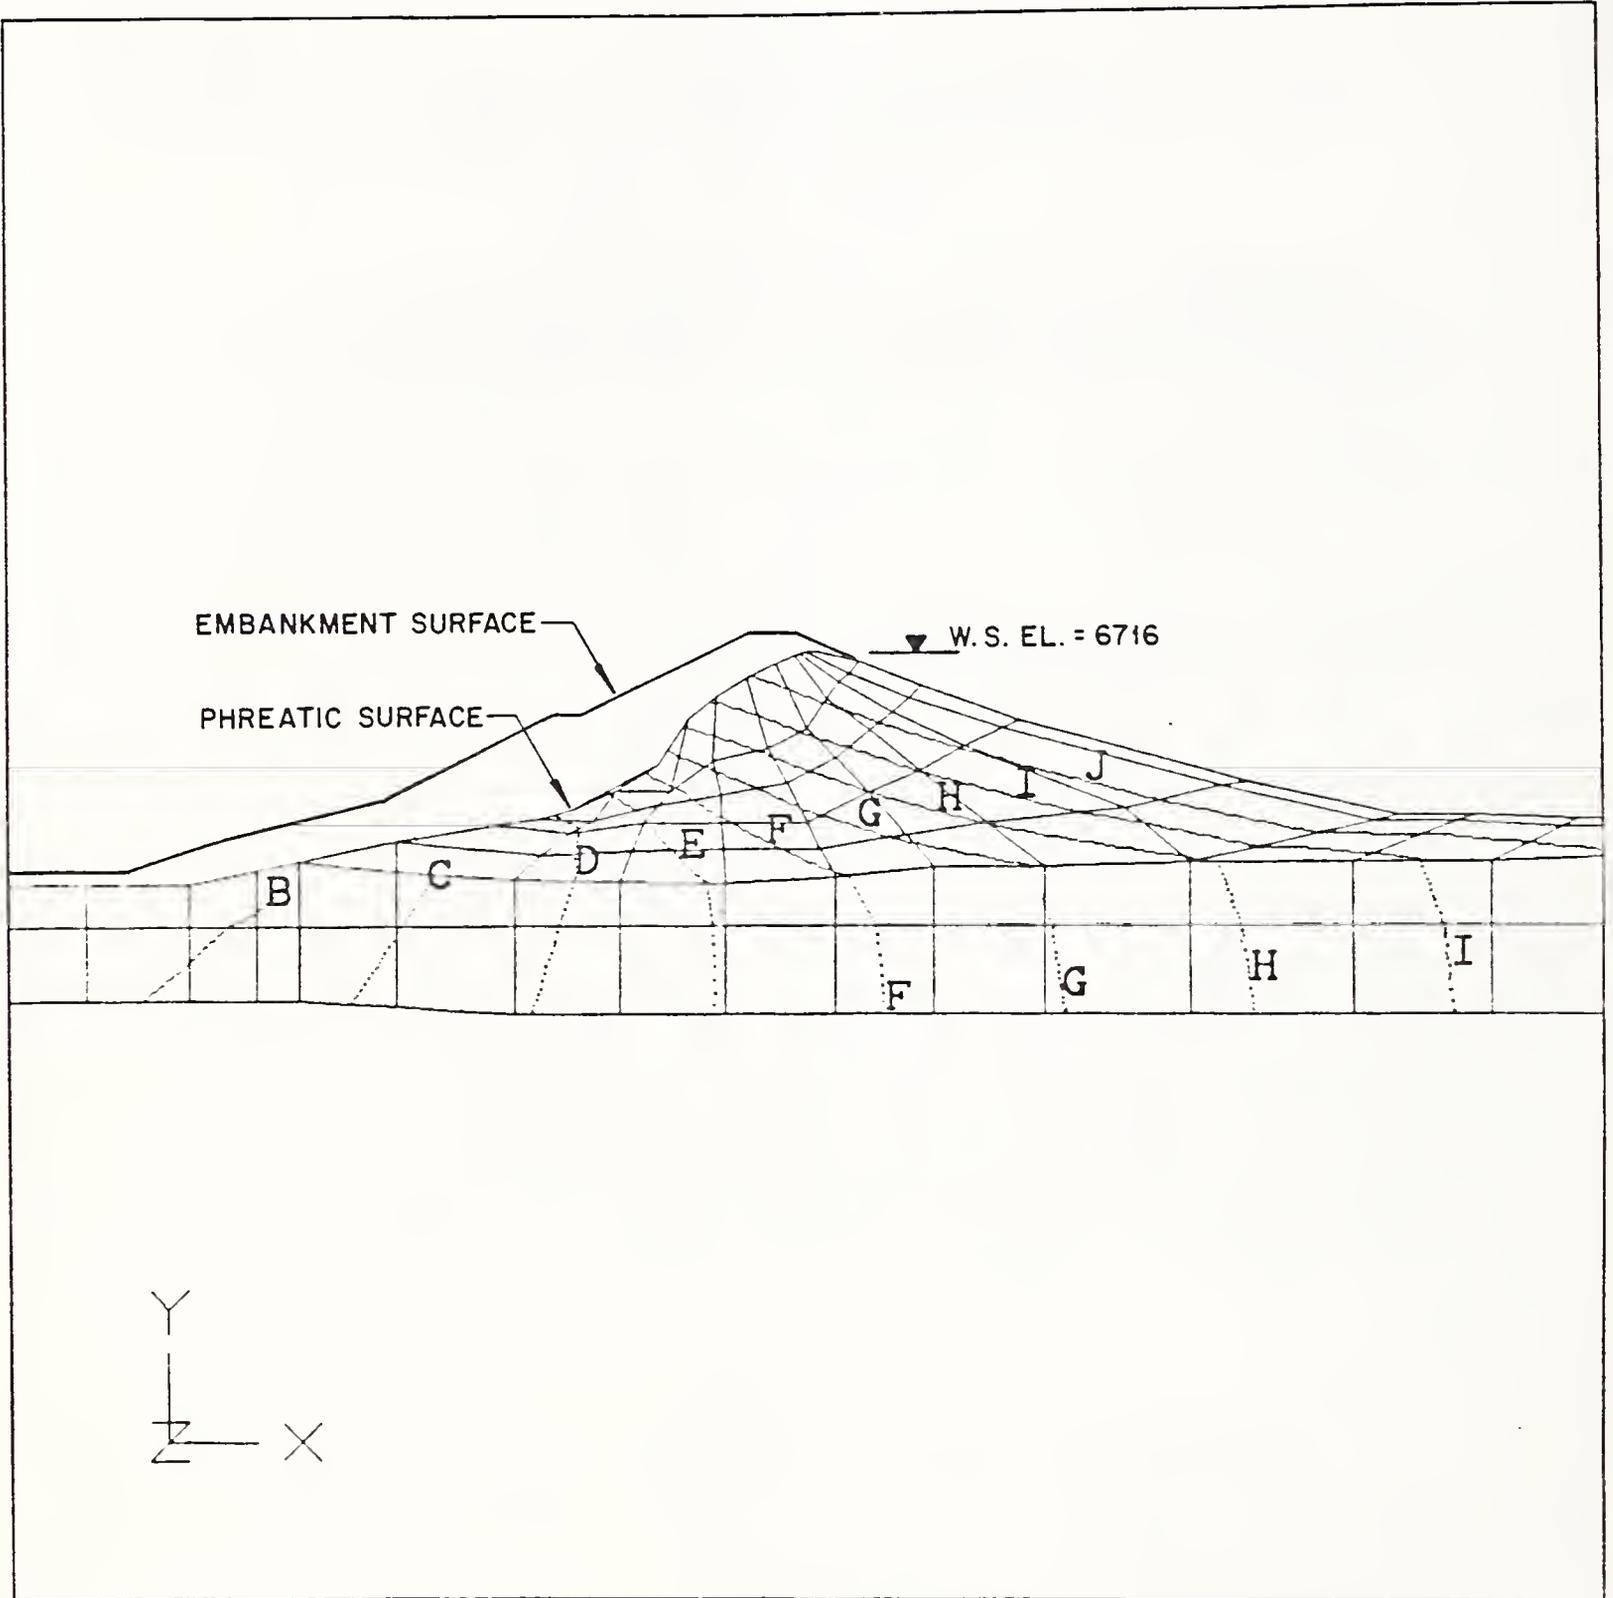
FIGURE 6

<u>CONTOUR</u>	<u>HEAD (in Ft. N.G.V.D.)</u>
B	6617
C	6628
D	6639
E	6650
F	6661
G	6672
H	6683
I	6694
J	6705

Source : Computer generated, see reference 9

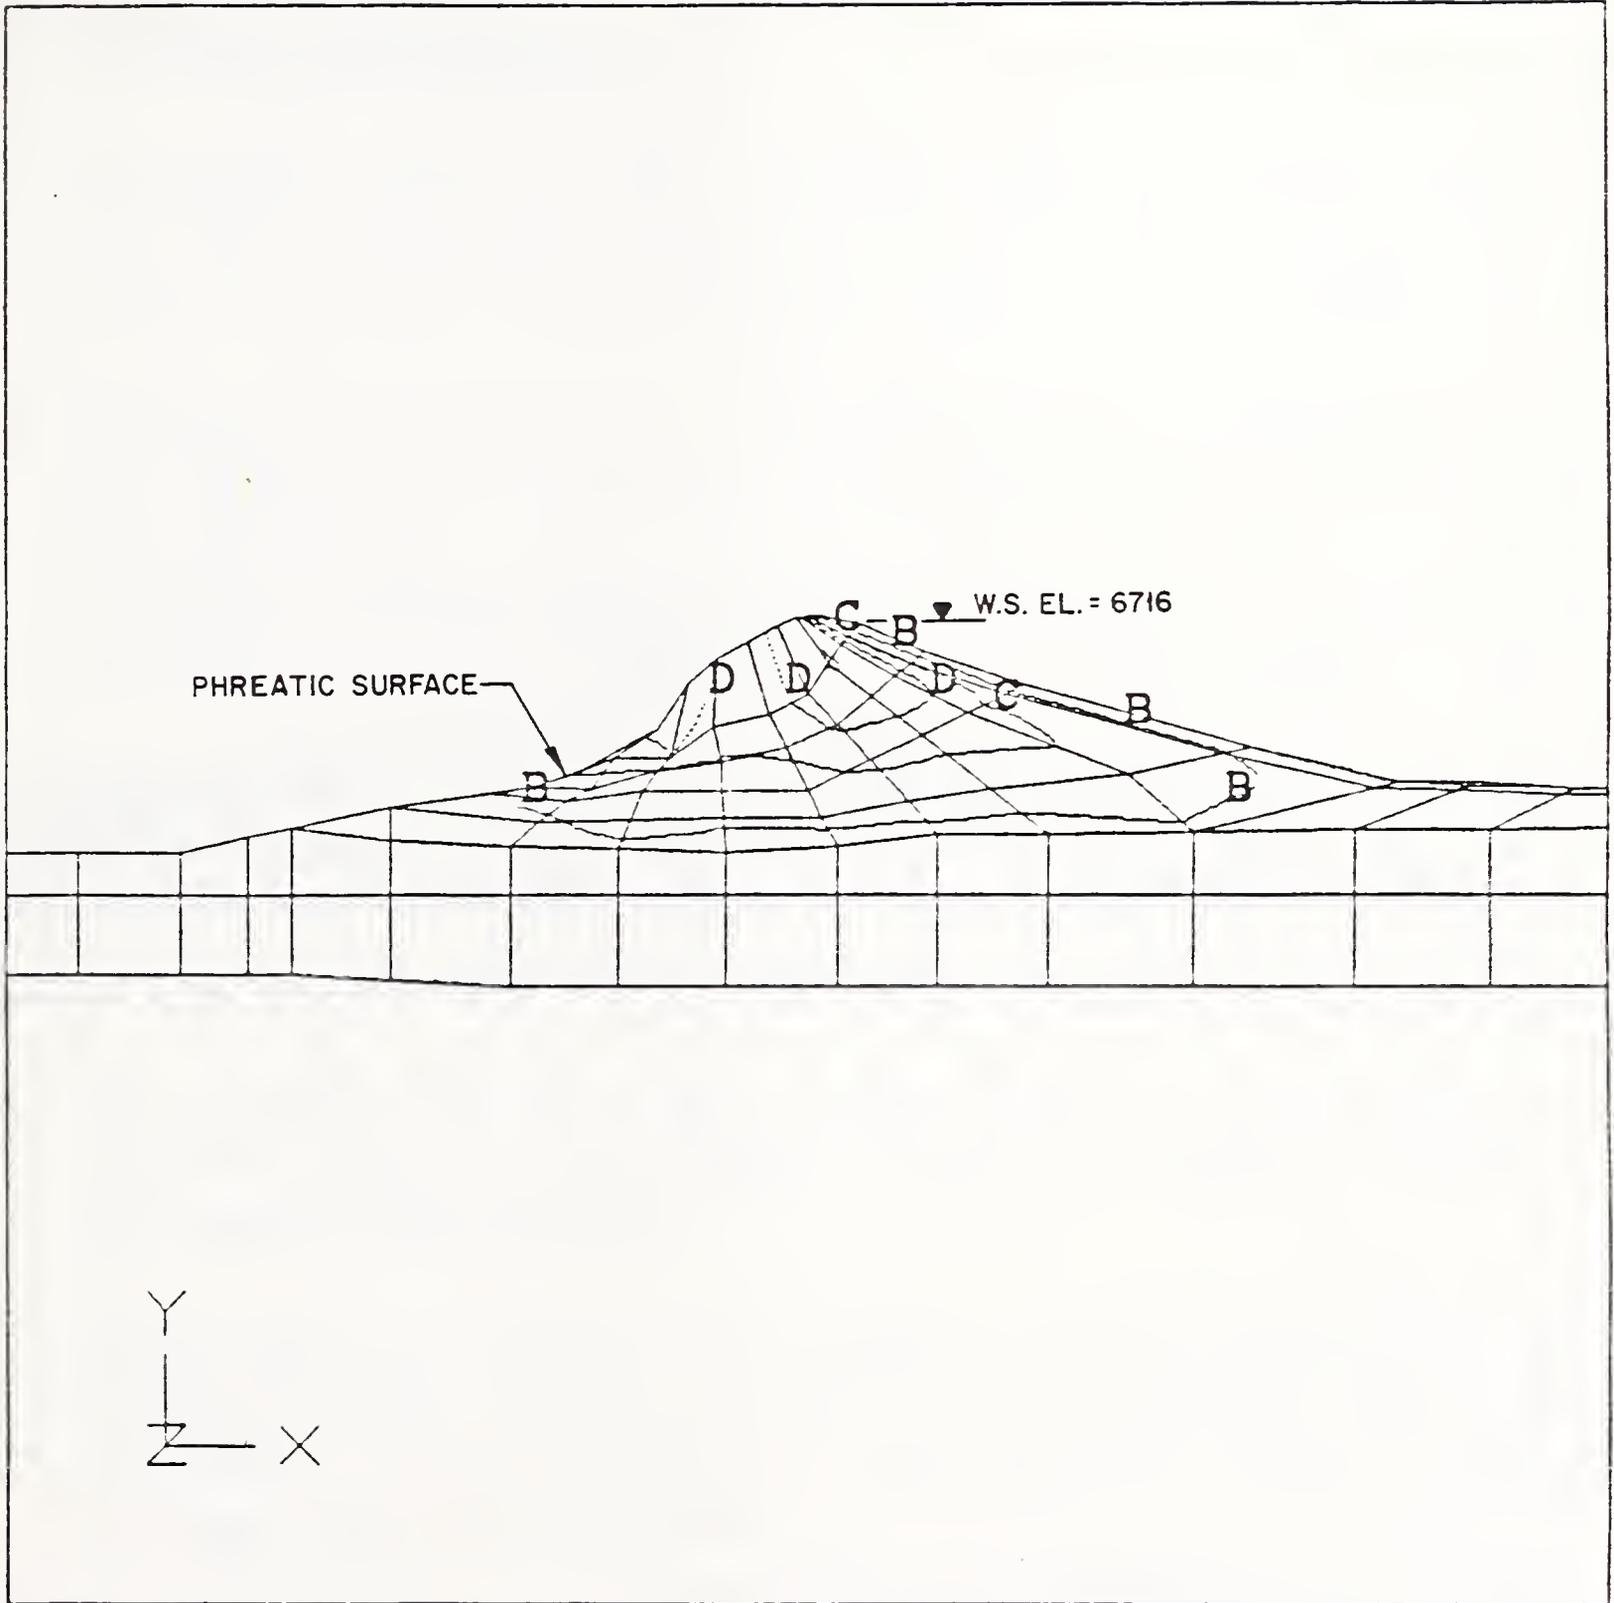
FIGURE 7

<u>CONTOUR</u>	<u>HYDRAULIC GRADIENT</u>
A	0.0
B	0.2
C	0.4
D	0.6
E	0.8

Source : Computer generated, see reference 9

The horizontal permeability rate used in the computerized calculations for the embankment and foundation was assumed to be five times the vertical (ratio 5:1) permeability. This ratio was selected based on the knowledge that the materials are primarily gravel which has been compacted by a roller. A summary of the soil permeability parameters used in the calculations are presented in Table 10. Results of the computerized calculations are plotted on Figure 6 showing contours of equal hydraulic head. The hydraulic gradients in the vertical and horizontal direction are shown in Figures 7 and 8. A summary of the seepage volume calculations are presented in Table 11.

The results of the seepage analysis have been presented previously in Section VIII. The results of the computerized finite element program for seepage analysis also included calculations of the hydraulic gradient in the x and y directions. Figures 7 and 8, presented in Section VIII, show the computer graphic printout of the hydraulic gradient. Knowing the value of the hydraulic gradient at each element, the seepage forces at the nodes were calculated.

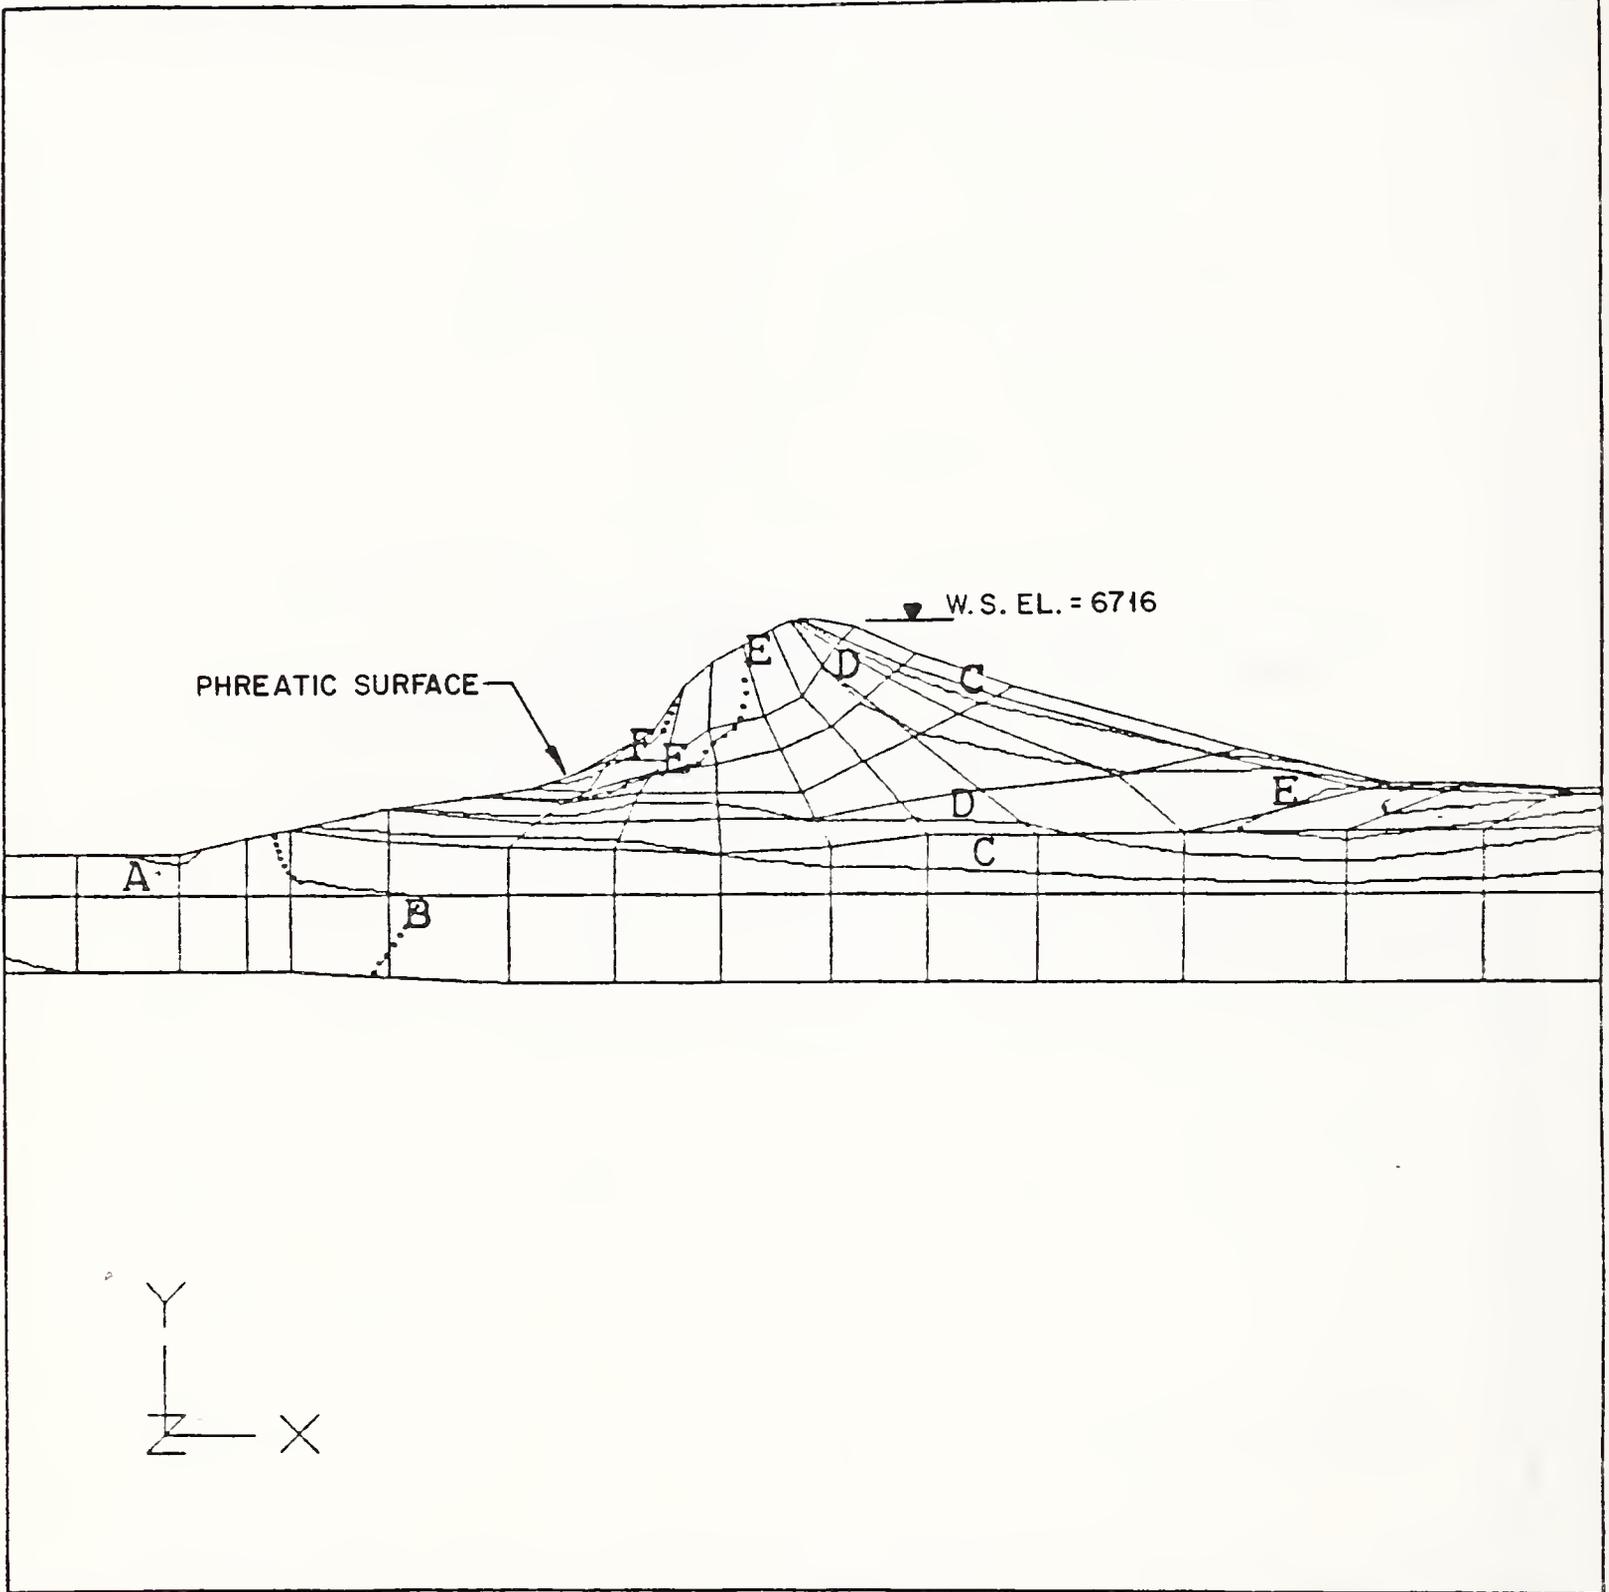
<u>CONTOUR</u>	<u>HYDRAULIC GRADIENT</u>
A	-0.30
B	-0.083
C	0.133
D	0.350
E	0.57
F	0.78
G	1.0

Source : Computer generated, see reference 9

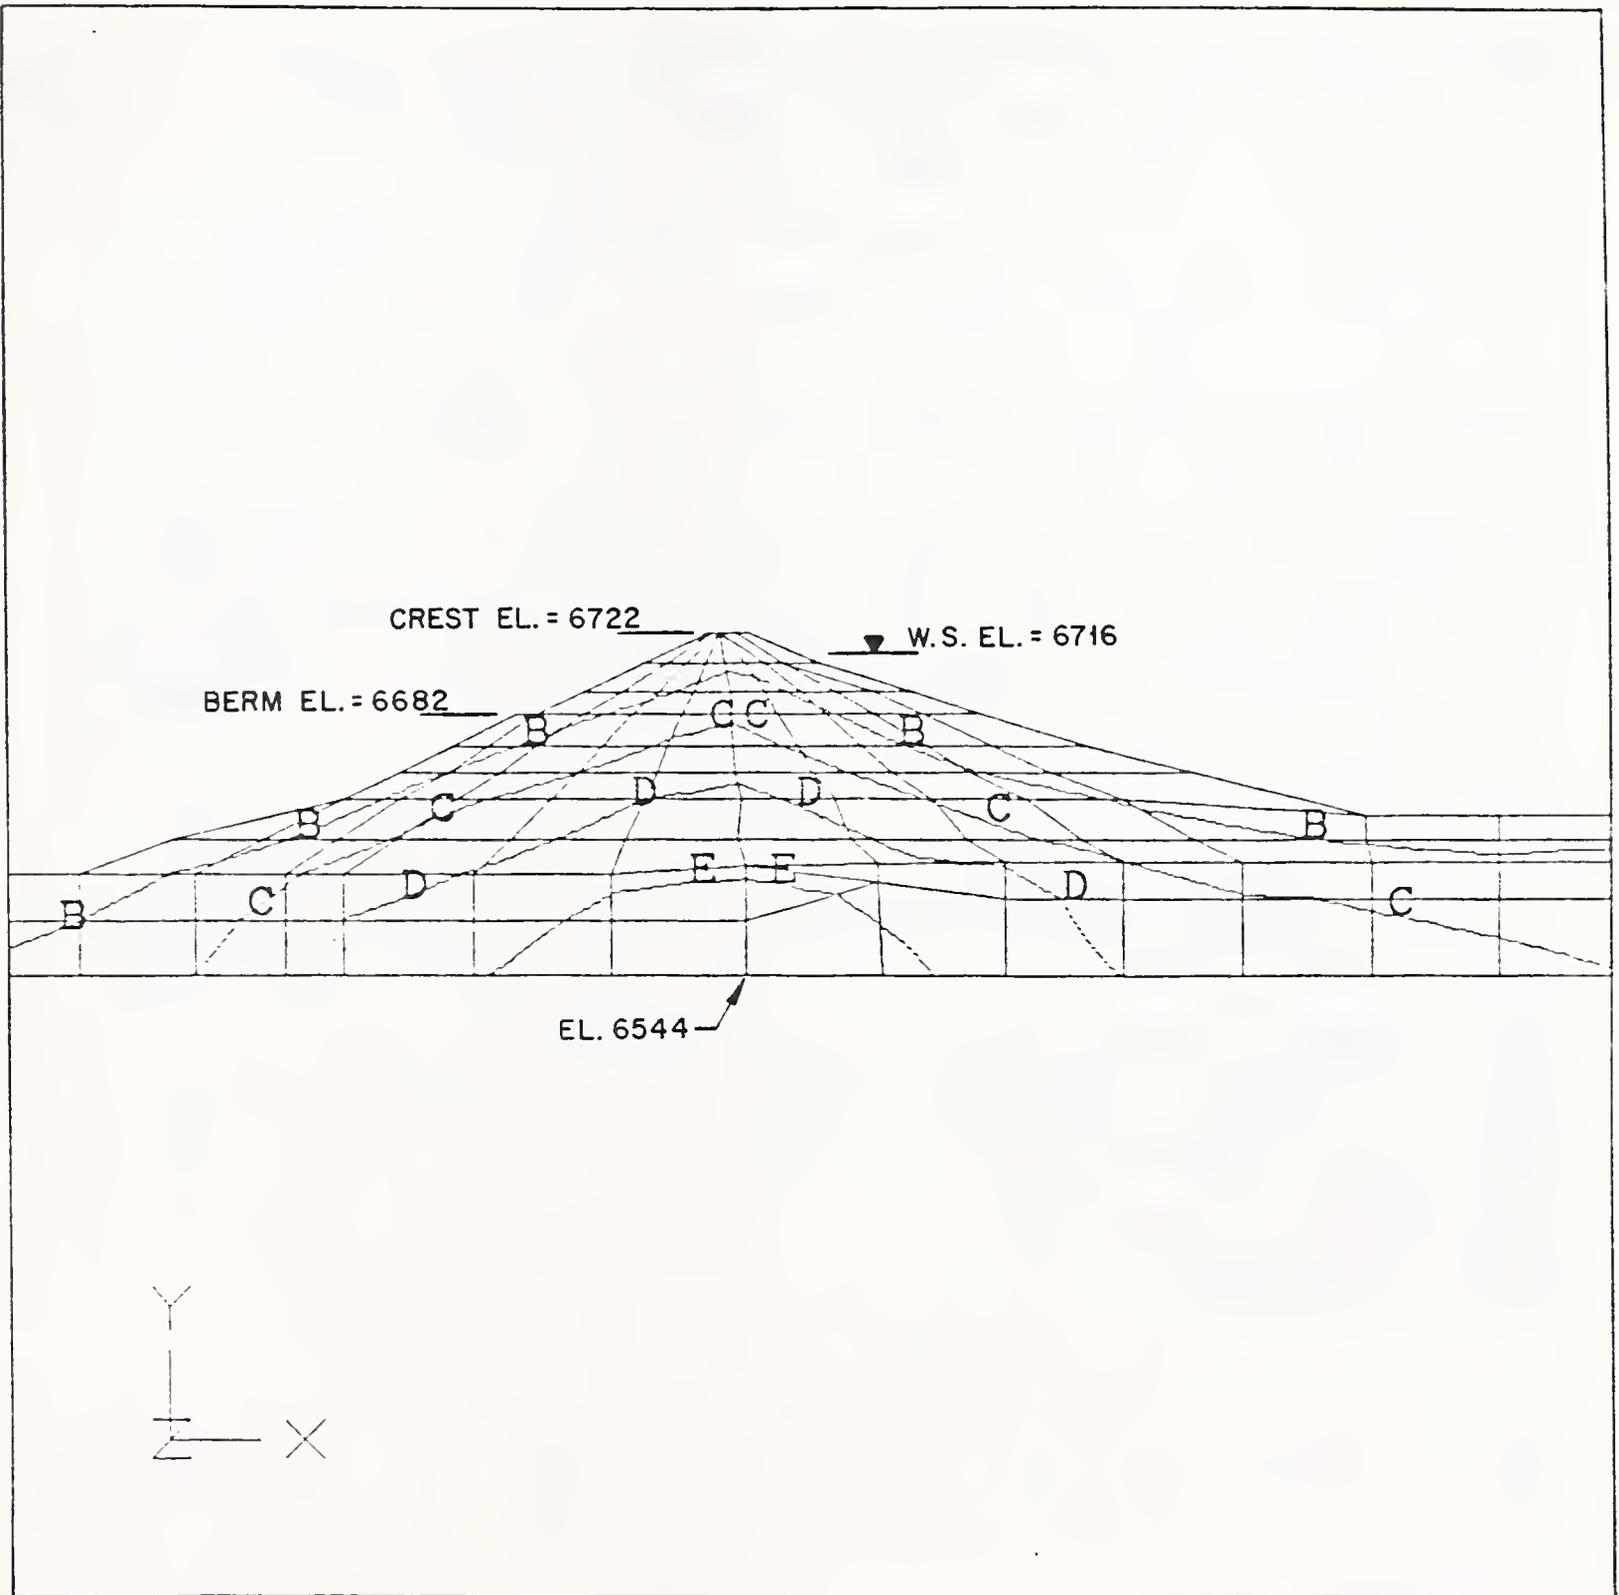
<u>CONTOUR</u>	<u>EFFECTIVE VERTICAL STRESS, in Tons/Ft.<sup>2</sup></u>
A	0
B	1.1
C	2.1
D	3.3
E	4.4
F	5.5

Source : Computer generated, see reference 23
