# MIDDLE CREEK DAM

## GEOTECHNICAL INVESTIGATION

MIDDLE CREEK DAM  
GEOTECHNICAL INVESTIGATION

February 1984  
8M087.113/0611H

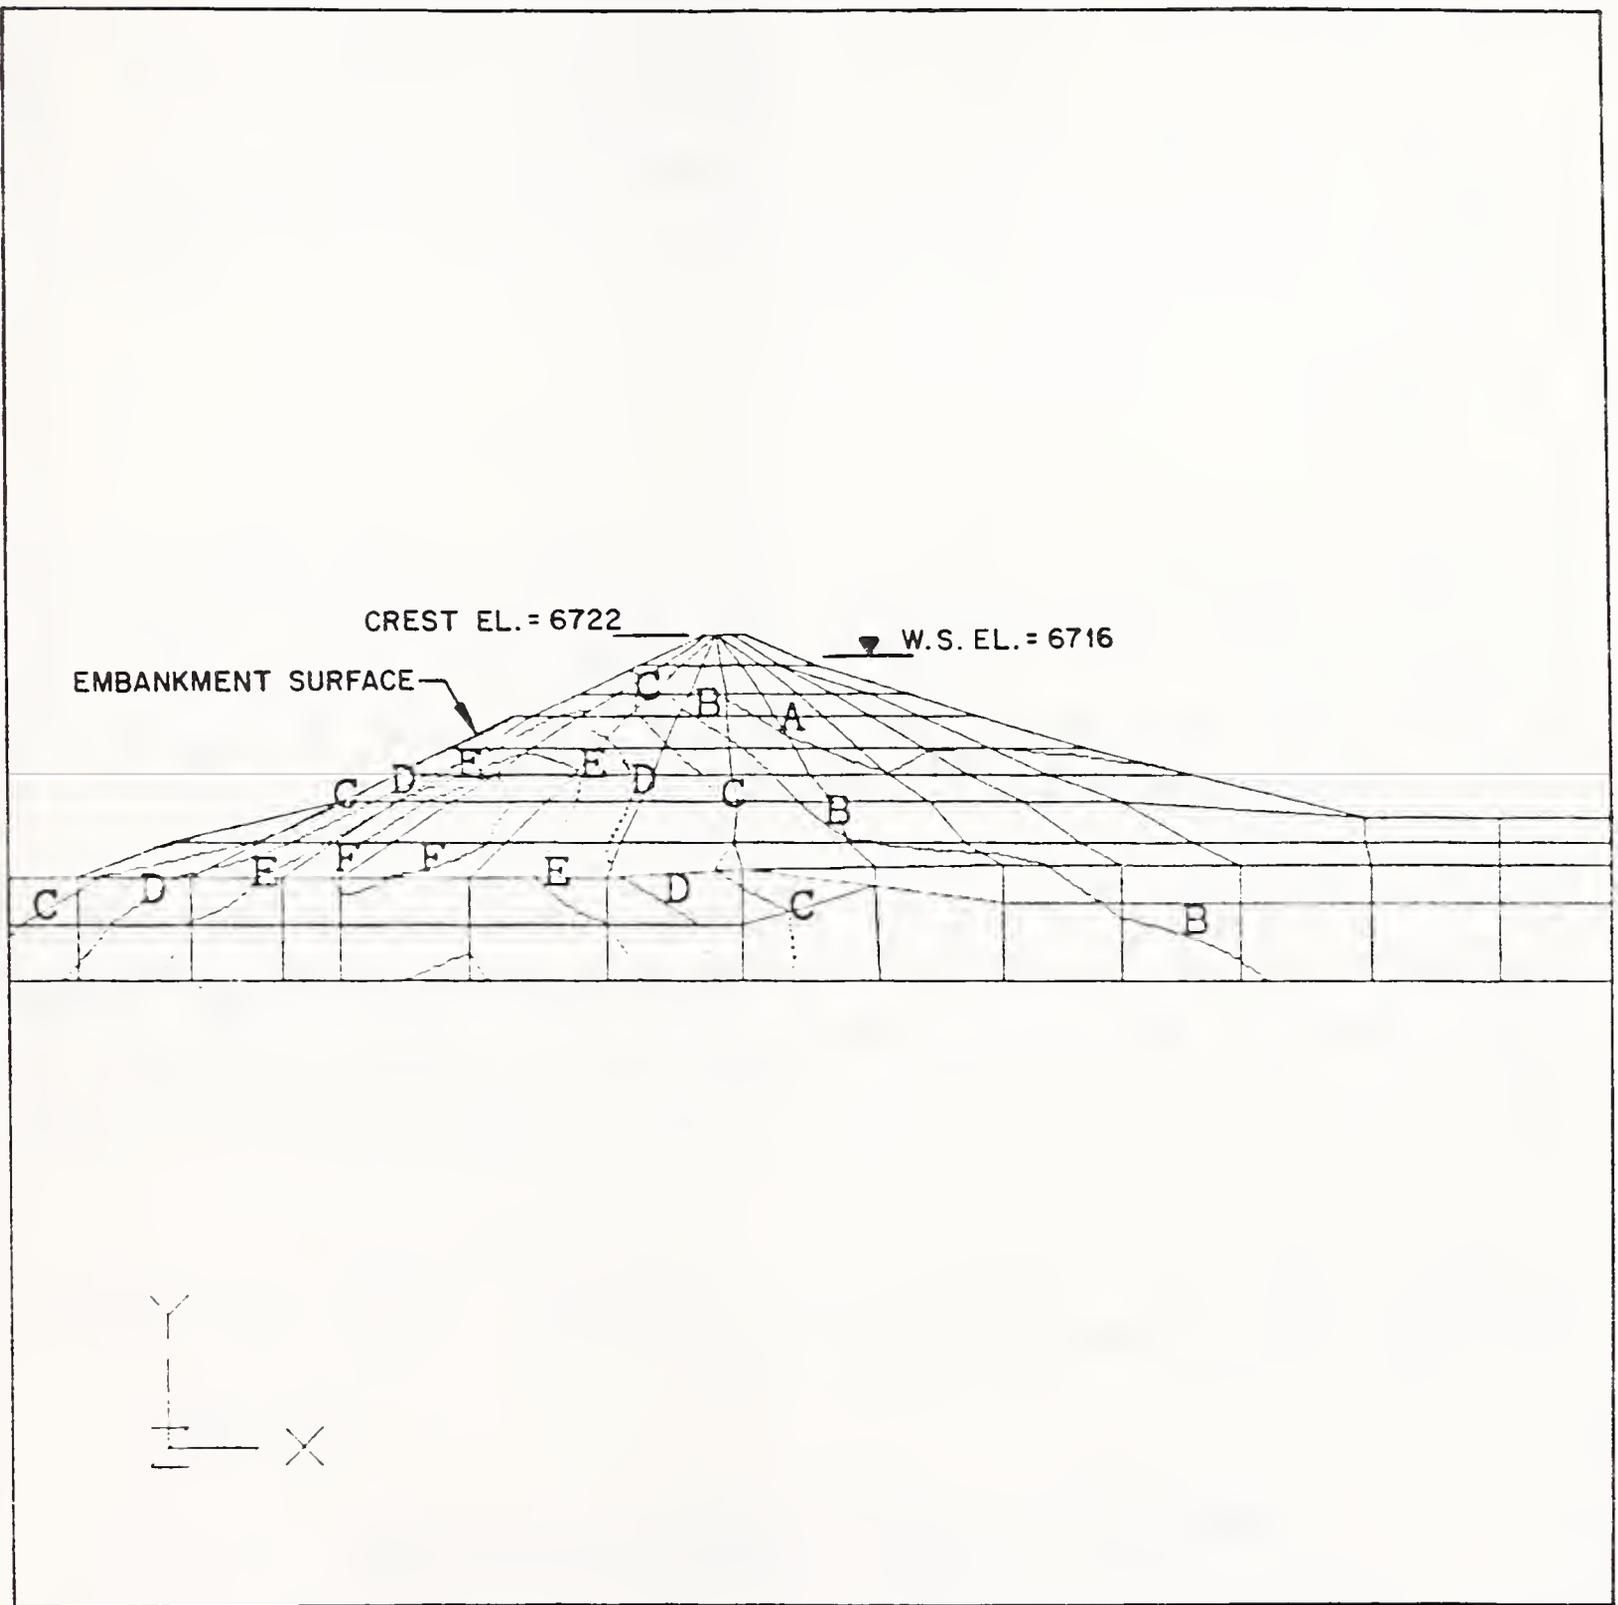
CONTOUR	SHEAR STRESS $\tau_{xy}$ , in Tons / Ft. <sup>2</sup>
A	0
B	0.2
C	0.4
D	0.6
E	0.8
F	1.0
G	1.2

Source : Computer generated, see reference 23

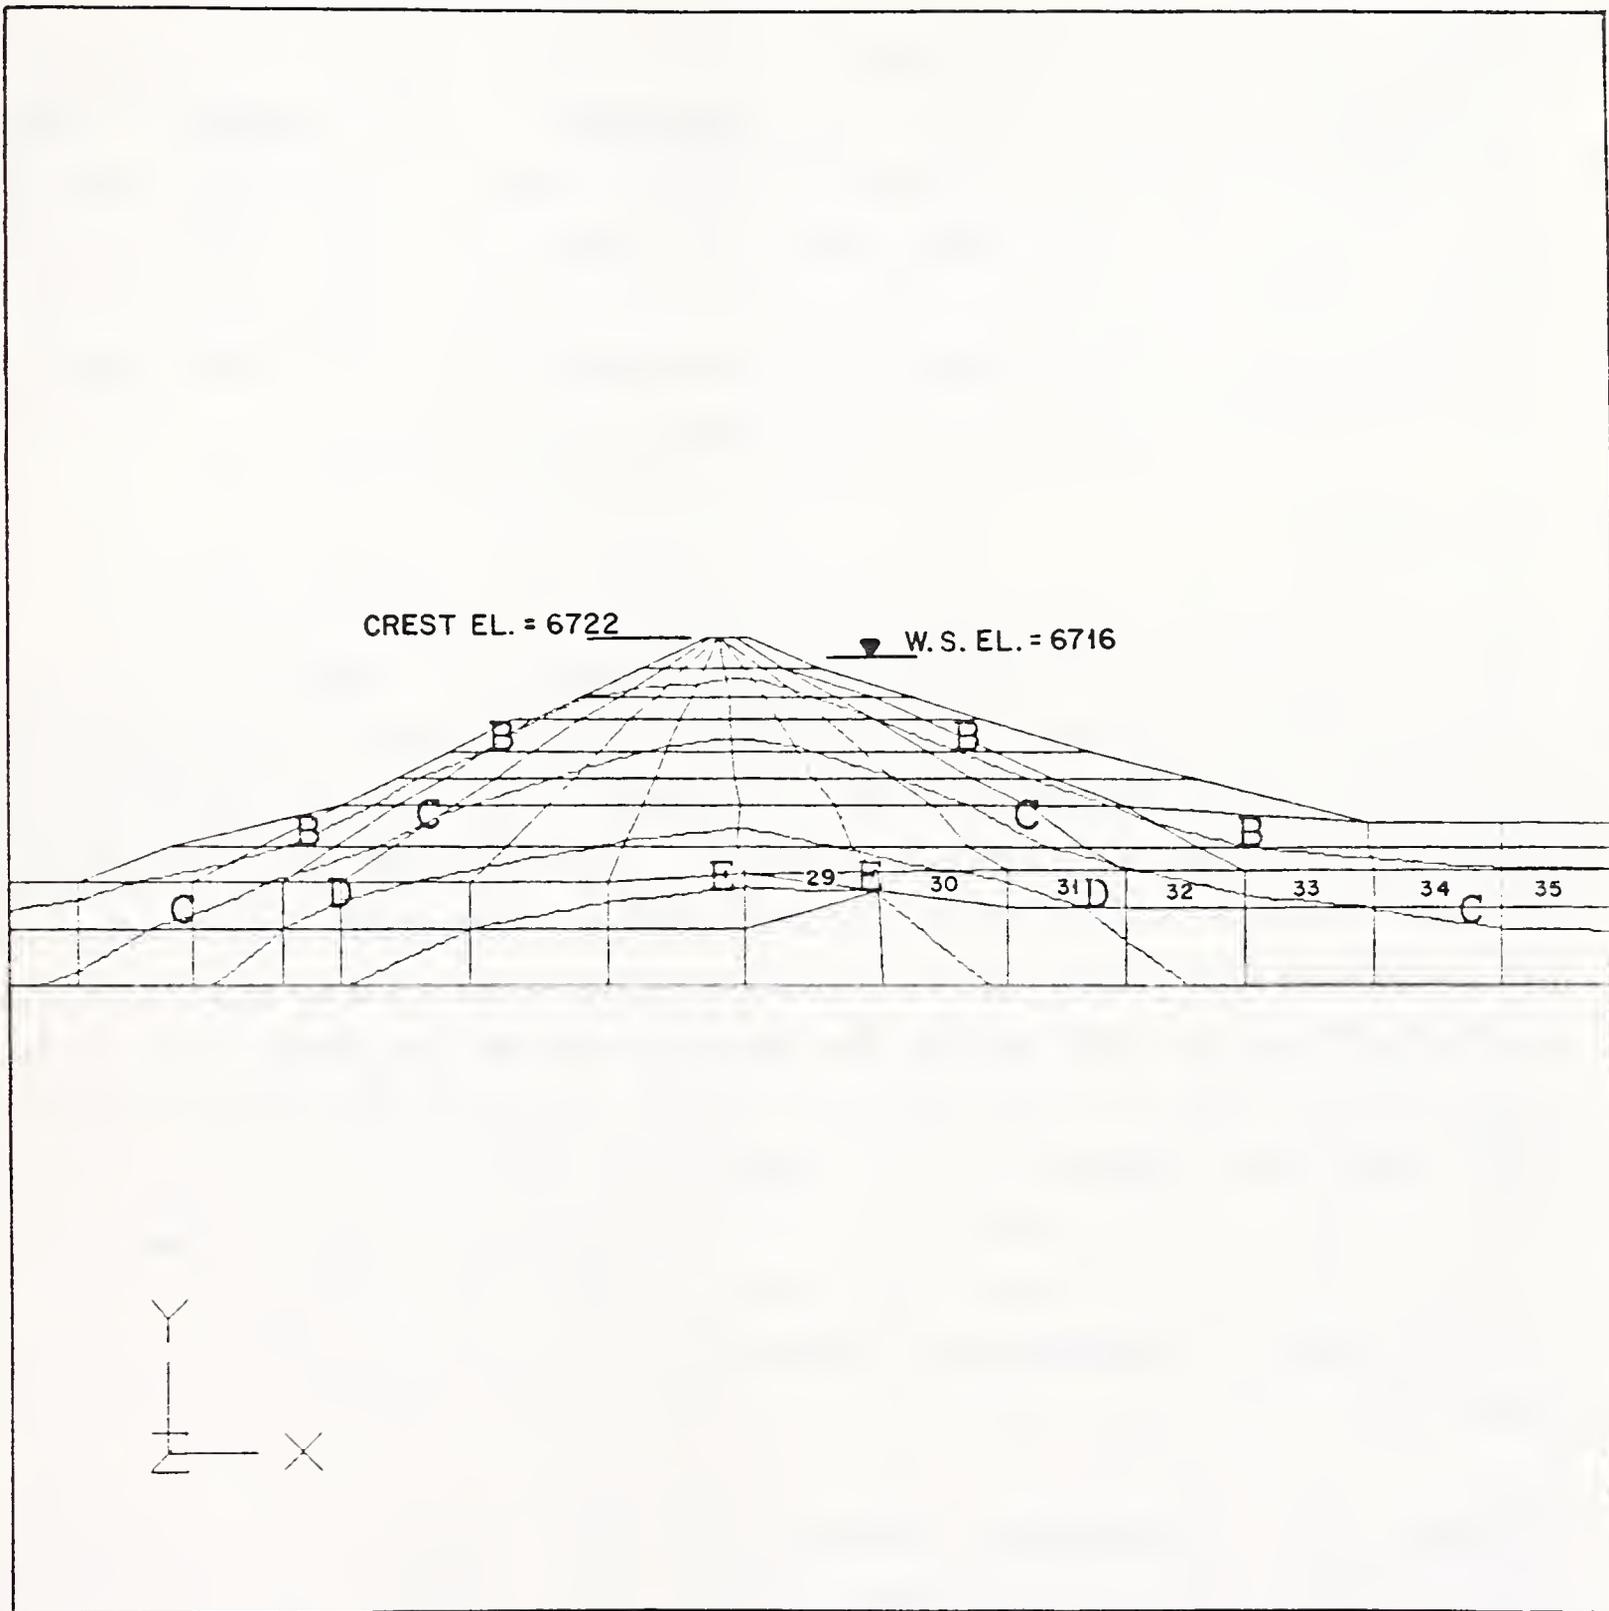
CONTOUR	MAXIMUM DYNAMIC SHEER STRESS $\tau_c$ , in pcf (induced by earthquake)
A	200
B	740
C	1280
D	1820
E	2360
F	2900

Elements 29-35 represent  
the sand deposit

<u>Element</u>	<u>Tc (max. induced, psf)</u>	<u>Cyclic Stress Tc X .65 (psf)</u>
29	2024	1316
30	1899	1234
31	1680	1092
32	1083	704
33	1208	785
34	918	596
35	968	629

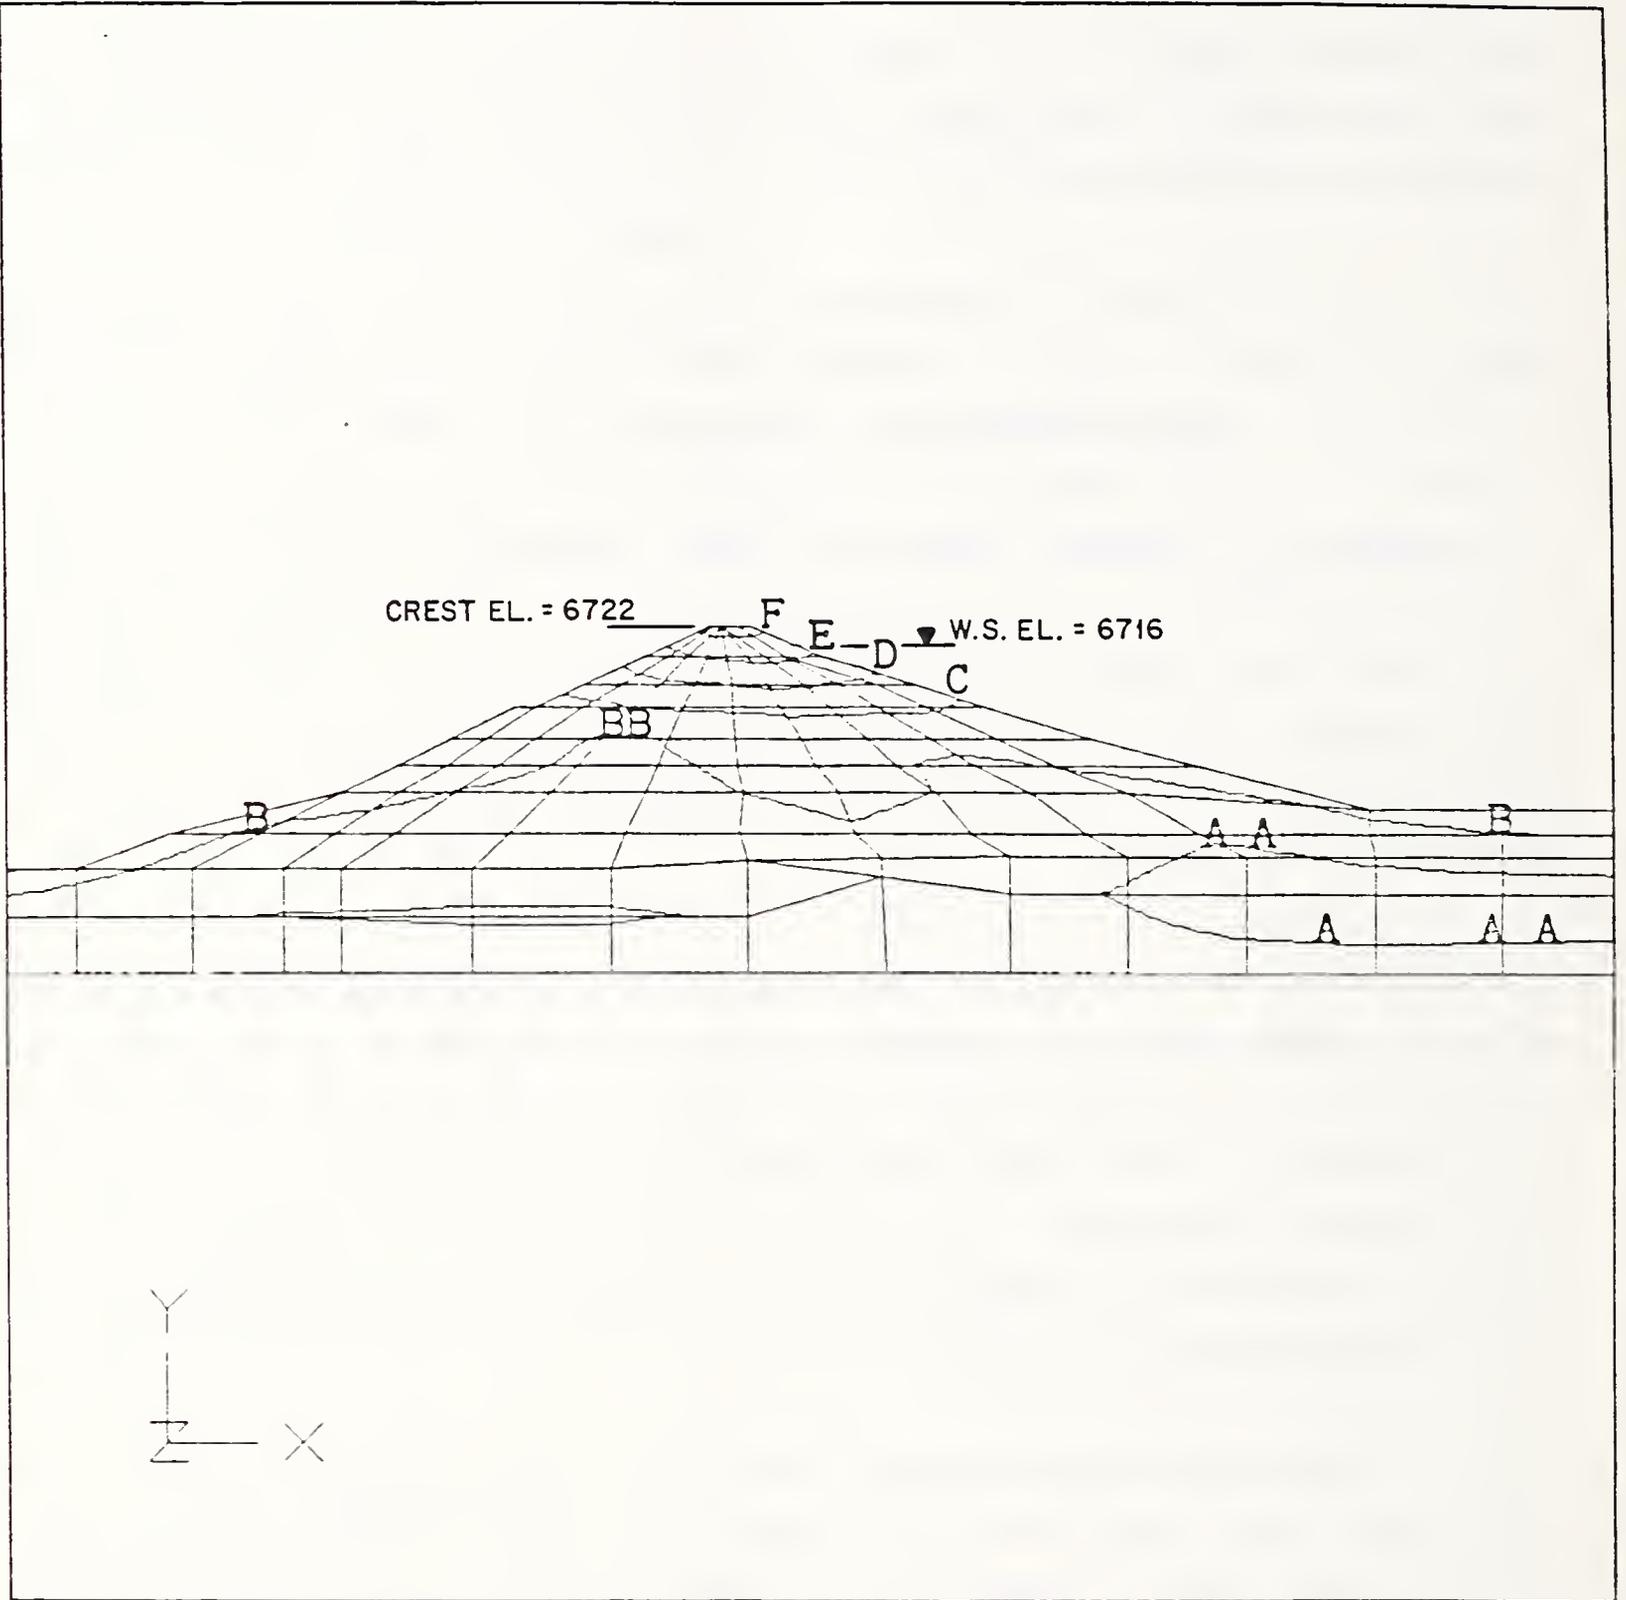
FIGURE 12

<u>CONTOUR</u>	<u>MAXIMUM HORIZONTAL ACCELERATION, (g's)</u>
A	0.20
B	0.25
C	0.30
D	0.35
E	0.40
F	0.47

Horizontal accelerations were generated using the design earthquake with a magnitude of 6.5 and a specified horizontal acceleration at the base of .22 g.

Contours of the maximum horizontal accelerations (g's) induced within the embankment by the design earthquake are presented in Figure 12. A maximum peak (at crest) acceleration of 0.47g was calculated by the Quad 4 computer program for this portion of the dynamic analysis. The natural period of the embankment due to the specified ground motion of 0.22g was also calculated to be 0.69 seconds.

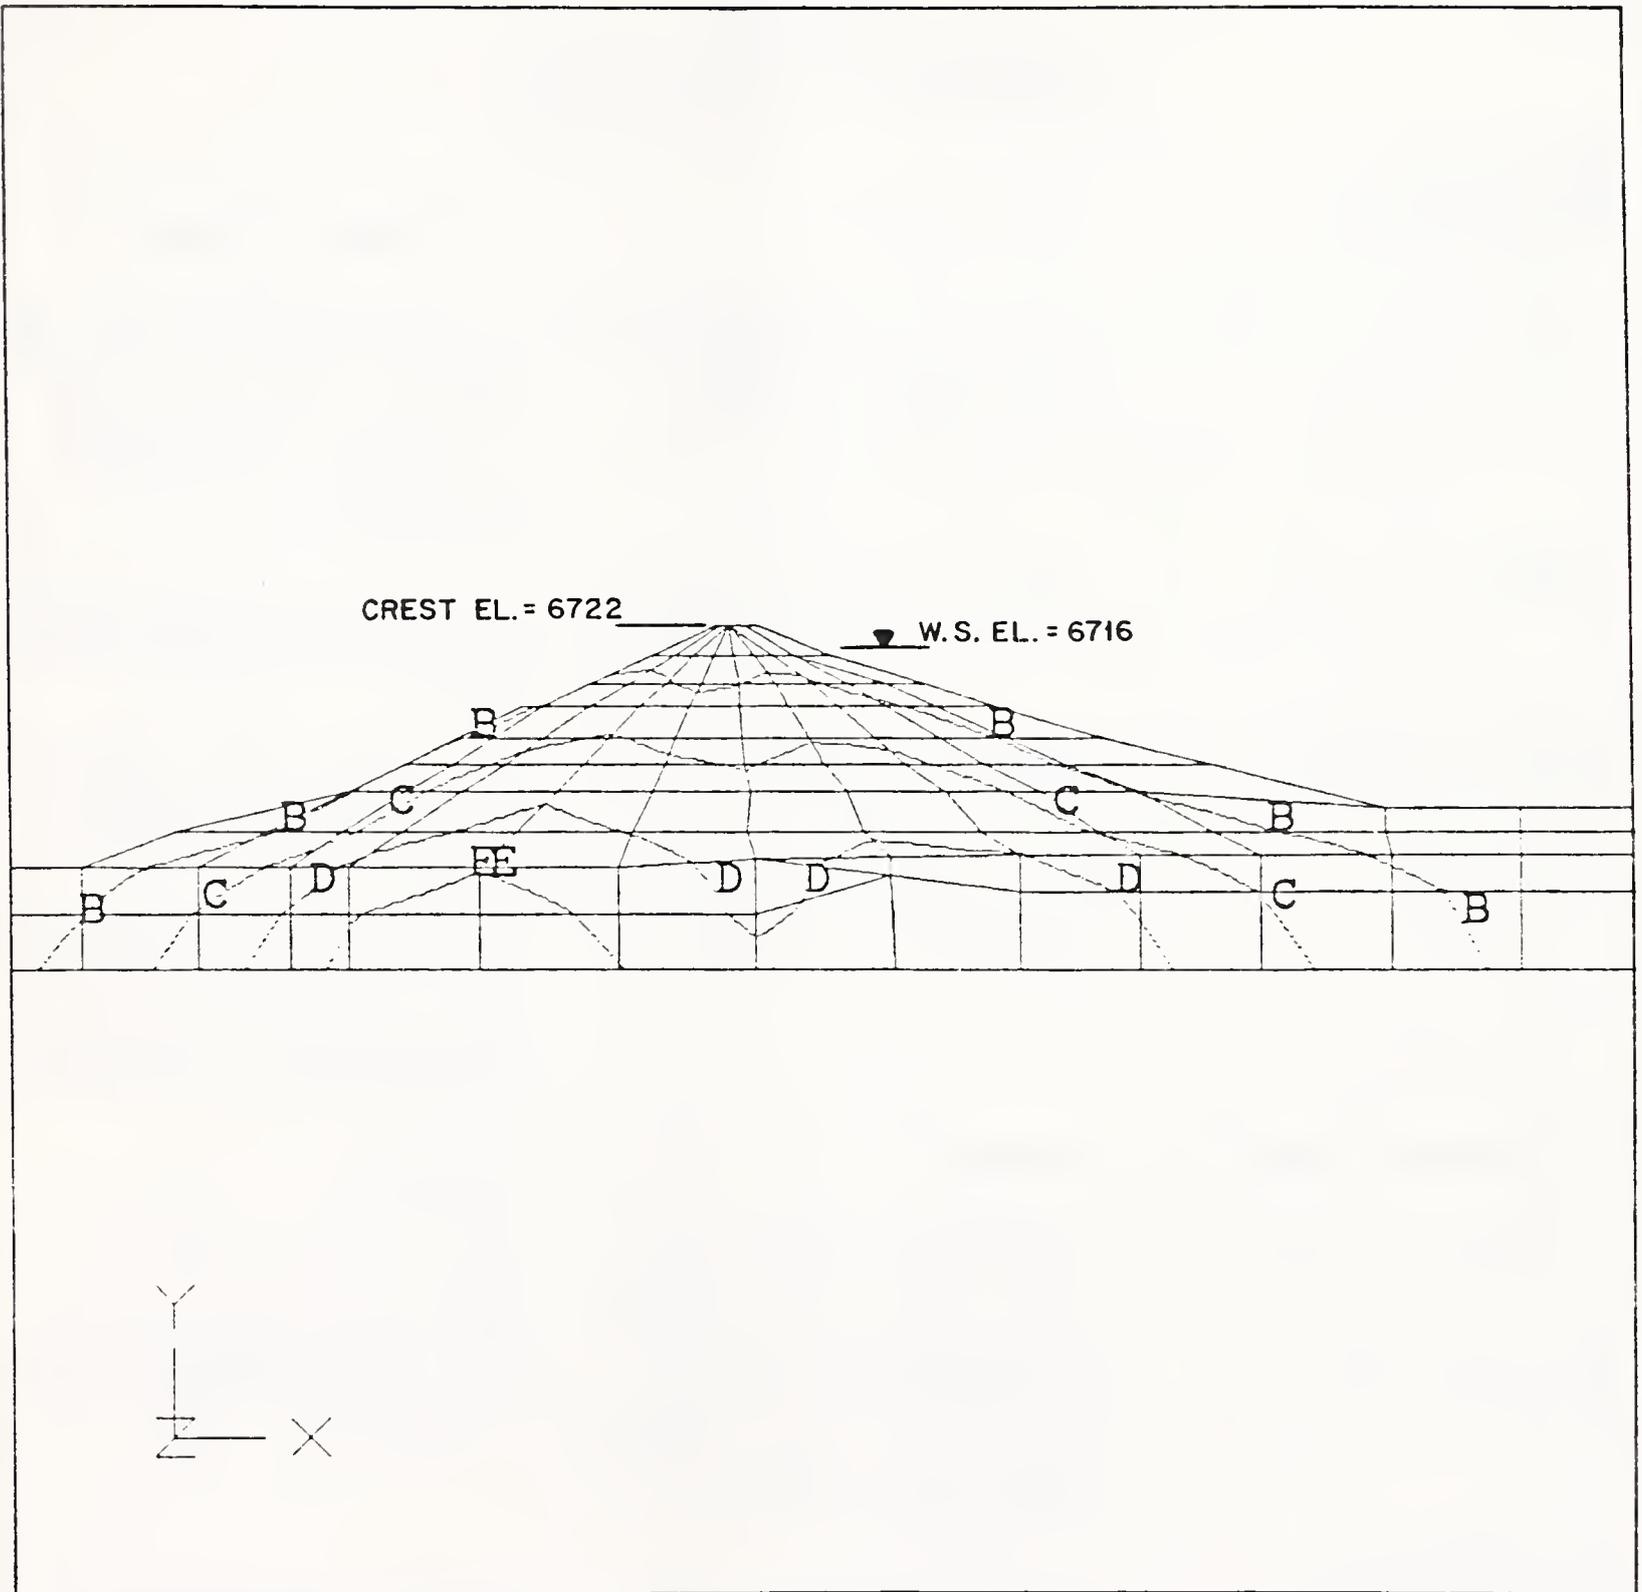
CONTOUR	MAXIMUM DYNAMIC VERTICAL STRESS, $\sigma_y$ , in psf
A	0
B	280
C	560
D	840
E	1120
F	1400

Source : Computer generated, see reference 15

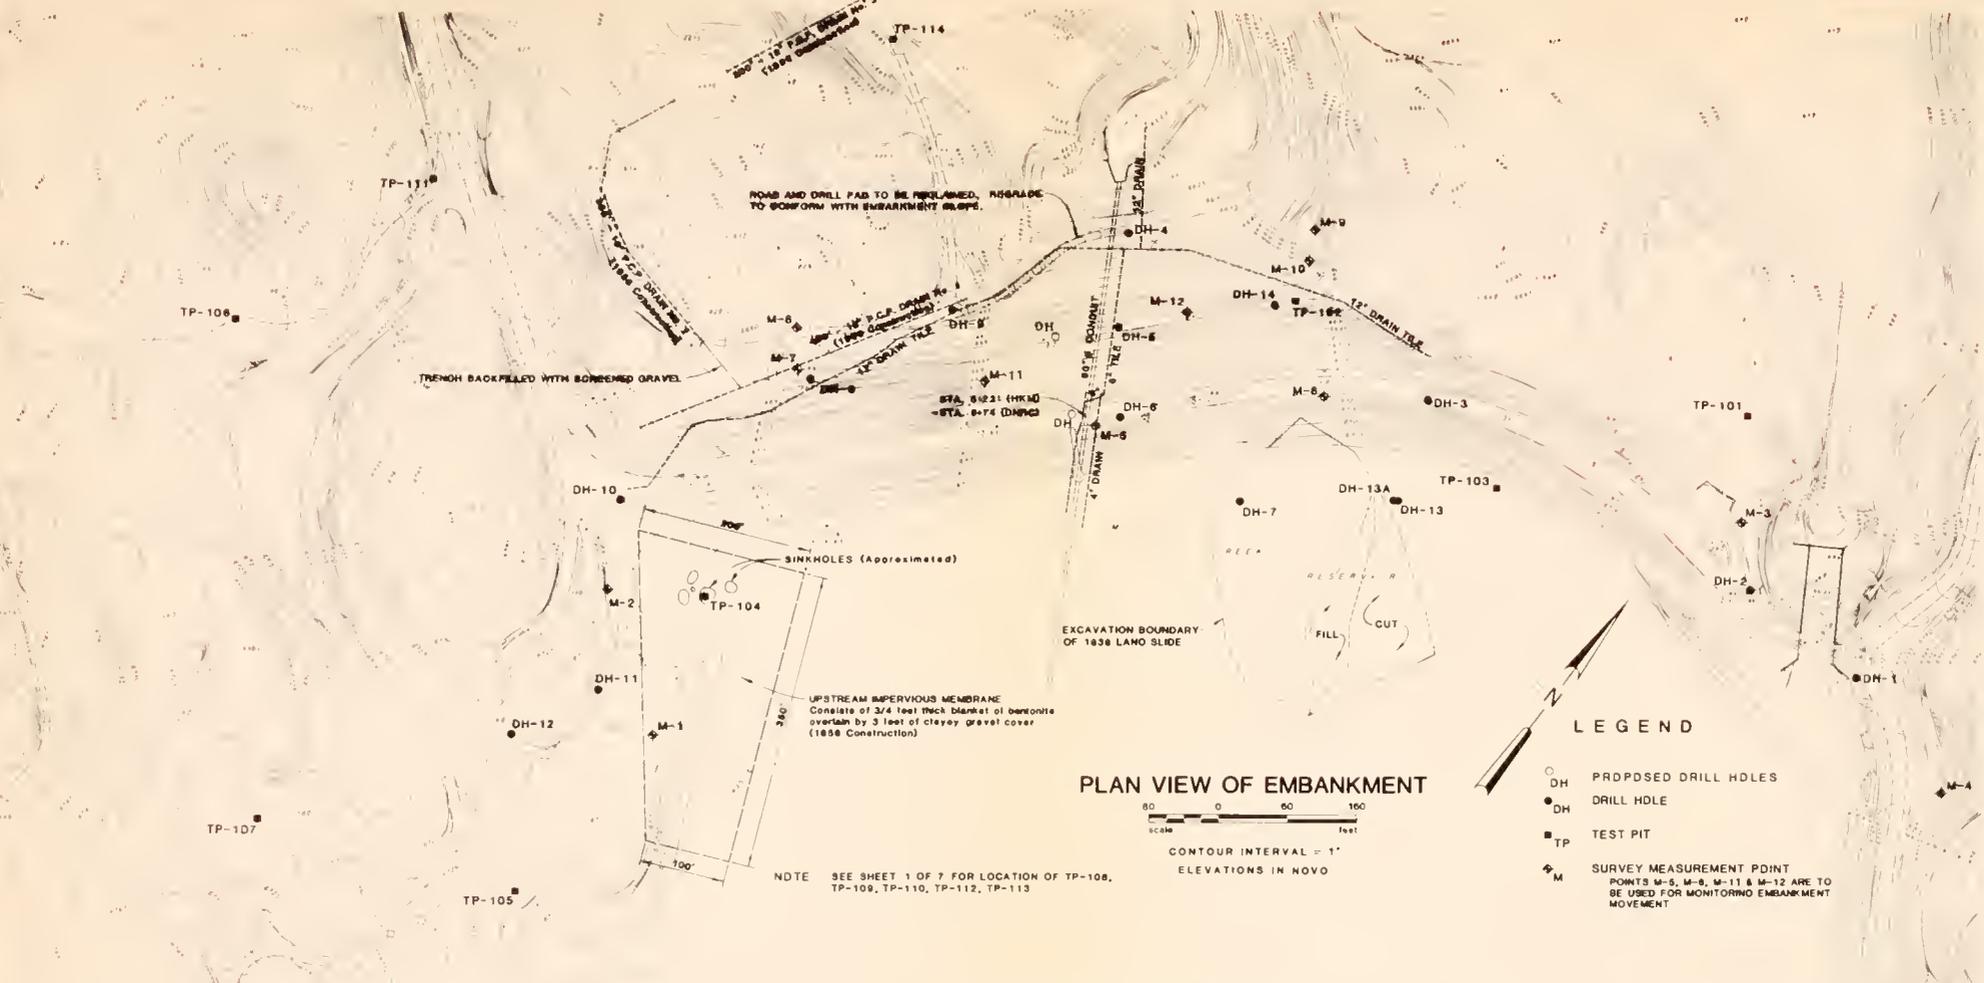
**PLAN VIEW OF EMBANKMENT**

**MIDDLE CREEK DAM**  
**GEOTECHNICAL INVESTIGATION**  
**EMBANKMENT PLAN AND PROFILE**

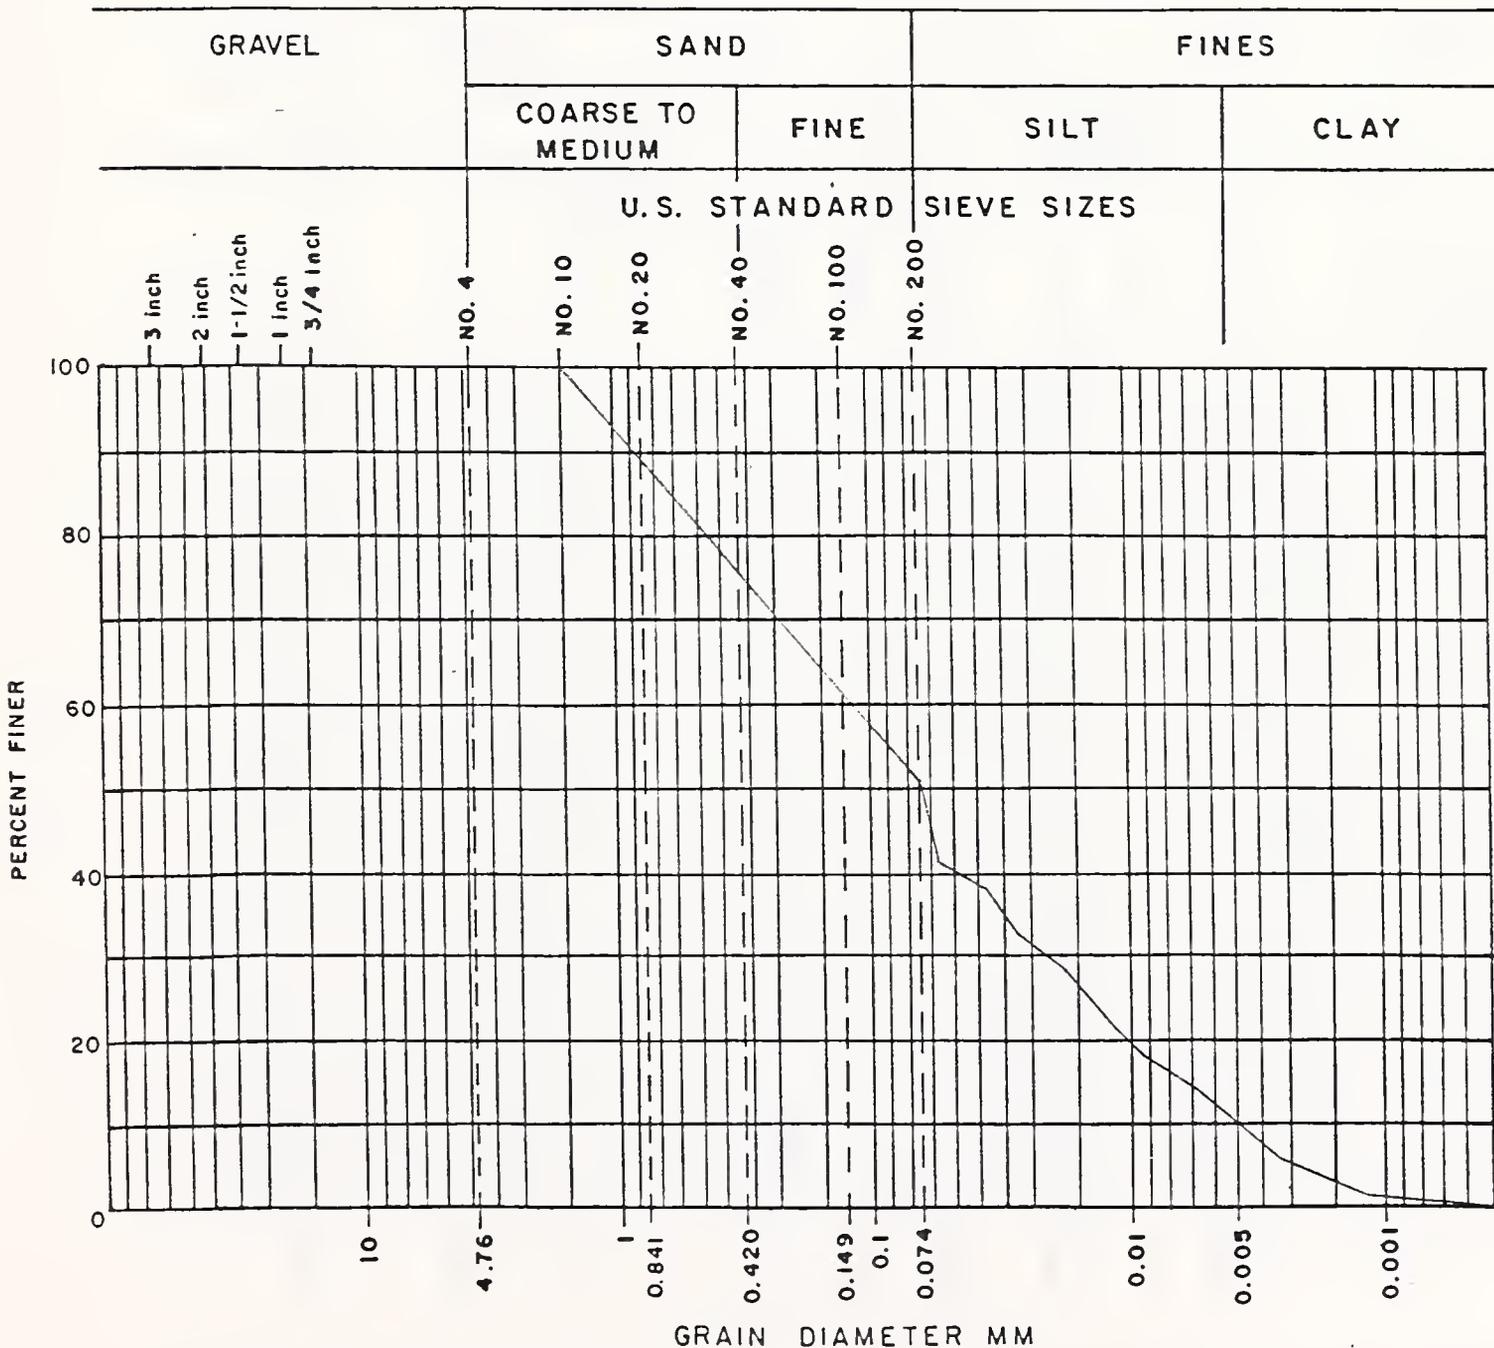
GRAIN SIZE DISTRIBUTION

PROJECT NO. 8M087.113 LAB NO. 2869  
 PROJECT NAME Middle Creek Dam FIELD NO. DH-2 (20.0-22.0')  
 DATE SAMPLED 8-3-83 DATE TESTED 9-23-83  
 SAMPLED BY DLD TESTED BY CS  
 TYPE SAMPLE Drive SAMPLE LOCATION Bridge  
 SOIL DESCRIPTION SANDY SILT (ML) Abutment

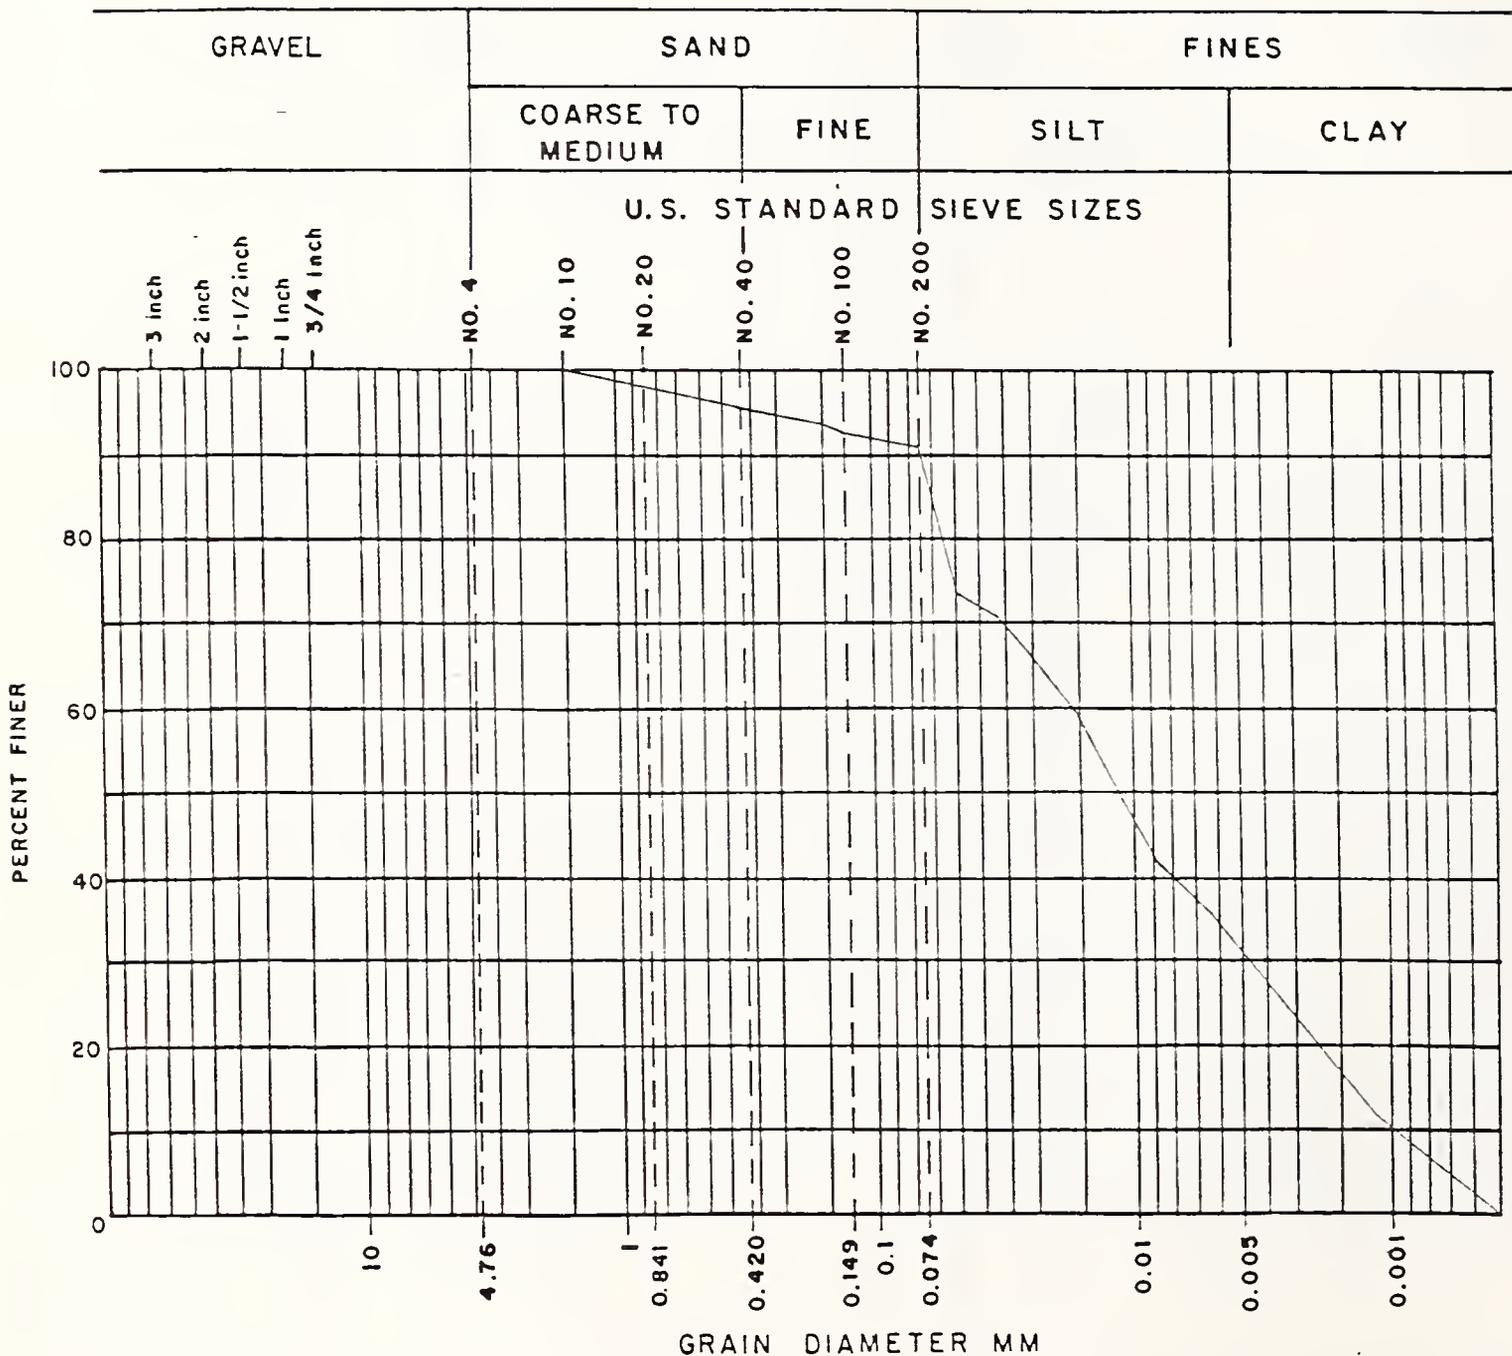
GRAIN SIZE DISTRIBUTION

PROJECT NO. 8M087.113 LAB NO. 2896  
 PROJECT NAME Middle Creek Dam FIELD NO. DH-4 (103.8-104.8')  
 DATE SAMPLED 8-10-83 DATE TESTED 9-21-83  
 SAMPLED BY DN TESTED BY CS  
 TYPE SAMPLE Core SAMPLE LOCATION Bedrock at  
 SOIL DESCRIPTION CLAYSTONE SHALE (CL-2) Downstream

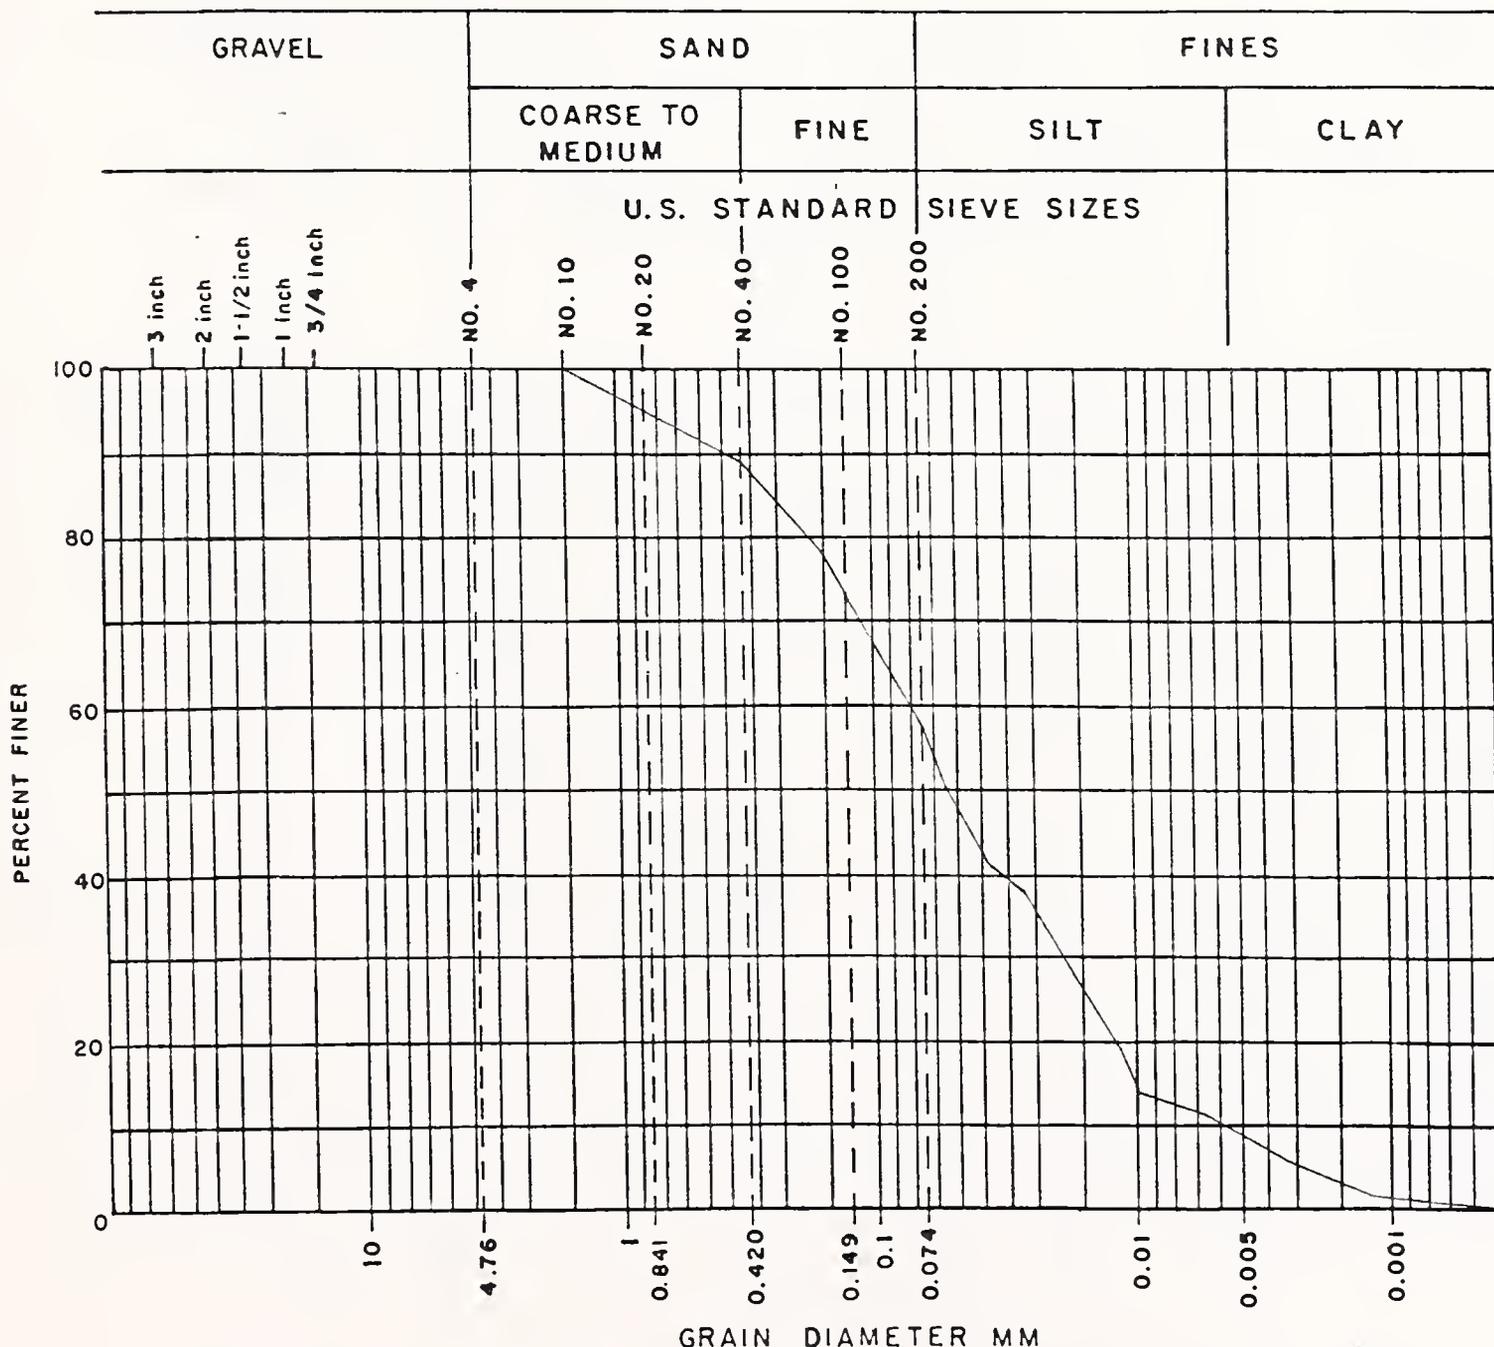
PROJECT NO. 8M087.113 LAB NO. 2912  
 PROJECT NAME Middle Creek Dam FIELD NO. DH-6 (10.0-12.0')  
 DATE SAMPLED 8-3-83 DATE TESTED 9-23-83  
 SAMPLED BY DLD TESTED BY CS  
 TYPE SAMPLE Drive SAMPLE LOCATION Semi-pervious  
 SOIL DESCRIPTION SANDY SILT (ML) Zone \_\_\_\_\_

- 1)\_ GRAVEL, Passing 3" & retained on no. 4 sieve \_ 0 \_ %
- 2)\_ SAND, Passing no. 4 sieve & retained on no. 200 sieve. \_ 42 \_ %
- 3)\_ SILT & CLAY, Passing no. 200 sieve \_ 58 \_ %

Liquid Limit = 31%  
 Plastic Index = 4

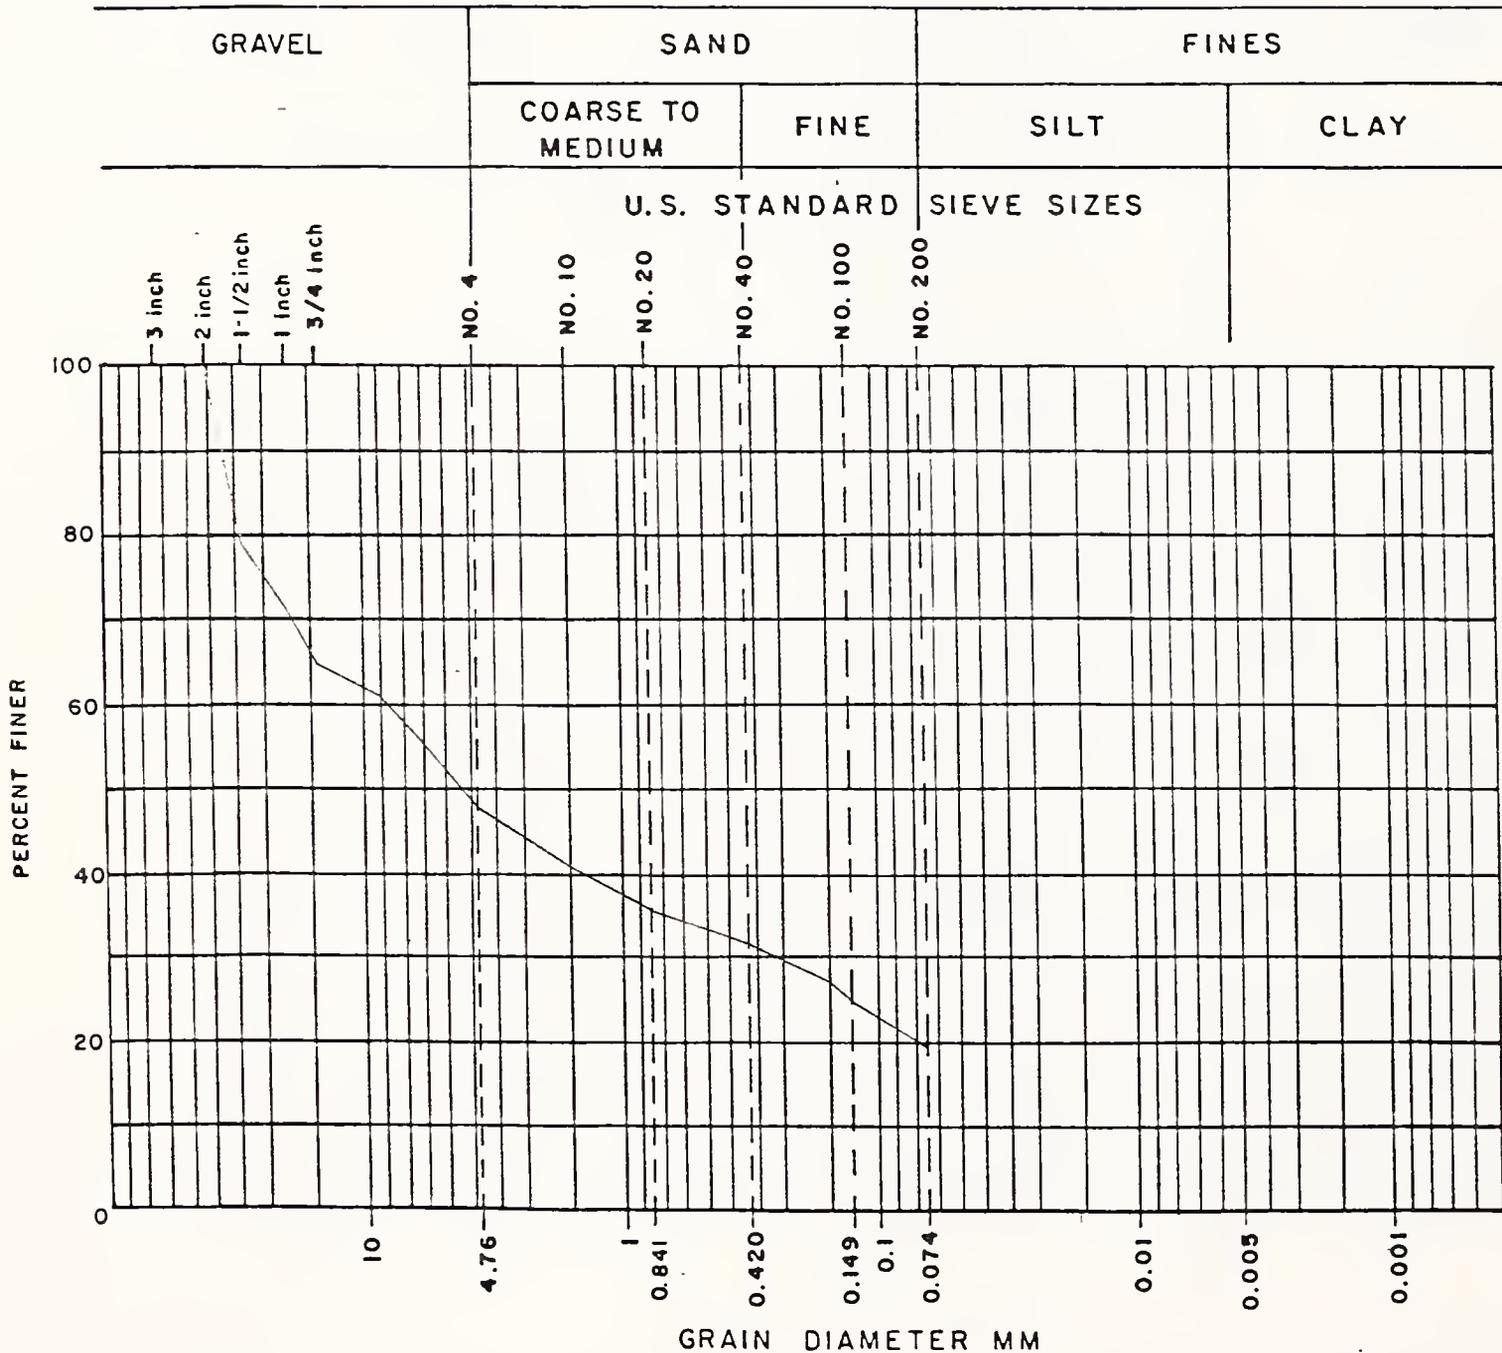
PROJECT NO. 8M087.113 LAB NO. 2916  
 PROJECT NAME Middle Creek Dam FIELD NO. DH-6 (45.0 - 47.1)  
 DATE SAMPLED 8-4-83 DATE TESTED 10-13-83  
 SAMPLED BY DLD TESTED BY CS  
 TYPE SAMPLE Drive SAMPLE LOCATION Semi-pervious  
 SOIL DESCRIPTION SILTY GRAVEL (GM) Zone

- 1) GRAVEL, Passing 3" & retained on no. 4 sieve 52 %
- 2) SAND, Passing no. 4 sieve & retained on no. 200 sieve. 29 %
- 3) SILT & CLAY, Passing no. 200 sieve 19 %

Liquid Limit = 28%  
 Plastic Index = 3
