# MIDDLE CREEK DAM

## GEOTECHNICAL INVESTIGATION

MIDDLE CREEK DAM  
GEOTECHNICAL INVESTIGATION

February 1984  
8M087.113/0611H

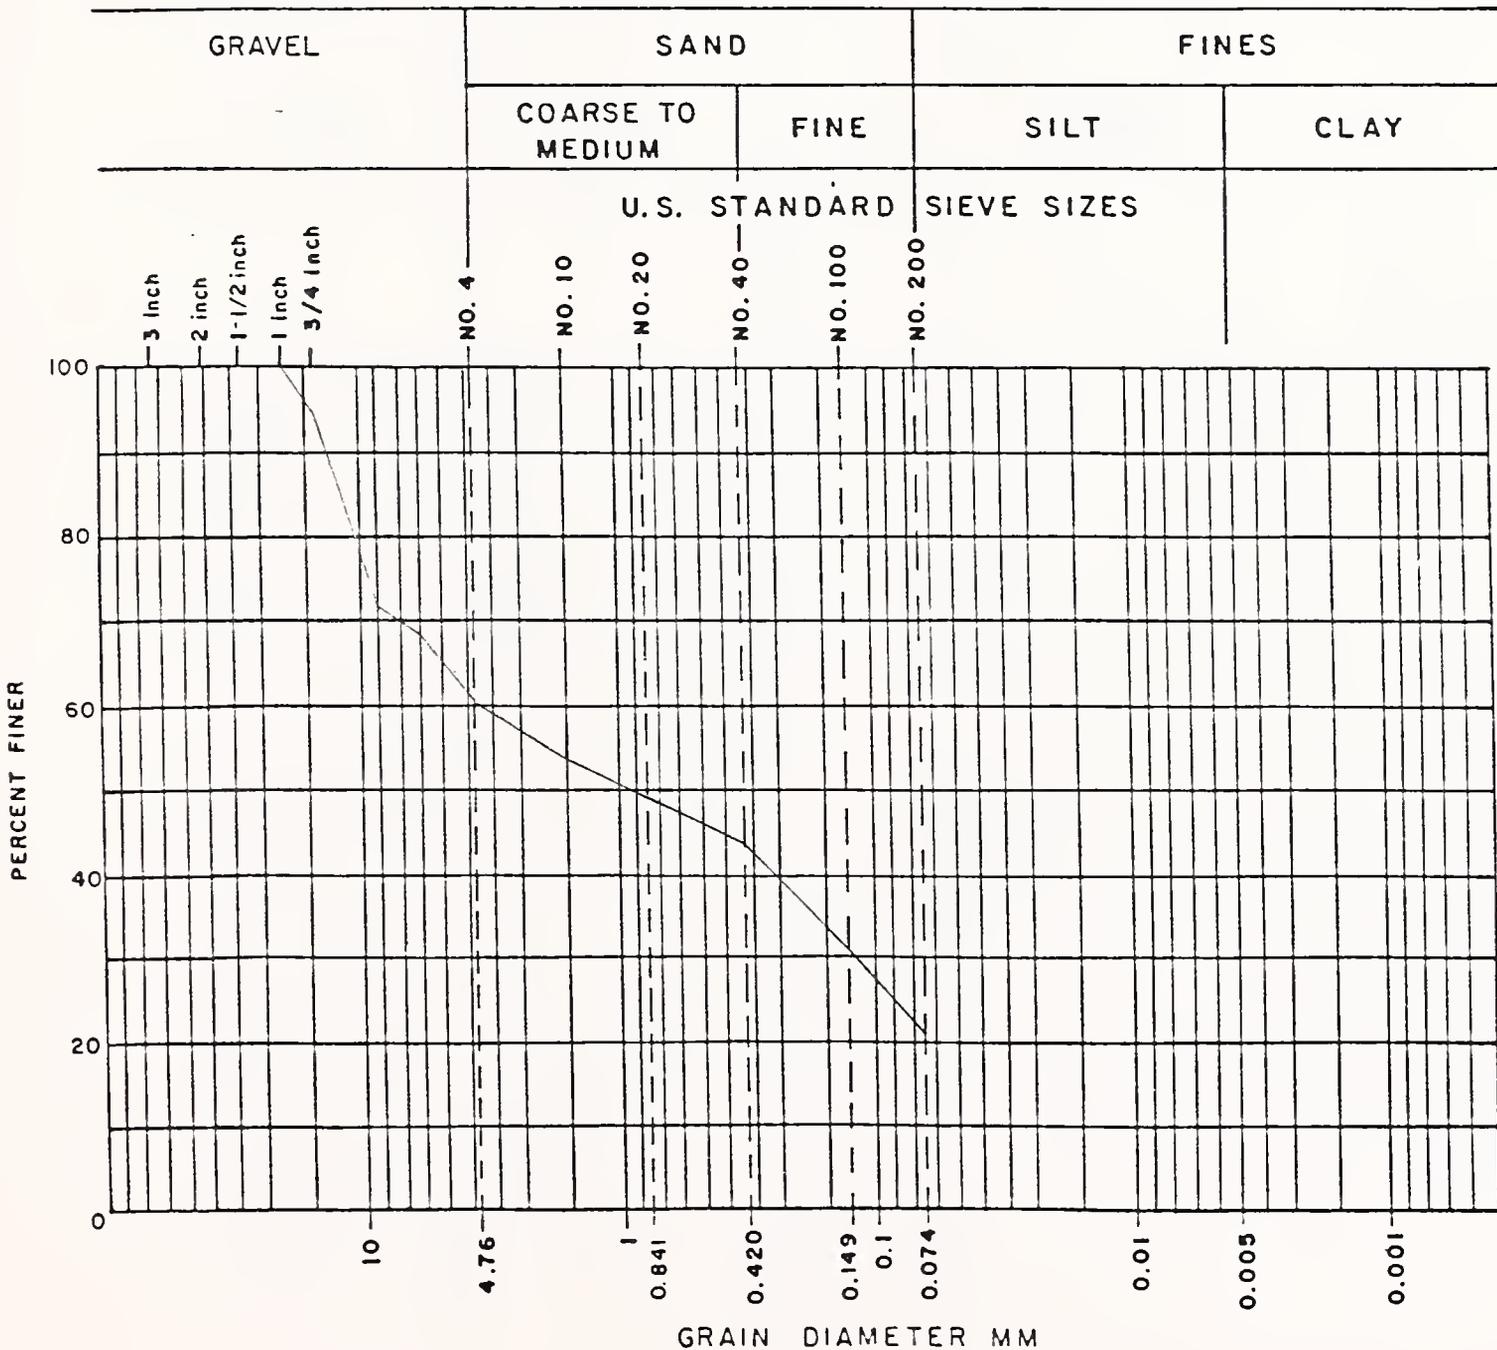
PROJECT NO. 8M087.113 LAB NO. 2918  
 PROJECT NAME Middle Creek Dam FIELD NO. DH-6 (65.0-66.5')  
 DATE SAMPLED 8-3-83 DATE TESTED 10-13-83  
 SAMPLED BY DLD TESTED BY CS  
 TYPE SAMPLE Drive SAMPLE LOCATION Semi-pervious  
 SOIL DESCRIPTION CLAYEY SAND (SC) Zone

- 1) GRAVEL, Passing 3" & retained on no. 4 sieve ----- 39 %
- 2) SAND, Passing no. 4 sieve & retained on no. 200 sieve. ----- 40 %
- 3) SILT & CLAY, Passing no. 200 sieve ----- 21 %

Liquid Limit = 41%  
 Plastic Index = 15

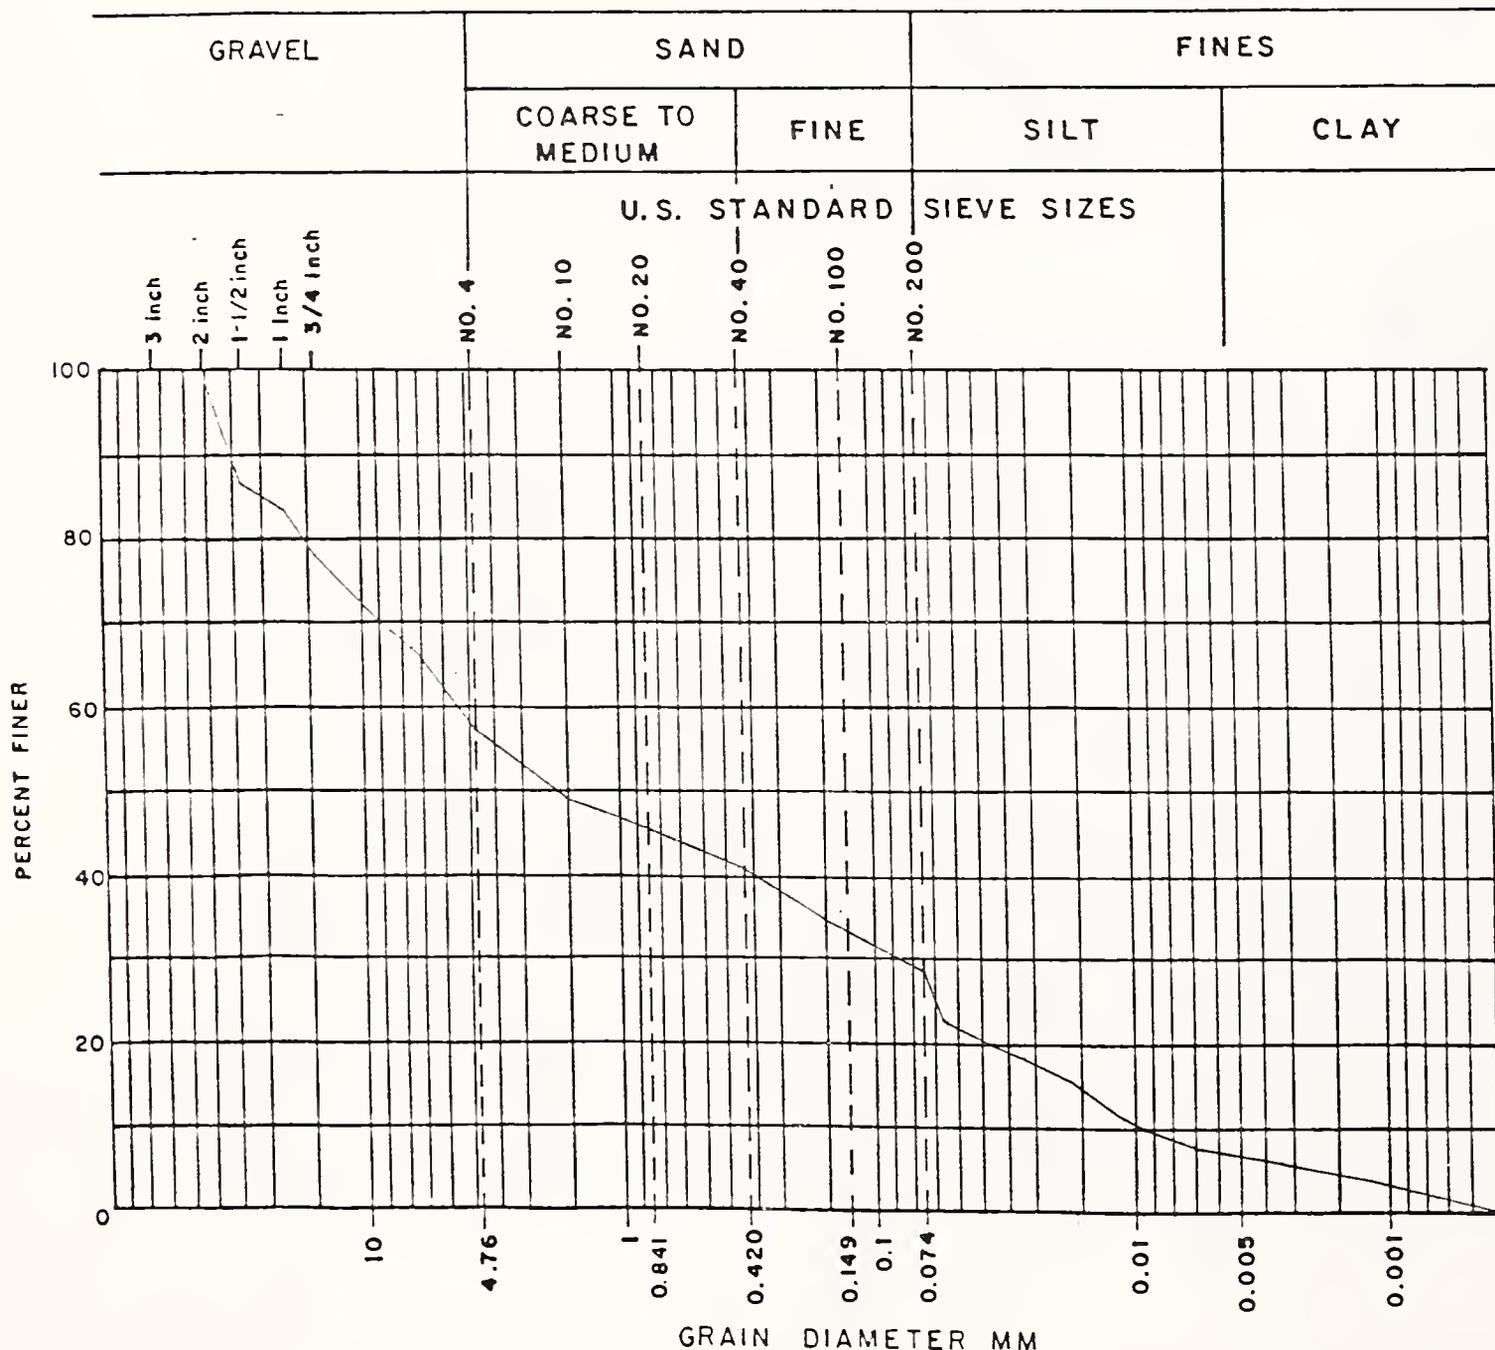
GRAIN SIZE DISTRIBUTION

PROJECT NO. 8M087.113 LAB NO. 3010  
 PROJECT NAME Middle Creek Dam FIELD NO. DH-7 (12.0-12.5')  
 DATE SAMPLED 9-28-83 DATE TESTED 10-21-83  
 SAMPLED BY DLD TESTED BY JP  
 TYPE SAMPLE Drive SAMPLE LOCATION Impervious Zone  
 SOIL DESCRIPTION CLAYEY GRAVEL (GC)

- 1) GRAVEL, Passing 3" & retained on no. 4 sieve 43 %
  - 2) SAND, Passing no. 4 sieve & retained on no. 200 sieve. 28 %
  - 3) SILT & CLAY, Passing no. 200 sieve 29 %
- Liquid Limit = 33%  
 Plastic Index = 18

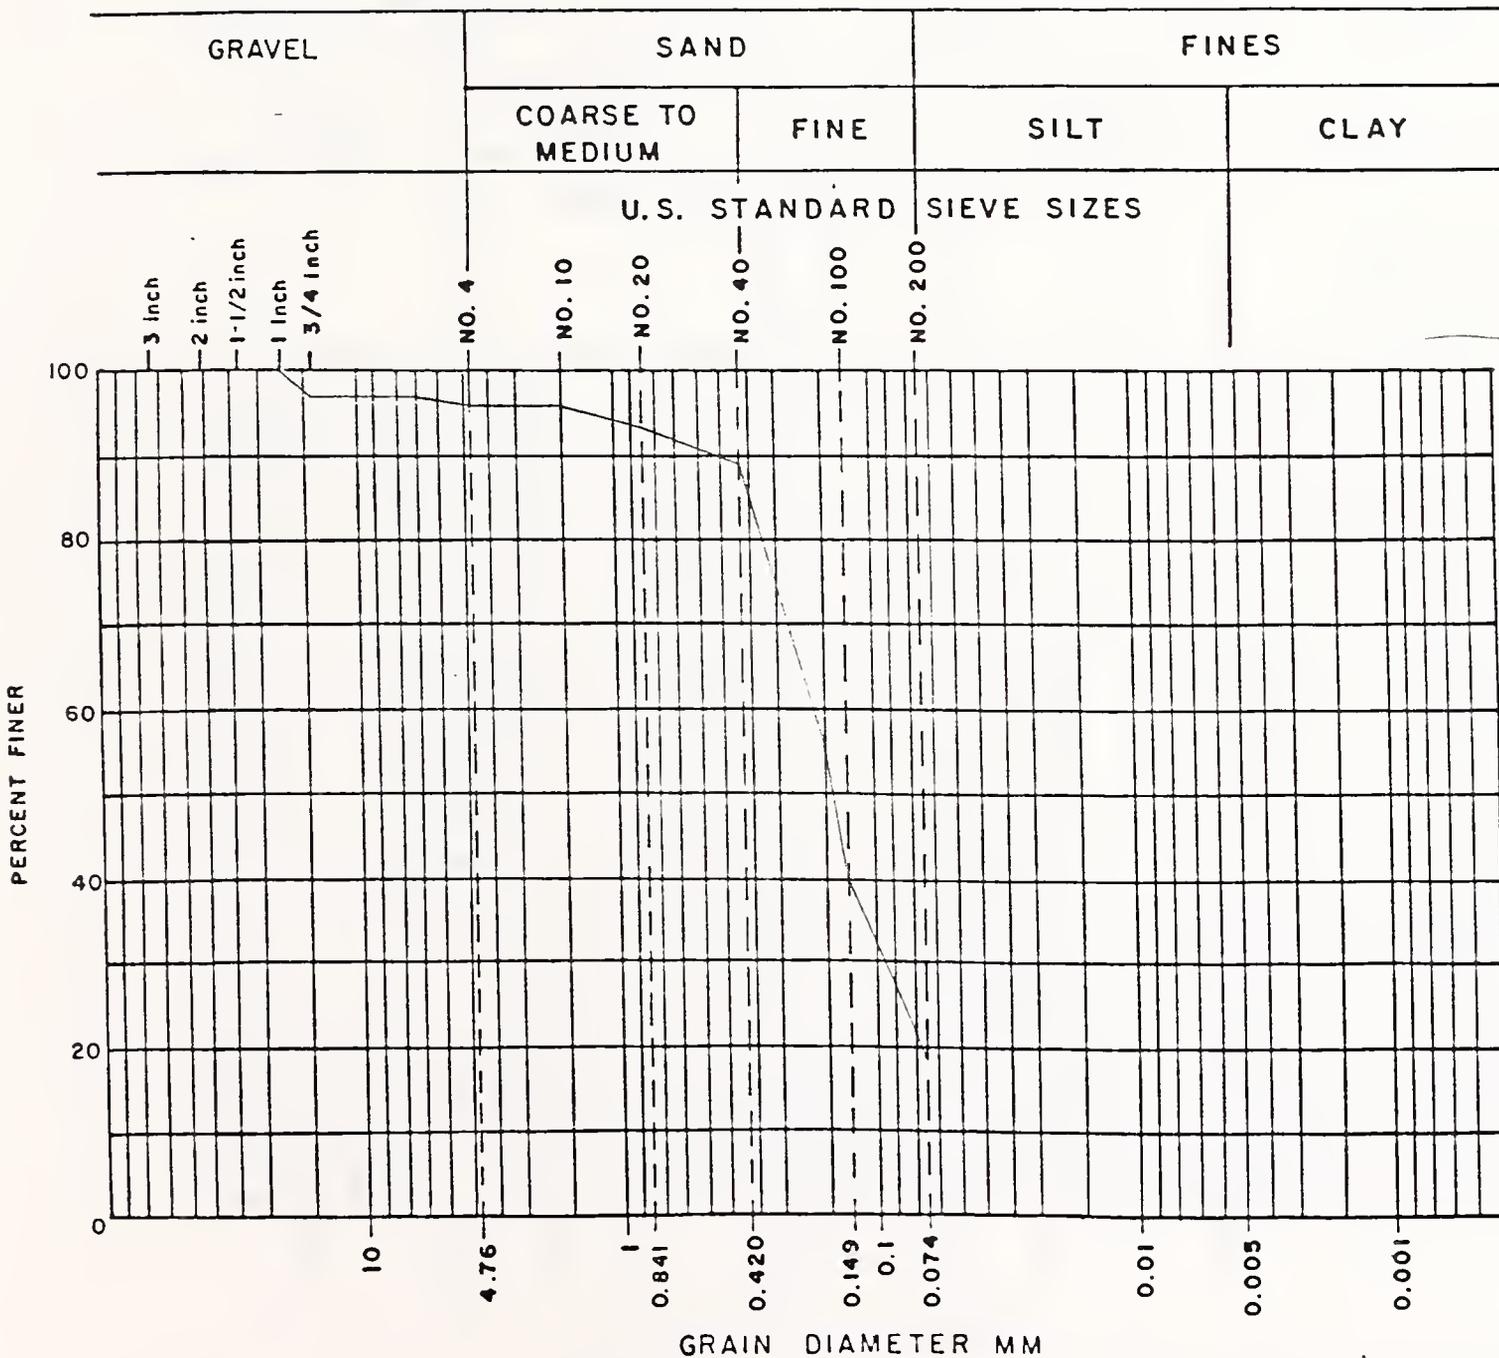
GRAIN SIZE DISTRIBUTION

PROJECT NO. 8M087.113 LAB NO. 3019  
 PROJECT NAME Middle Creek Dam FIELD NO. DH-7 (75.0-76.5')  
 DATE SAMPLED 10-6-83 DATE TESTED 10-24-83  
 SAMPLED BY DLD TESTED BY CS  
 TYPE SAMPLE Drive SAMPLE LOCATION Natural Sand  
 SOIL DESCRIPTION CLAYEY SAND Deposit under Upstream Face

- 1) GRAVEL, Passing 3" & retained on no. 4 sieve 4 %
- 2) SAND, Passing no. 4 sieve & retained on no. 200 sieve. 77 %
- 3) SILT & CLAY, Passing no. 200 sieve 19 %

Fine Sand = 70% Passing no. 40 and retained on no. 200

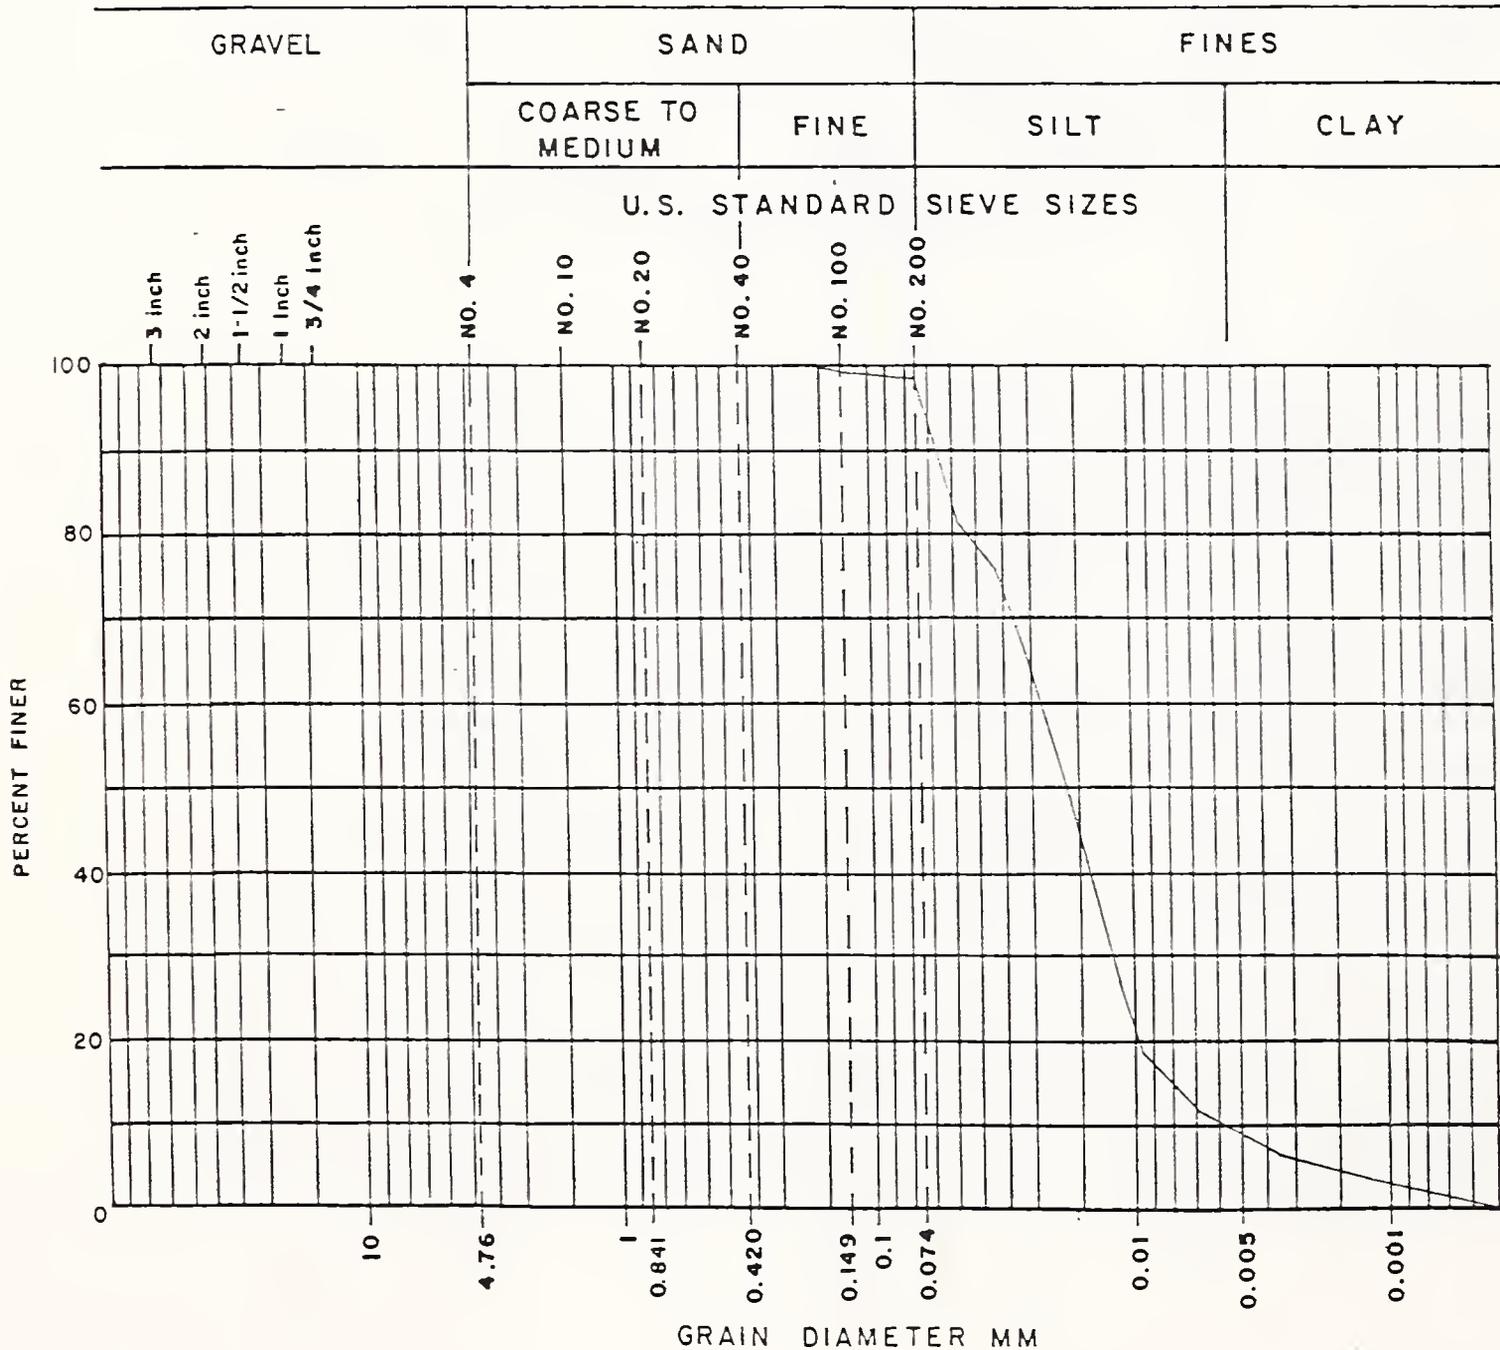
GRAIN SIZE DISTRIBUTION

PROJECT NO. 8M087.113 LAB NO. 3020  
 PROJECT NAME Middle Creek Dam FIELD NO. DH-7 (82.0-83.5')  
 DATE SAMPLED 10-7-83 DATE TESTED 10-25-83  
 SAMPLED BY DLD TESTED BY JP  
 TYPE SAMPLE Drive SAMPLE LOCATION Foundation Soil  
 SOIL DESCRIPTION CLAYEY SILT Under Upstream Slope

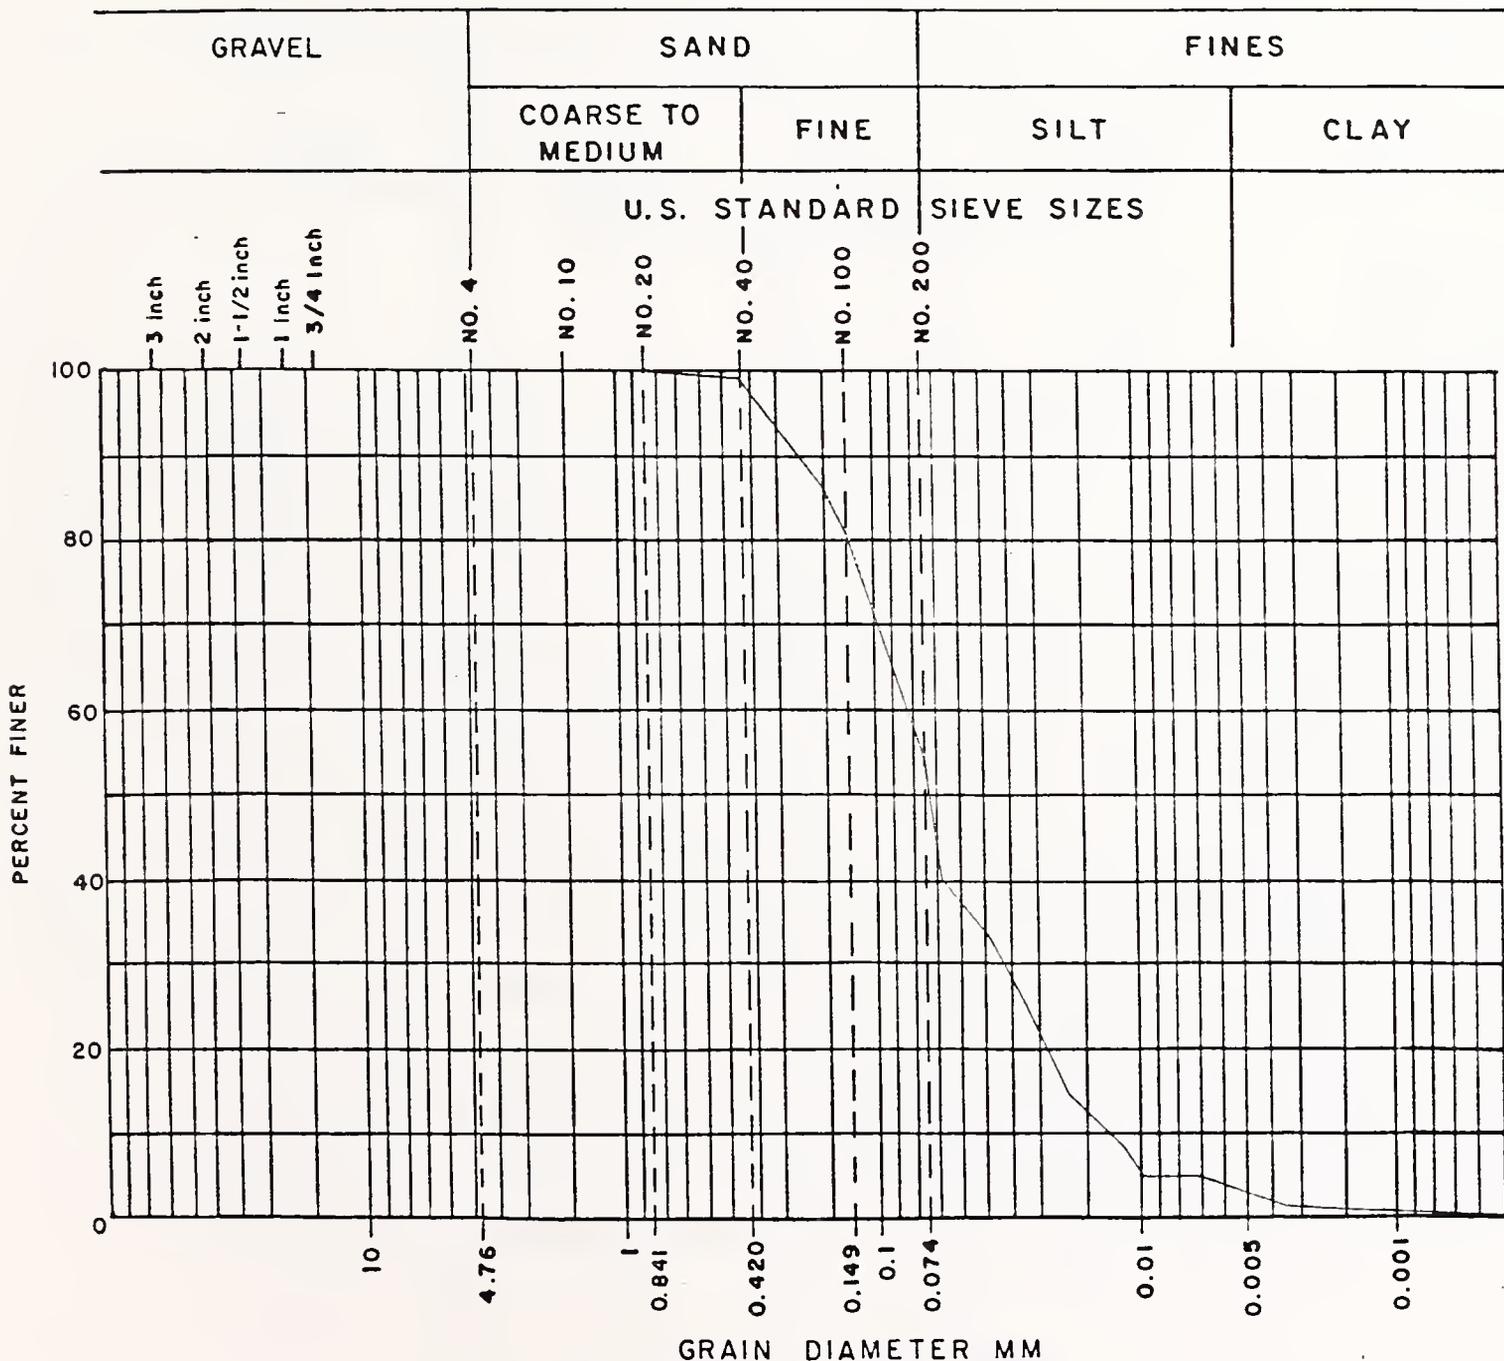
GRAIN SIZE DISTRIBUTION

PROJECT NO. 8M087.113 LAB NO. 3049  
 PROJECT NAME Middle Creek Dam FIELD NO. DH-13 (57.0-67.0')  
 DATE SAMPLED 10-12-83 DATE TESTED 10-21-83  
 SAMPLED BY DLD TESTED BY JP  
 TYPE SAMPLE Sack (cuttings) SAMPLE LOCATION Right Abutment  
 SOIL DESCRIPTION SANDY SILT Foundation Area

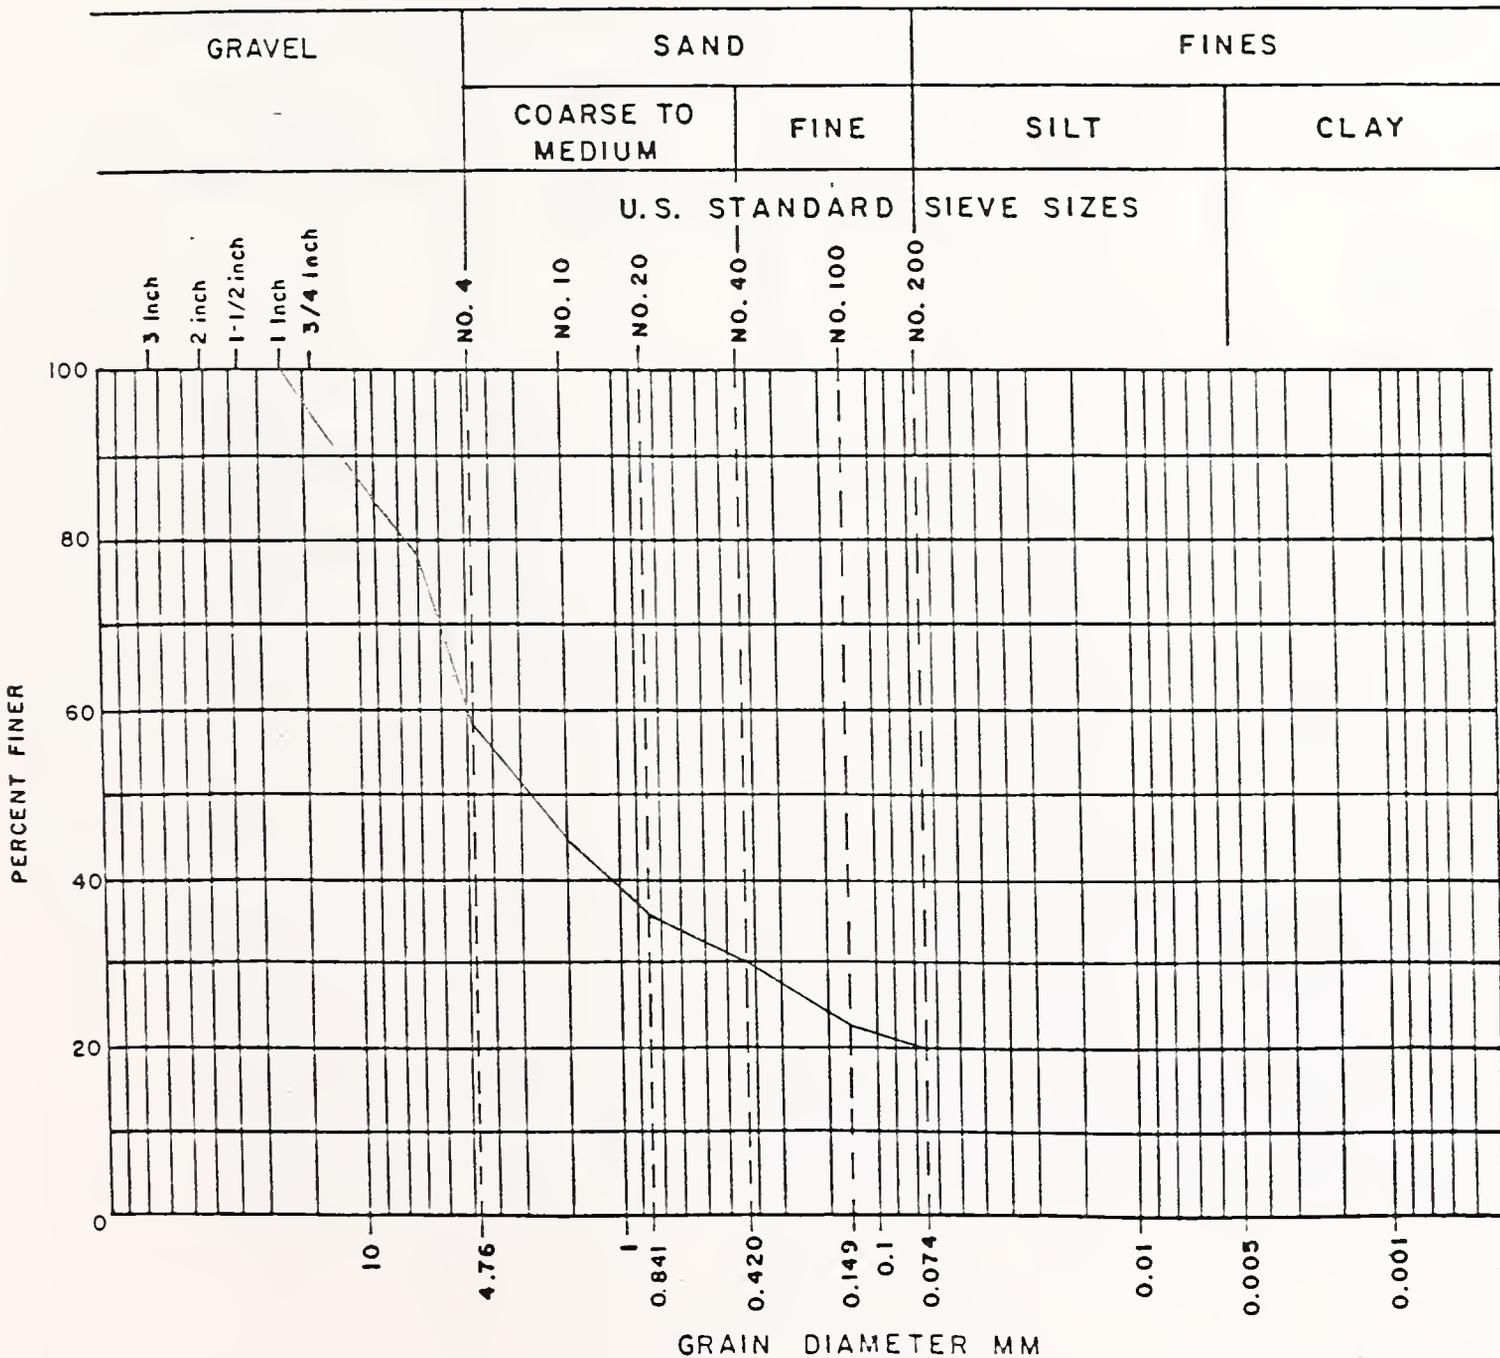
GRAIN SIZE DISTRIBUTION

PROJECT NO. 8M087.113 LAB NO. 2944  
 PROJECT NAME Middle Creek Dam FIELD NO. DH-10 (10.0-11.5')  
 DATE SAMPLED 7-22-83 DATE TESTED 10-8-83  
 SAMPLED BY DLD TESTED BY CS  
 TYPE SAMPLE Drive SAMPLE LOCATION Left Abutment  
 SOIL DESCRIPTION CLAYEY GRAVEL FILL

- 1)\_ GRAVEL, Passing 3" & retained on no. 4 sieve 41 %
- 2)\_ SAND, Passing no. 4 sieve & retained on no. 200 sieve. 39 %
- 3)\_ SILT & CLAY, Passing no. 200 sieve 20 %

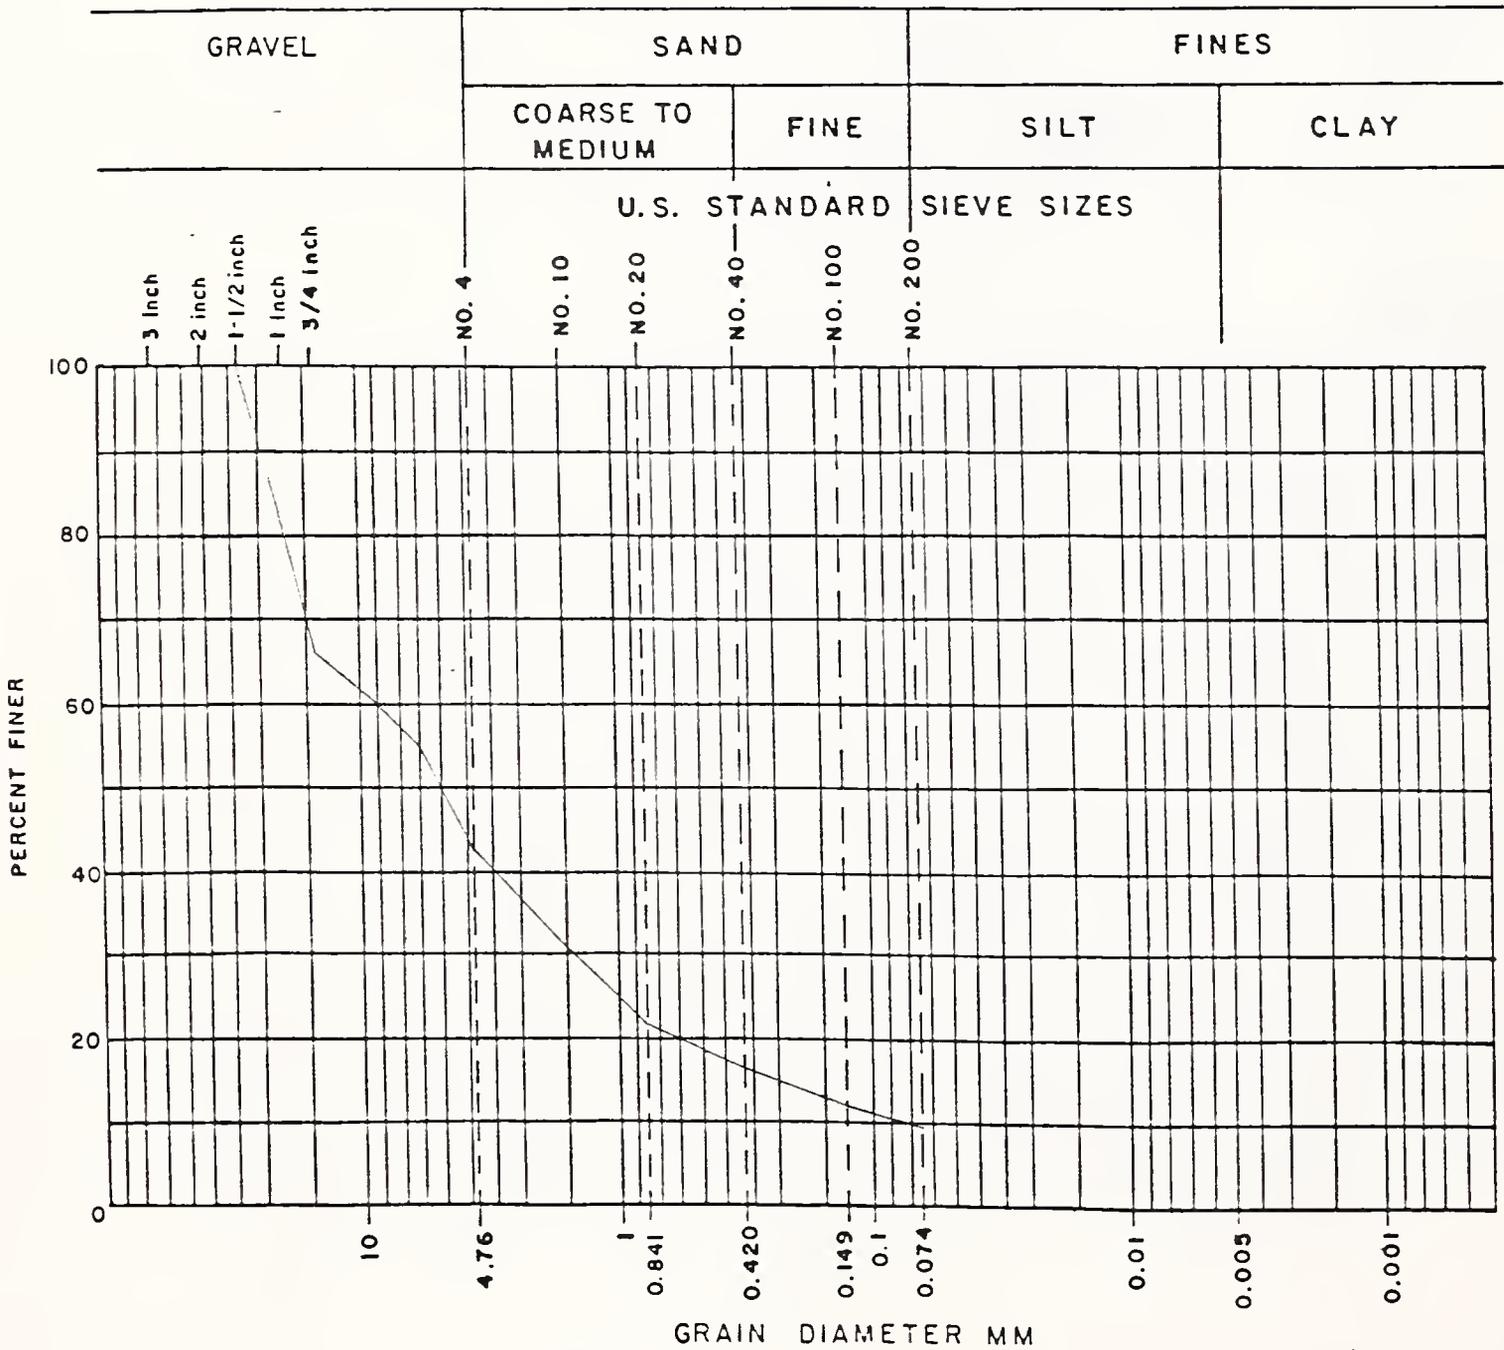
GRAIN SIZE DISTRIBUTION

PROJECT NO. 8M087.113 LAB NO. 3039  
 PROJECT NAME Middle Creek Dam FIELD NO. DH-12 (8.0-9.5')  
 DATE SAMPLED 10-12-83 DATE TESTED 11-2-83  
 SAMPLED BY DLD TESTED BY CS  
 TYPE SAMPLE Drive SAMPLE LOCATION Potential Auxiliary  
 SOIL DESCRIPTION SANDY GRAVEL TILL Spillway Area

- 1) GRAVEL, Passing 3" & retained on no. 4 sieve 57 %
- 2) SAND, Passing no. 4 sieve & retained on no. 200 sieve. 33 %
- 3) SILT & CLAY, Passing no. 200 sieve 10 %

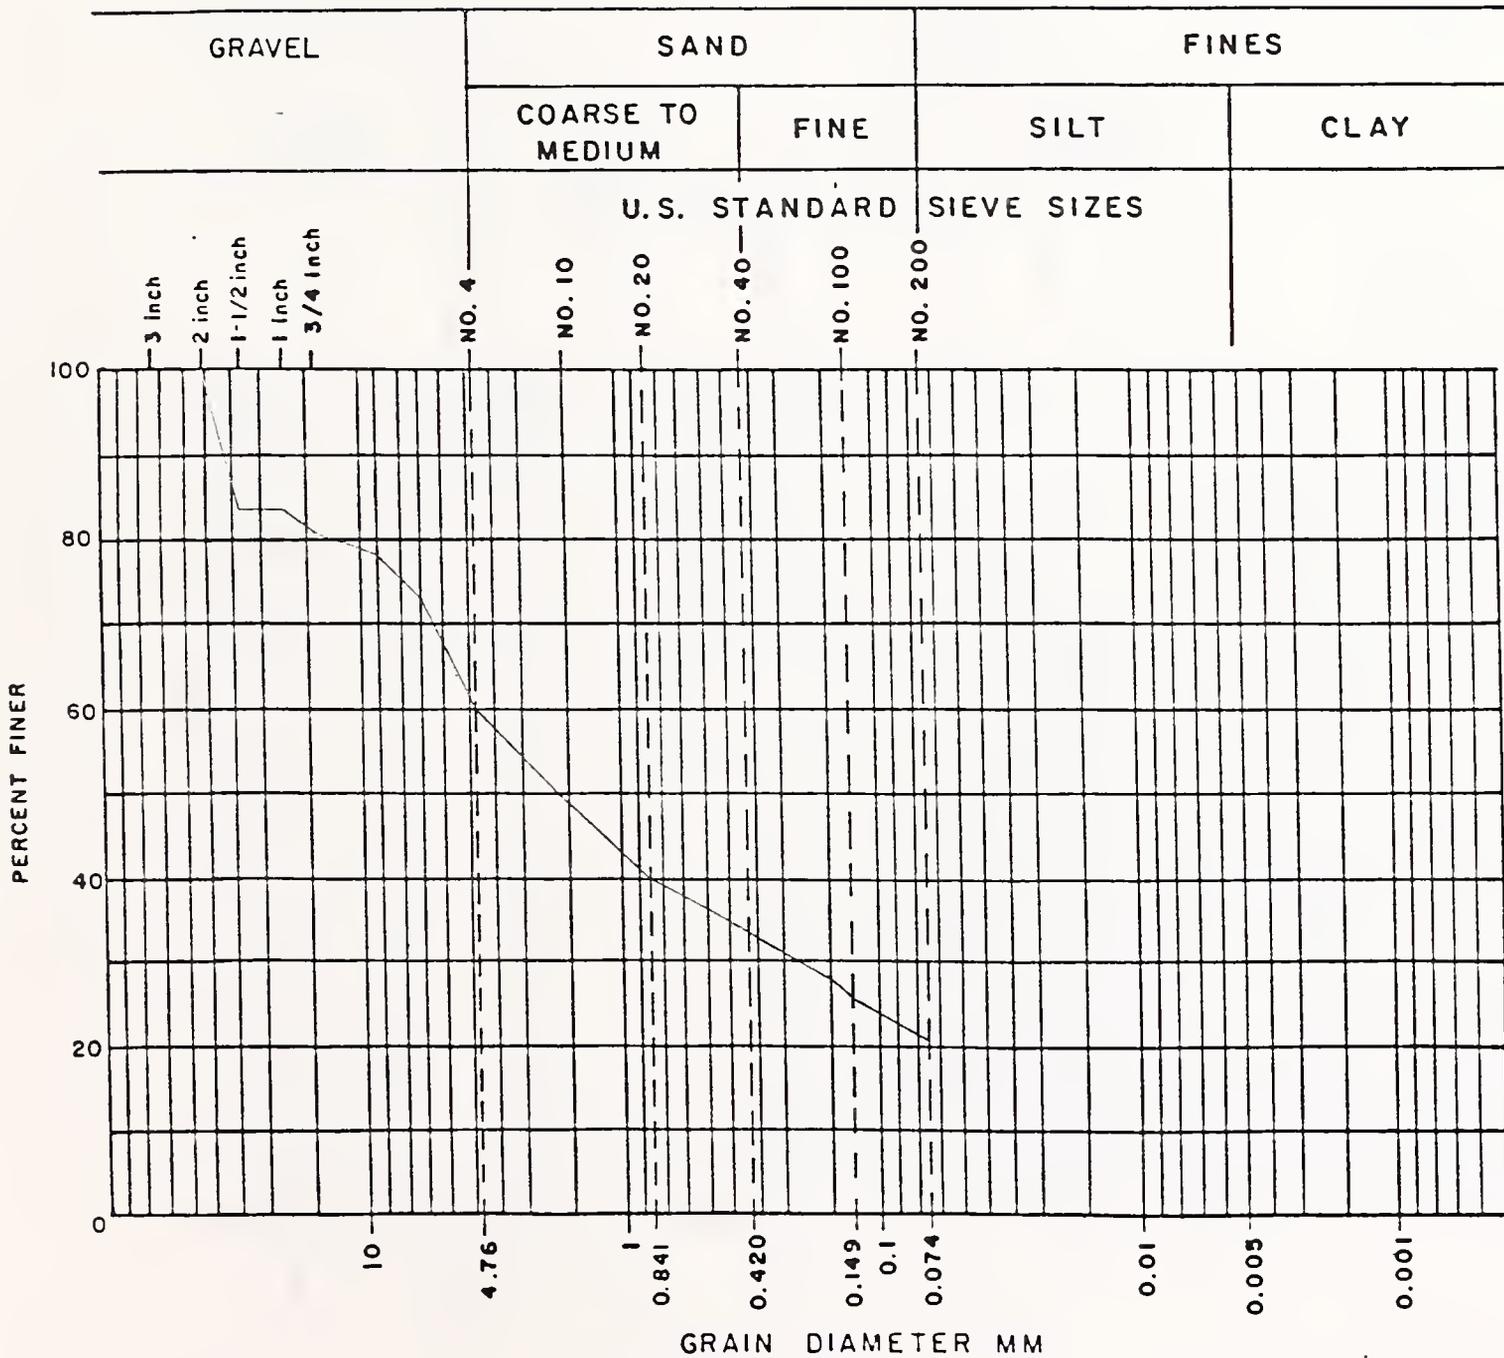
GRAIN SIZE DISTRIBUTION

PROJECT NO. 8M087.113 LAB NO. 3044  
 PROJECT NAME Middle Creek Dam FIELD NO. DH-13 (27.0-29.0')  
 DATE SAMPLED 10-10-83 DATE TESTED 11-2-83  
 SAMPLED BY DLD TESTED BY CS  
 TYPE SAMPLE Drive SAMPLE LOCATION Upstream Face-  
 SOIL DESCRIPTION CLAYEY GRAVEL FILL Impervious Zone

- 1) GRAVEL, Passing 3" & retained on no. 4 sieve 40 %
- 2) SAND, Passing no. 4 sieve & retained on no. 200 sieve. 39 %
- 3) SILT & CLAY, Passing no. 200 sieve 21 %

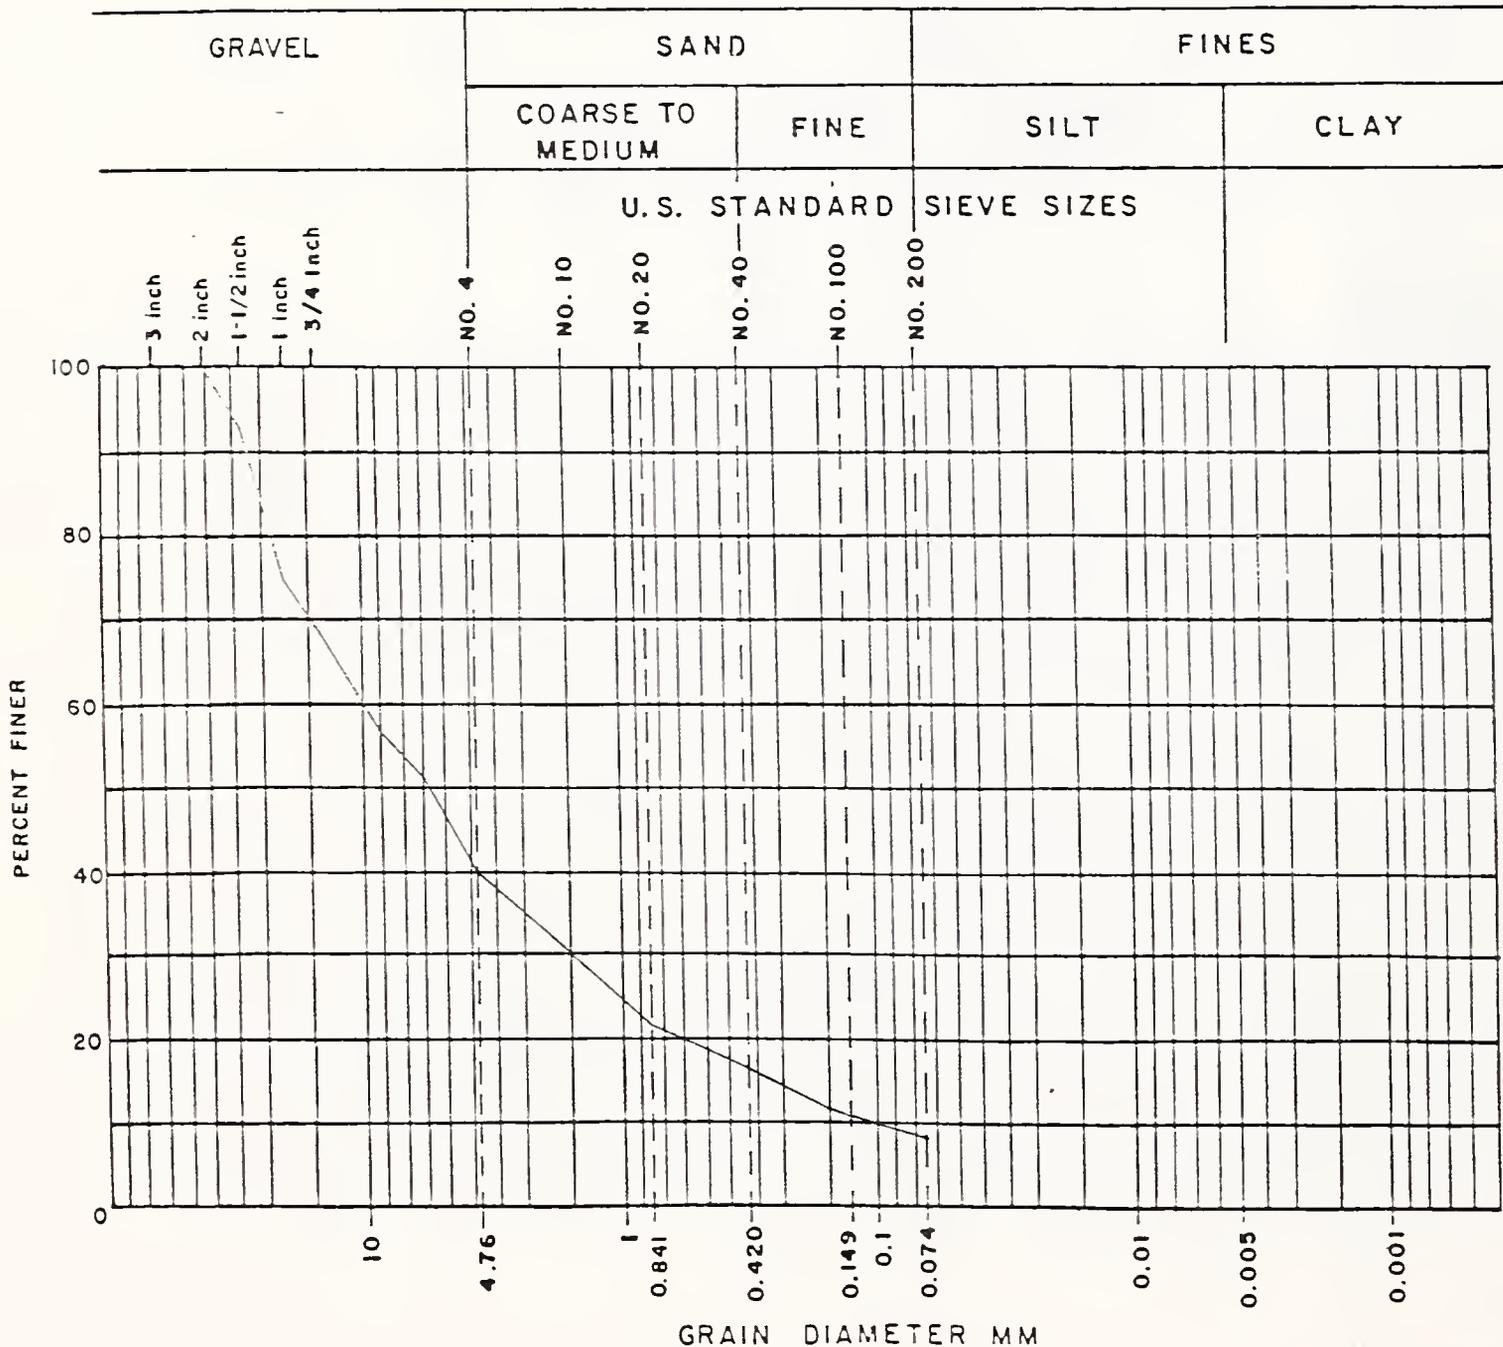
GRAIN SIZE DISTRIBUTION

PROJECT NO. 8M087.113 LAB NO. 2956  
 PROJECT NAME Middle Creek Dam FIELD NO. DH-14 (6.0-7.5')  
 DATE SAMPLED 8-14-83 DATE TESTED 10-13-83  
 SAMPLED BY DLD TESTED BY CS  
 TYPE SAMPLE Drive SAMPLE LOCATION Pervious Zone  
 SOIL DESCRIPTION SANDY GRAVEL FILL Near Right Abutment

- 1)\_ GRAVEL, Passing 3" & retained on no. 4 sieve --- 60 --- %
- 2)\_ SAND, Passing no. 4 sieve & retained on no. 200 sieve. --- 32 --- %
- 3)\_ SILT & CLAY, Passing no. 200 sieve --- 8 --- %

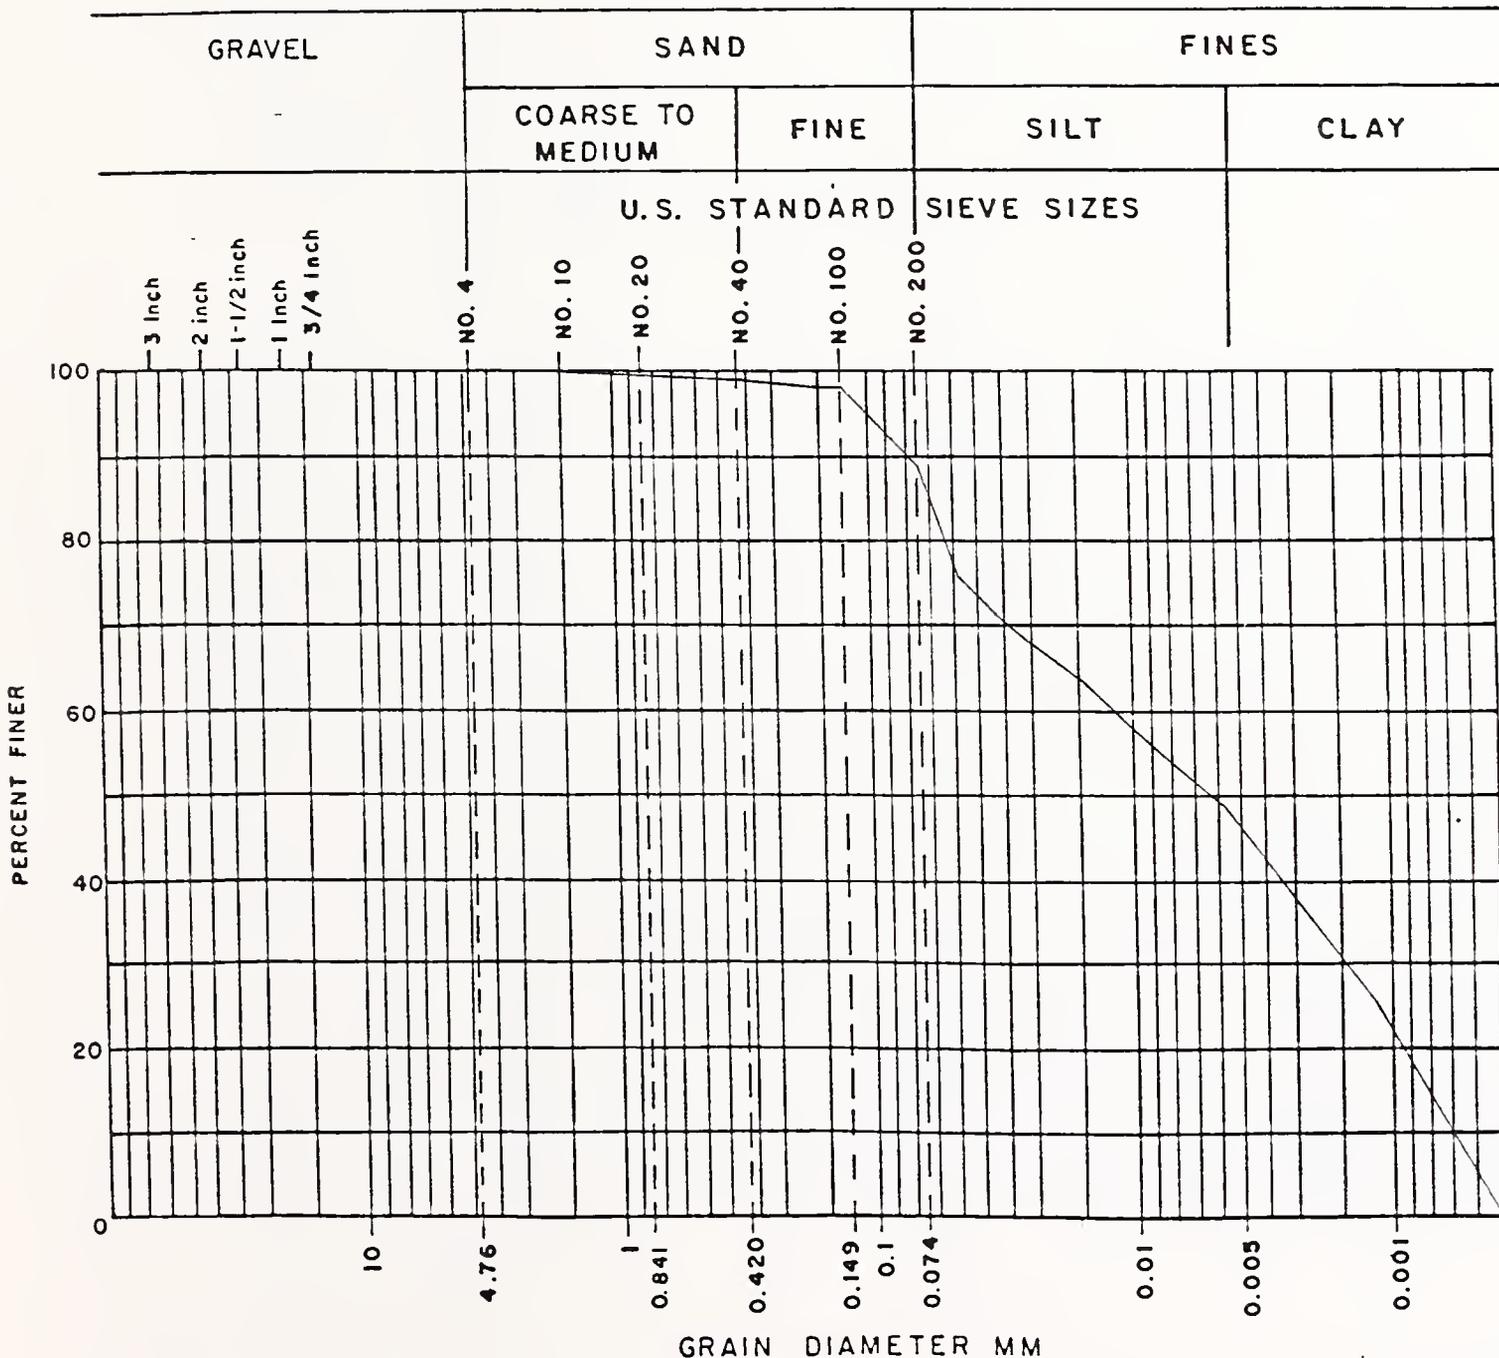
GRAIN SIZE DISTRIBUTION

PROJECT NO. 8M087.113 LAB NO. 2960  
 PROJECT NAME Middle Creek Dam FIELD NO. DH-14 (36.0-37.5)  
 DATE SAMPLED 8-15-83 DATE TESTED 9-23-83  
 SAMPLED BY DLD TESTED BY CS  
 TYPE SAMPLE Drive SAMPLE LOCATION Right Abutment  
 SOIL DESCRIPTION SILTY CLAY (CL-2)
