# MIDDLE CREEK DAM

## GEOTECHNICAL INVESTIGATION

MIDDLE CREEK DAM  
GEOTECHNICAL INVESTIGATION

February 1984  
8M087.113/0611H

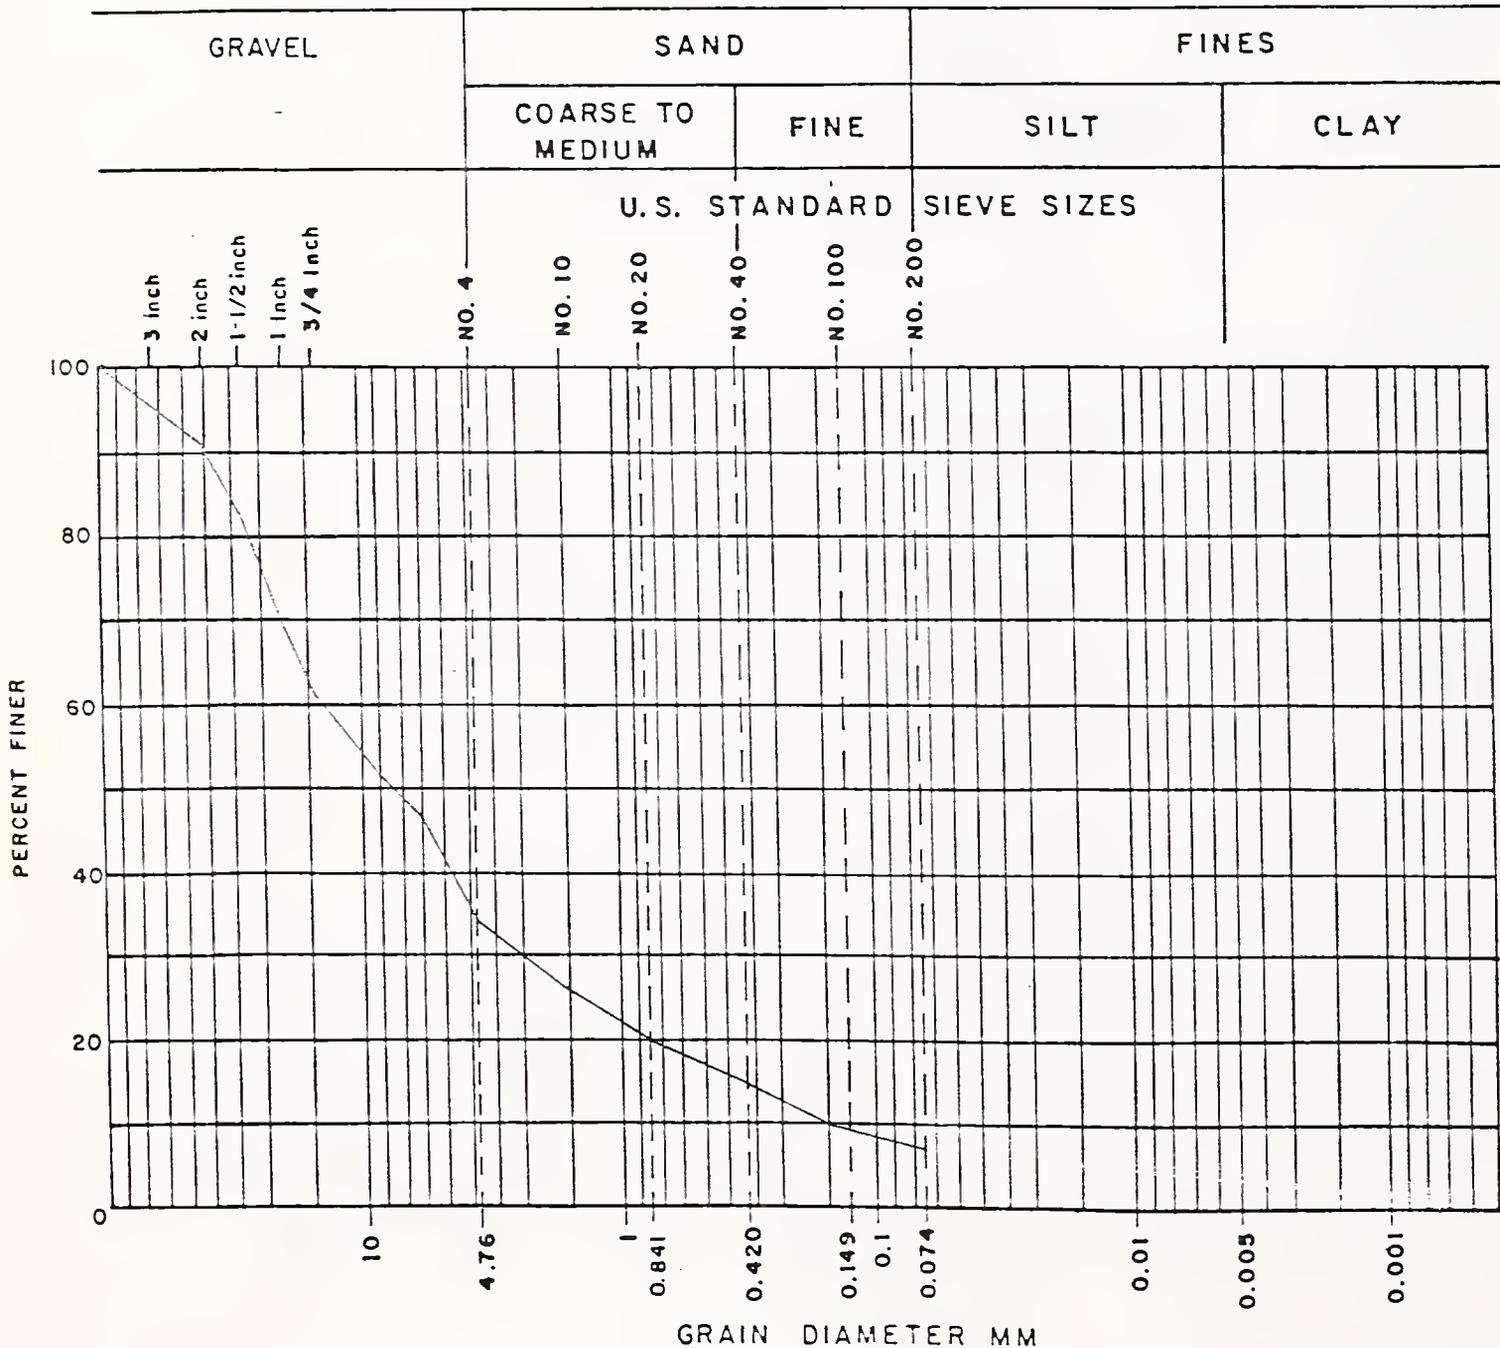
GRAIN SIZE DISTRIBUTION

PROJECT NO. 8M087.113 LAB NO. 3052  
 PROJECT NAME Middle Creek Dam FIELD NO. TP-102 (1.0-4.0')  
 DATE SAMPLED 10-19-83 DATE TESTED 10-24-83  
 SAMPLED BY DLD TESTED BY CS  
 TYPE SAMPLE Sack SAMPLE LOCATION Pervious Zone  
 SOIL DESCRIPTION SANDY GRAVEL FILL Near Right Abutment

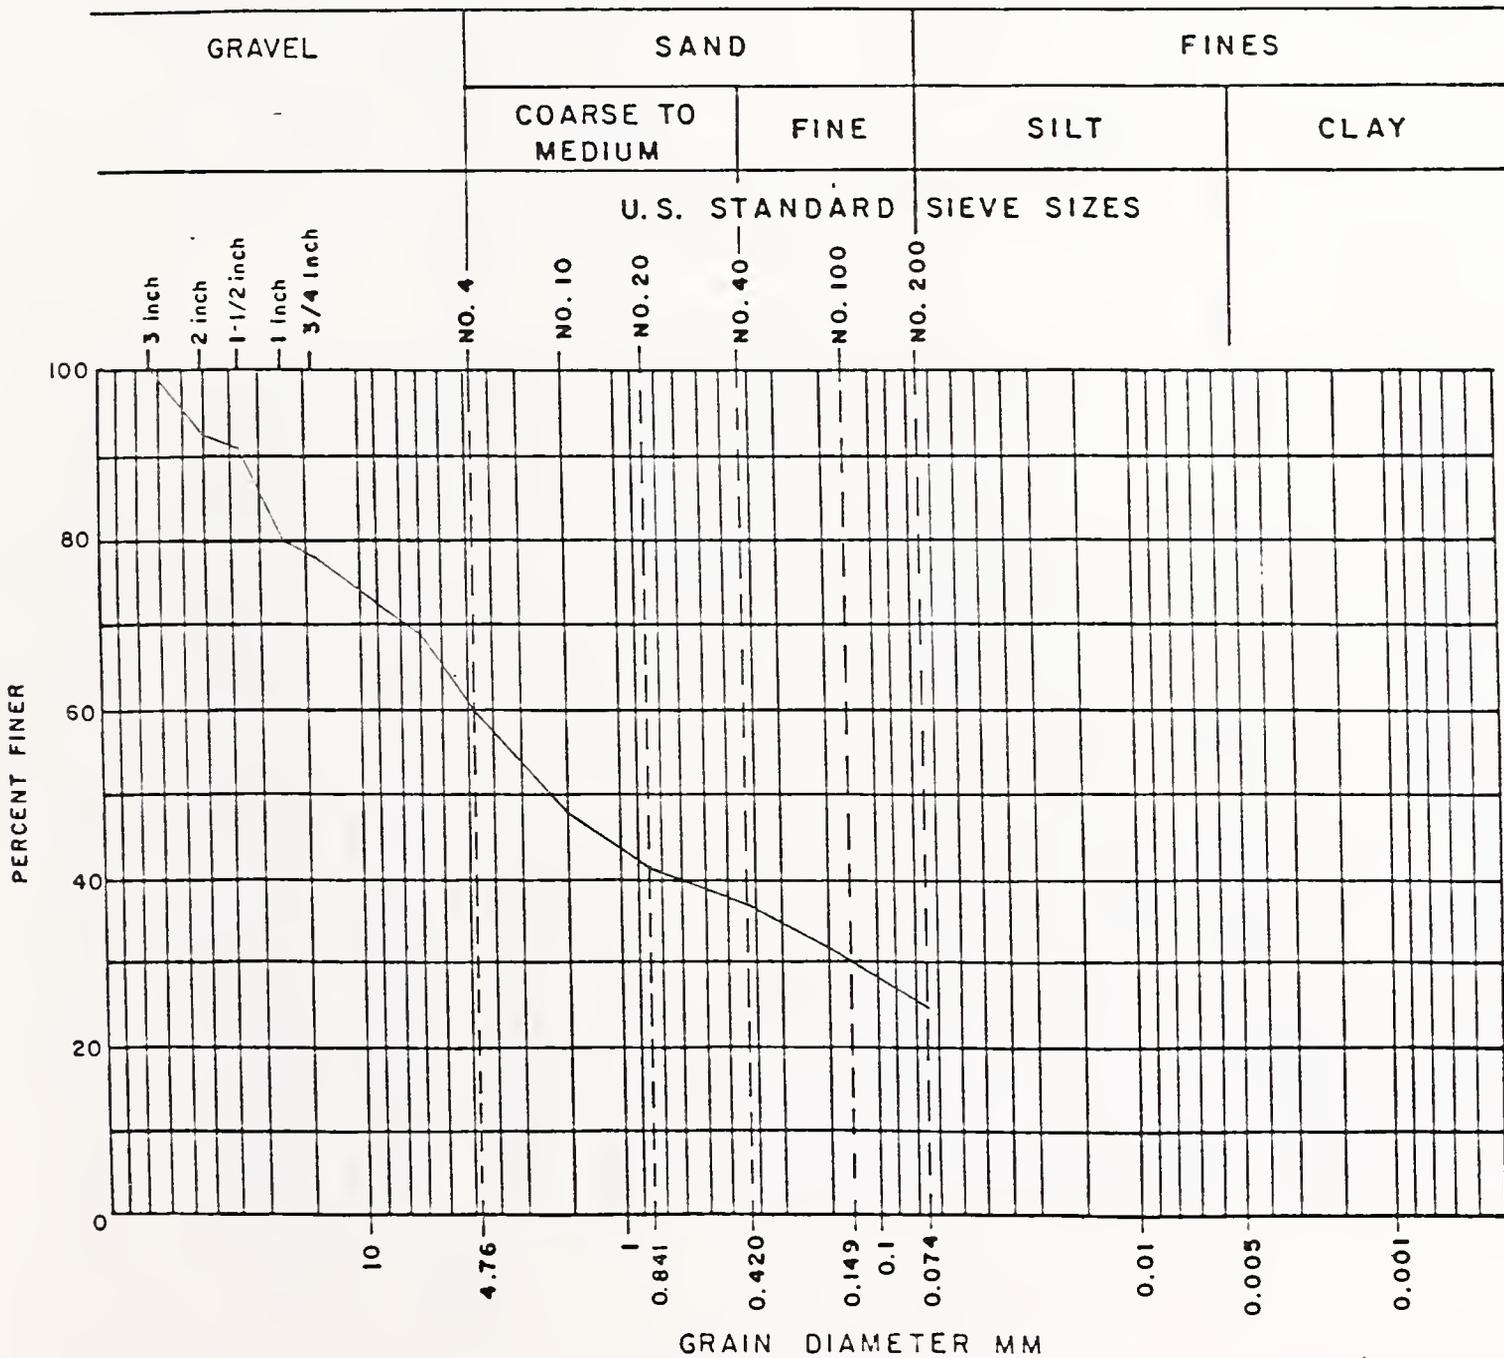
GRAIN SIZE DISTRIBUTION

PROJECT NO. 8M087.113 LAB NO. 3053  
 PROJECT NAME Middle Creek Dam FIELD NO. TP-103 (4.0-7.0')  
 DATE SAMPLED 10-12-83 DATE TESTED 10-24-83  
 SAMPLED BY DLD TESTED BY CS  
 TYPE SAMPLE Sack SAMPLE LOCATION Right Abutment  
 SOIL DESCRIPTION CLAYEY GRAVEL (GC) On Upstream Face

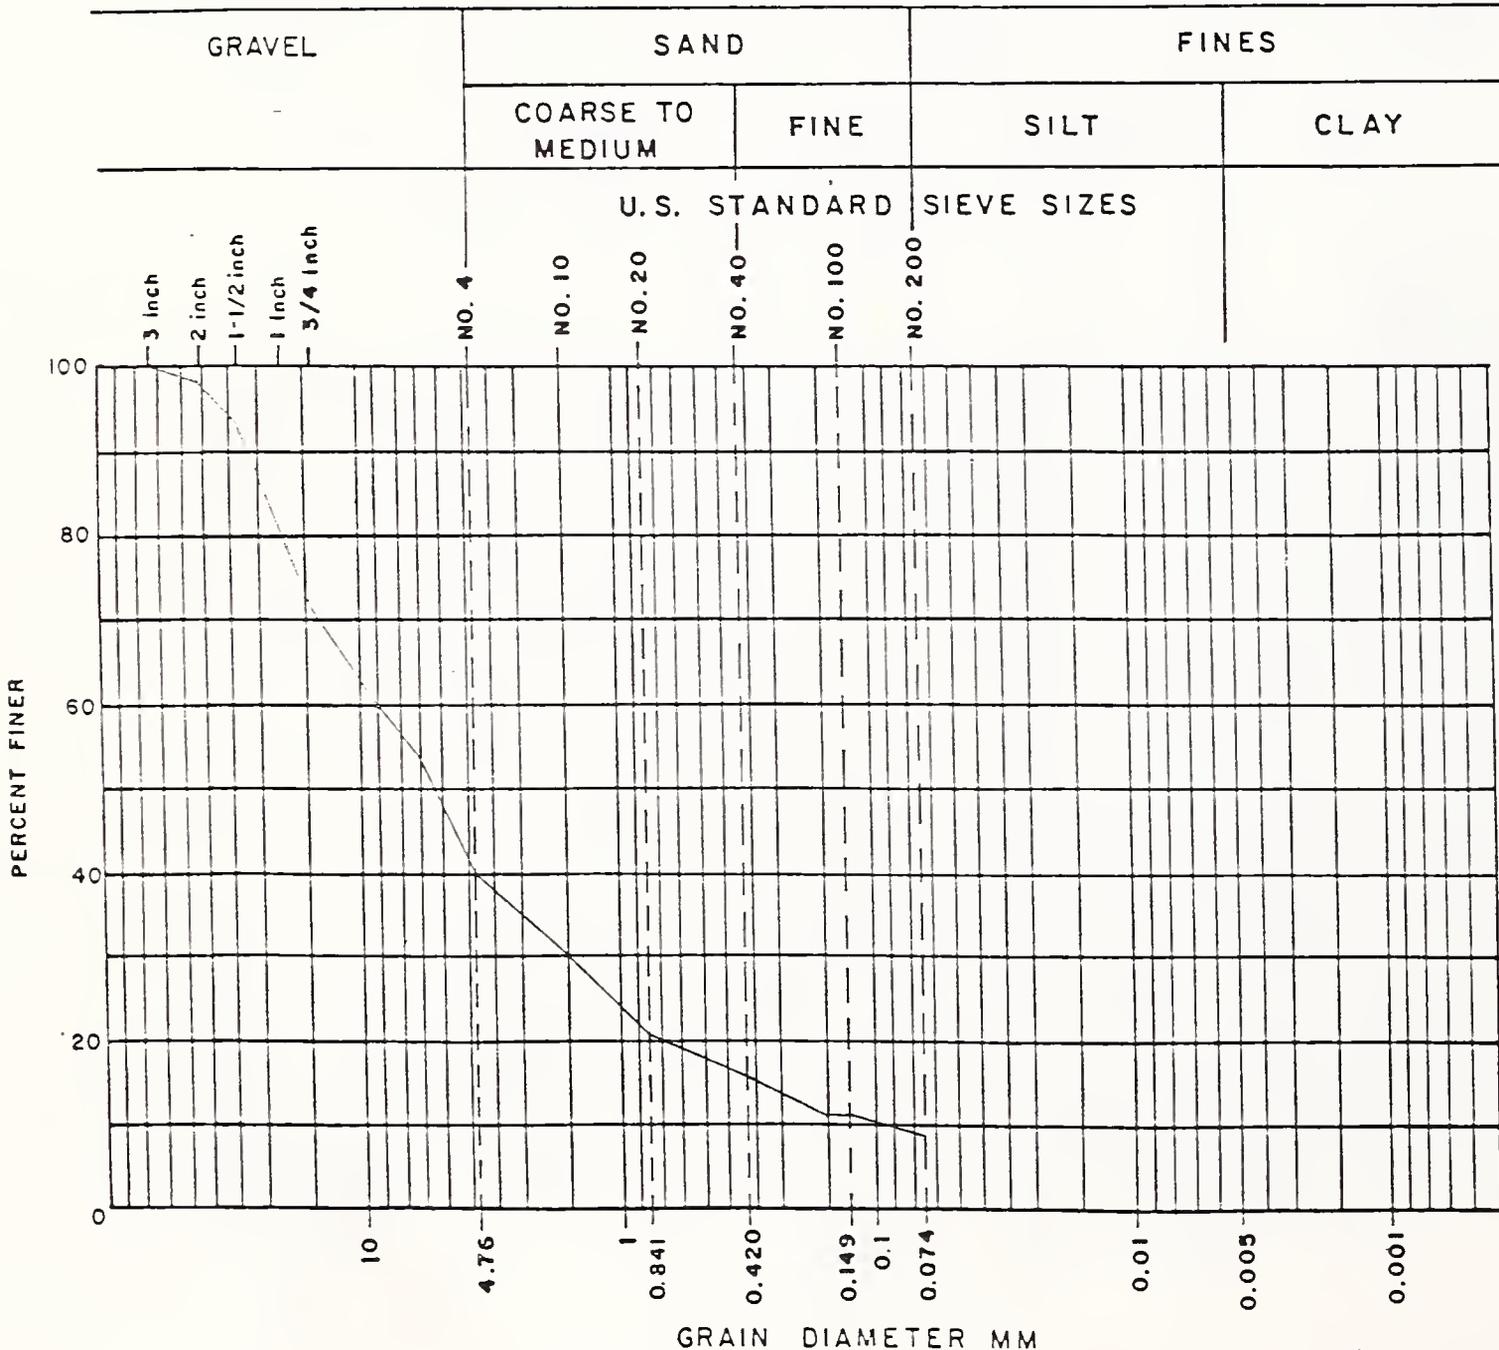
GRAIN SIZE DISTRIBUTION

PROJECT NO. 8M087.113 LAB NO. 3026  
 PROJECT NAME Middle Creek Dam FIELD NO. TP-104 (3.7 - 10.0')  
 DATE SAMPLED 10-12-83 DATE TESTED 11-2-83  
 SAMPLED BY DLD TESTED BY CS  
 TYPE SAMPLE Sack SAMPLE LOCATION Sink Hole Area  
 SOIL DESCRIPTION SANDY GRAVEL TILL

- 1) GRAVEL, Passing 3" & retained on no. 4 sieve 60 %
- 2) SAND, Passing no. 4 sieve & retained on no. 200 sieve. 31 %
- 3) SILT & CLAY, Passing no. 200 sieve 9 %

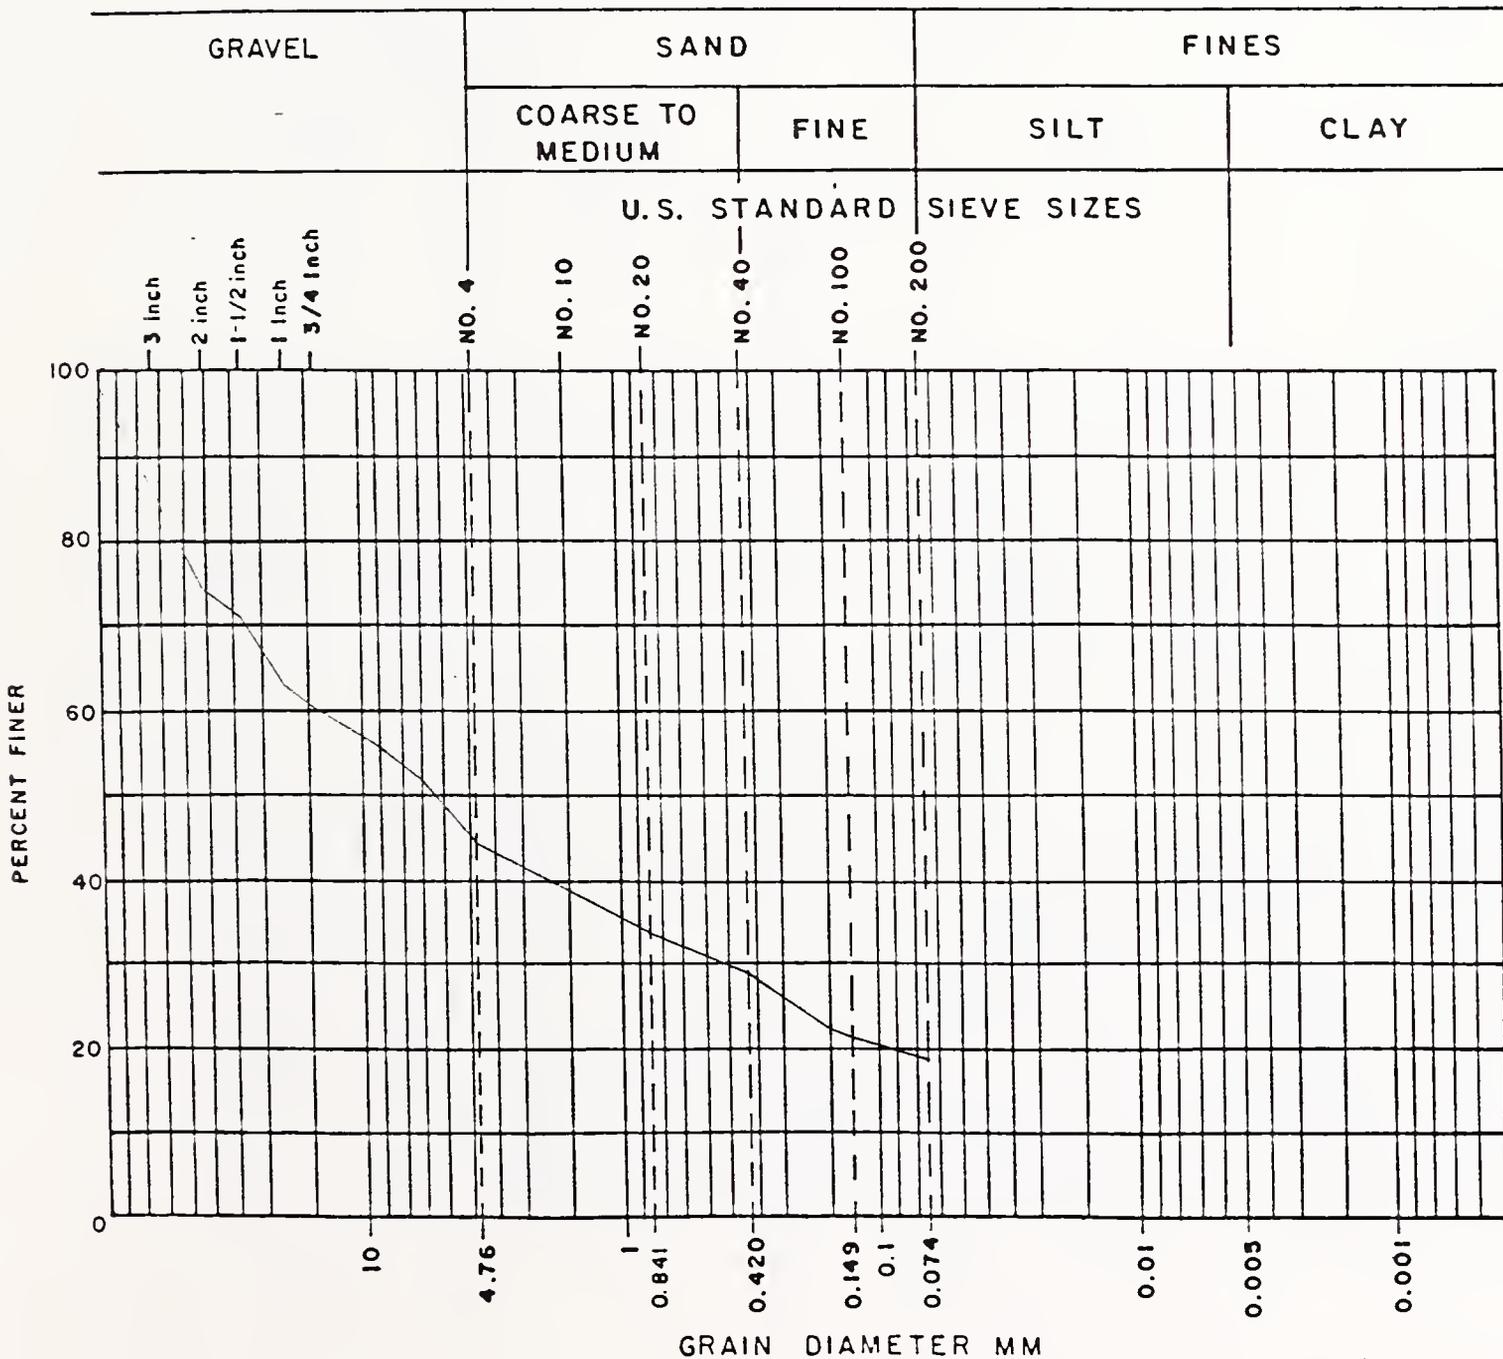
GRAIN SIZE DISTRIBUTION

PROJECT NO. 8M087.113 LAB NO. 3054  
 PROJECT NAME Middle Creek Dam FIELD NO. TP-105 (1.0-8.0')  
 DATE SAMPLED 10-19-83 DATE TESTED 11-2-83  
 SAMPLED BY DLD TESTED BY CS  
 TYPE SAMPLE Sack SAMPLE LOCATION Potential Auxiliary  
 SOIL DESCRIPTION CLAYEY GRAVEL (GC) Spillway Area

- 1) GRAVEL, Passing 6" & retained on no. 4 sieve 55 %
- 2) SAND, Passing no. 4 sieve & retained on no. 200 sieve. 26 %
- 3) SILT & CLAY, Passing no. 200 sieve 19 %

Maximum Size = 6"  
 Liquid Limit = 30%  
 Plastic Index = 9

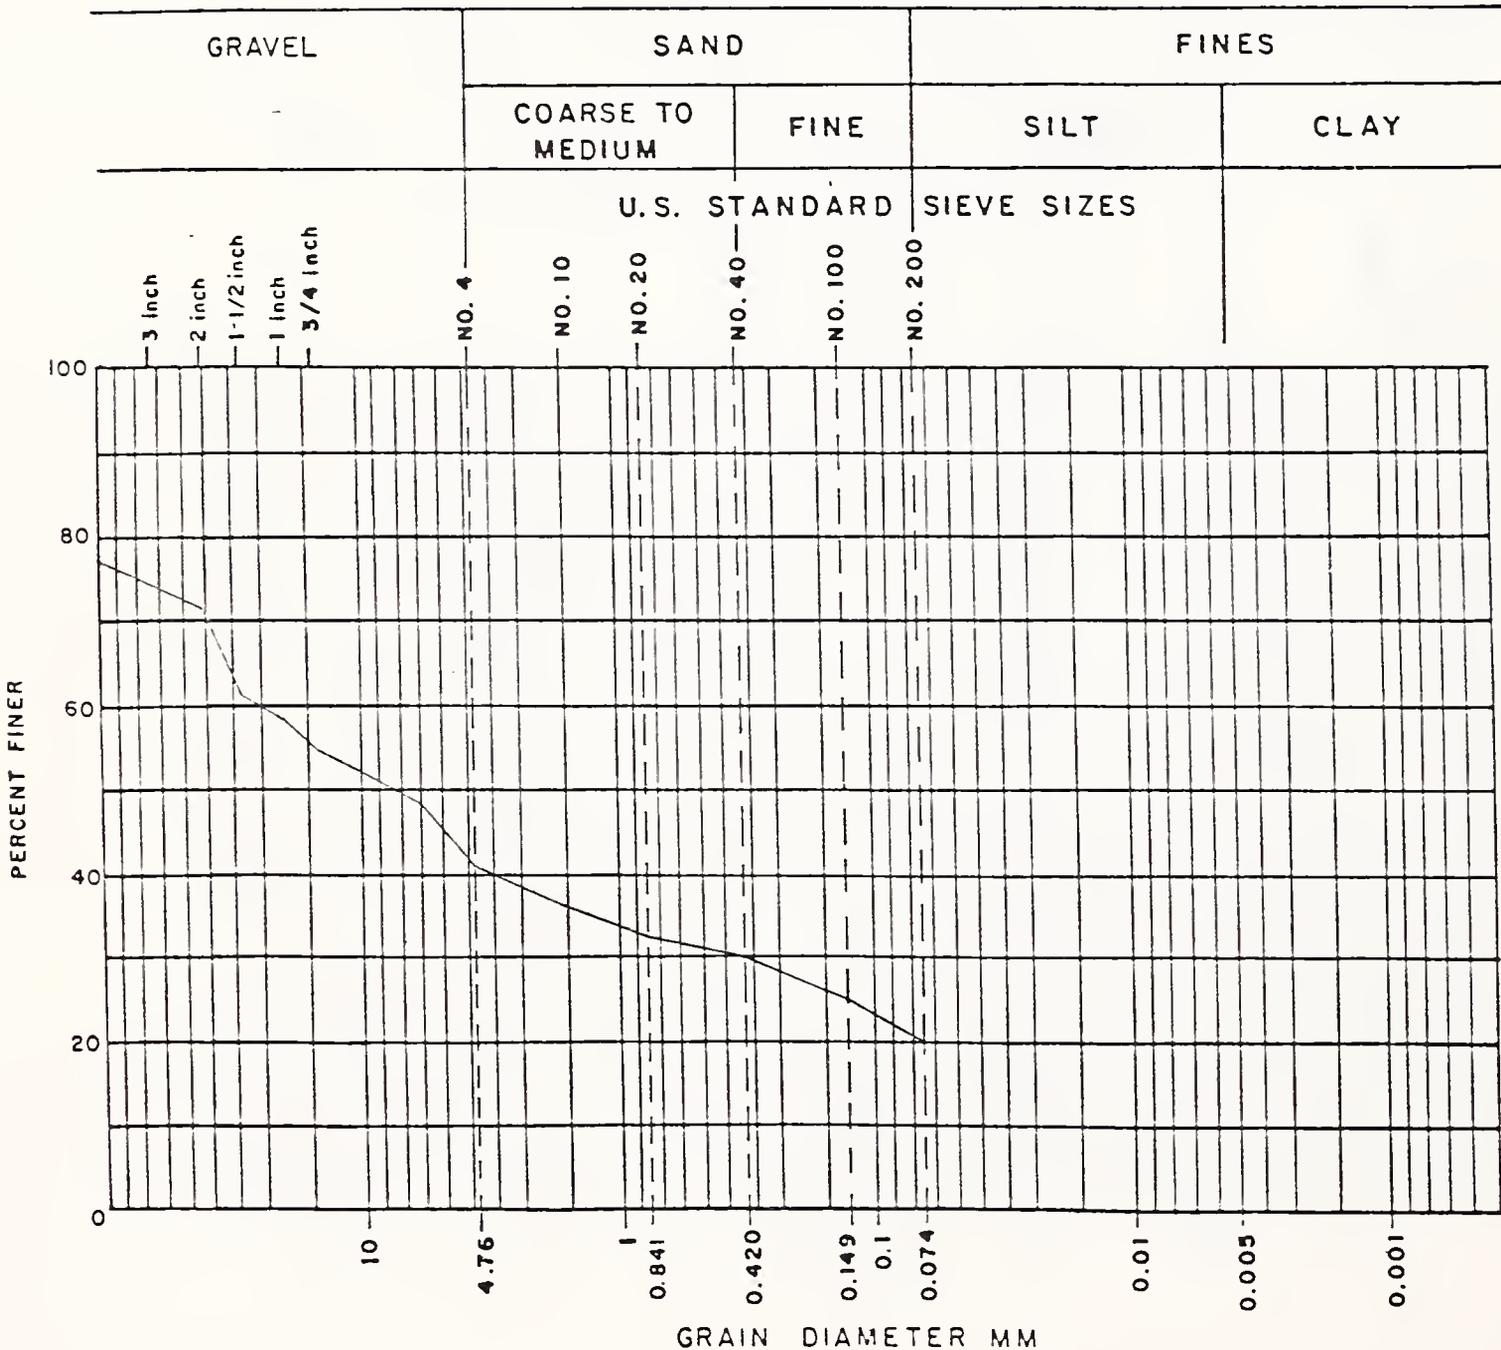
GRAIN SIZE DISTRIBUTION

PROJECT NO. 8M087.113 LAB NO. 3056  
 PROJECT NAME Middle Creek Dam FIELD NO. TP-106 (3.0-8.0')  
 DATE SAMPLED 10-19-83 DATE TESTED 10-28-83  
 SAMPLED BY DLD TESTED BY JP  
 TYPE SAMPLE Sack SAMPLE LOCATION Potential Auxiliary  
 SOIL DESCRIPTION CLAYEY GRAVEL (GC) Spillway Area

- 1) GRAVEL, Passing 6" & retained on no. 4 sieve 59 \_\_\_\_\_ %
- 2) SAND, Passing no. 4 sieve & retained on no. 200 sieve. 21 \_\_\_\_\_ %
- 3) SILT & CLAY, Passing no. 200 sieve 20 \_\_\_\_\_ %

Maximum Size = 6"

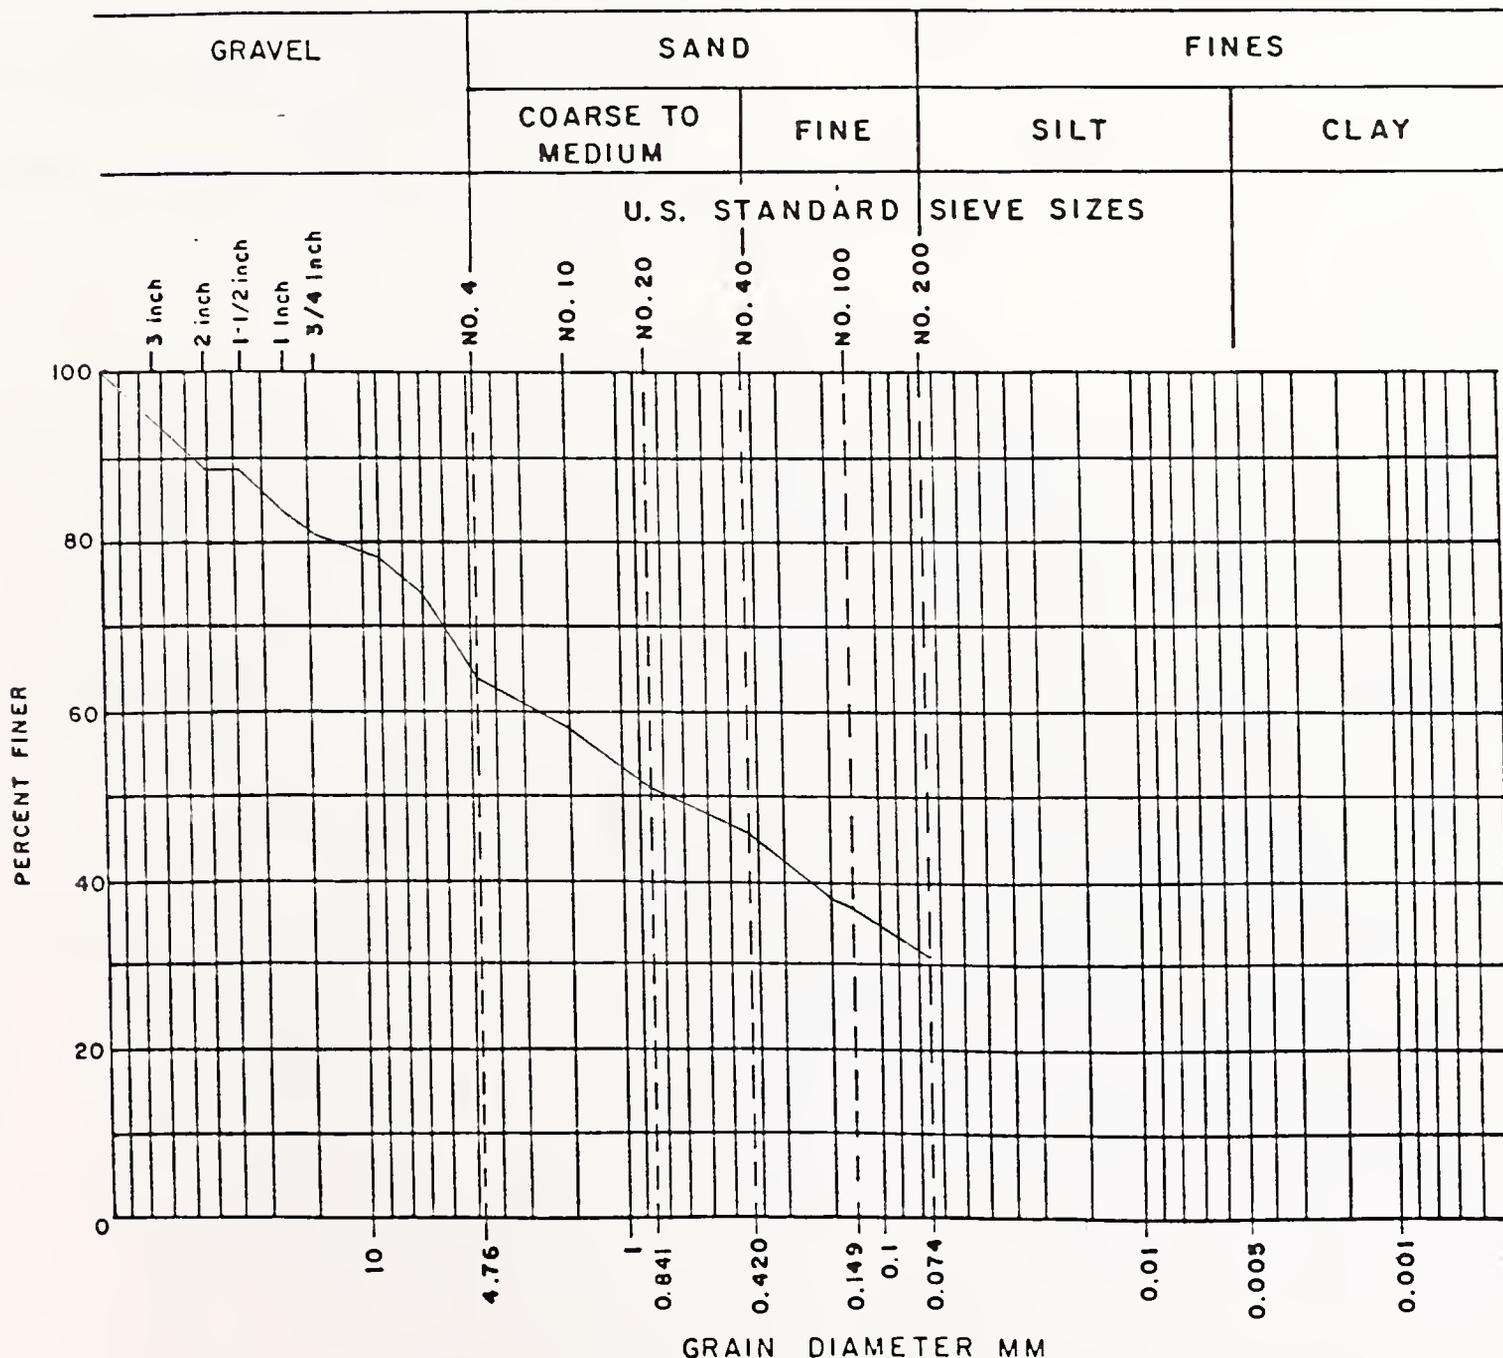
GRAIN SIZE DISTRIBUTION

PROJECT NO. 8M087.113 LAB NO. 3058  
 PROJECT NAME Middle Creek Dam FIELD NO. TP-108 (1.4-6.0')  
 DATE SAMPLED 10-18-83 DATE TESTED 11-2-83  
 SAMPLED BY DLD TESTED BY CS  
 TYPE SAMPLE Sack SAMPLE LOCATION Borrow Area  
 SOIL DESCRIPTION CLAYEY GRAVEL (GC) Southeast of Embankment

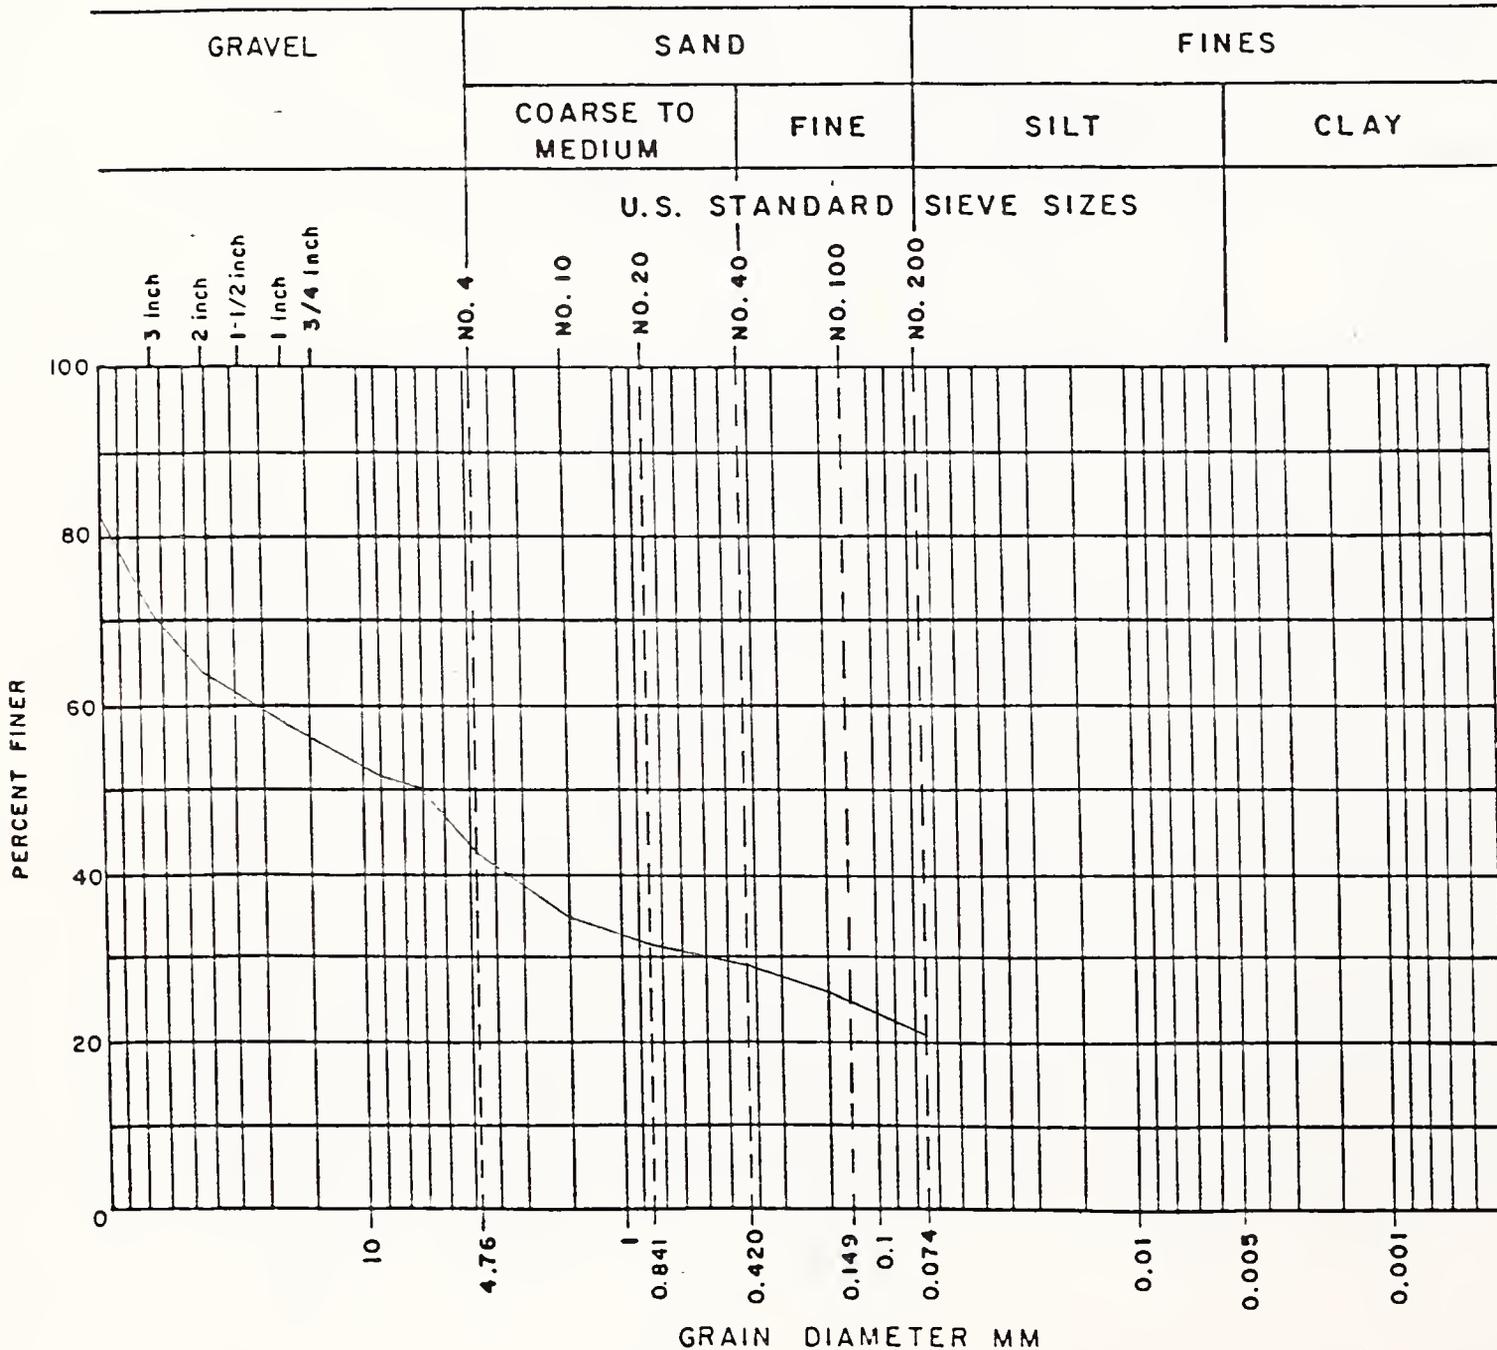
GRAIN SIZE DISTRIBUTION

PROJECT NO. 8M087.113 LAB NO. 3025  
 PROJECT NAME Middle Creek Dam FIELD NO. TP-112 (1.2 - 4.0')  
 DATE SAMPLED 10-12-83 DATE TESTED 10-25-83  
 SAMPLED BY DLD TESTED BY JP  
 TYPE SAMPLE Sack SAMPLE LOCATION Borrow Area  
 SOIL DESCRIPTION CLAYEY GRAVEL (GC)

- 1)\_ GRAVEL, Passing 6" & retained on no. 4 sieve 58 %
- 2)\_ SAND, Passing no. 4 sieve & retained on no. 200 sieve. 21 %
- 3)\_ SILT & CLAY, Passing no. 200 sieve 21 %

Maximum Size = 6"  
 Liquid Limit = 41%  
 Plastic Index = 16

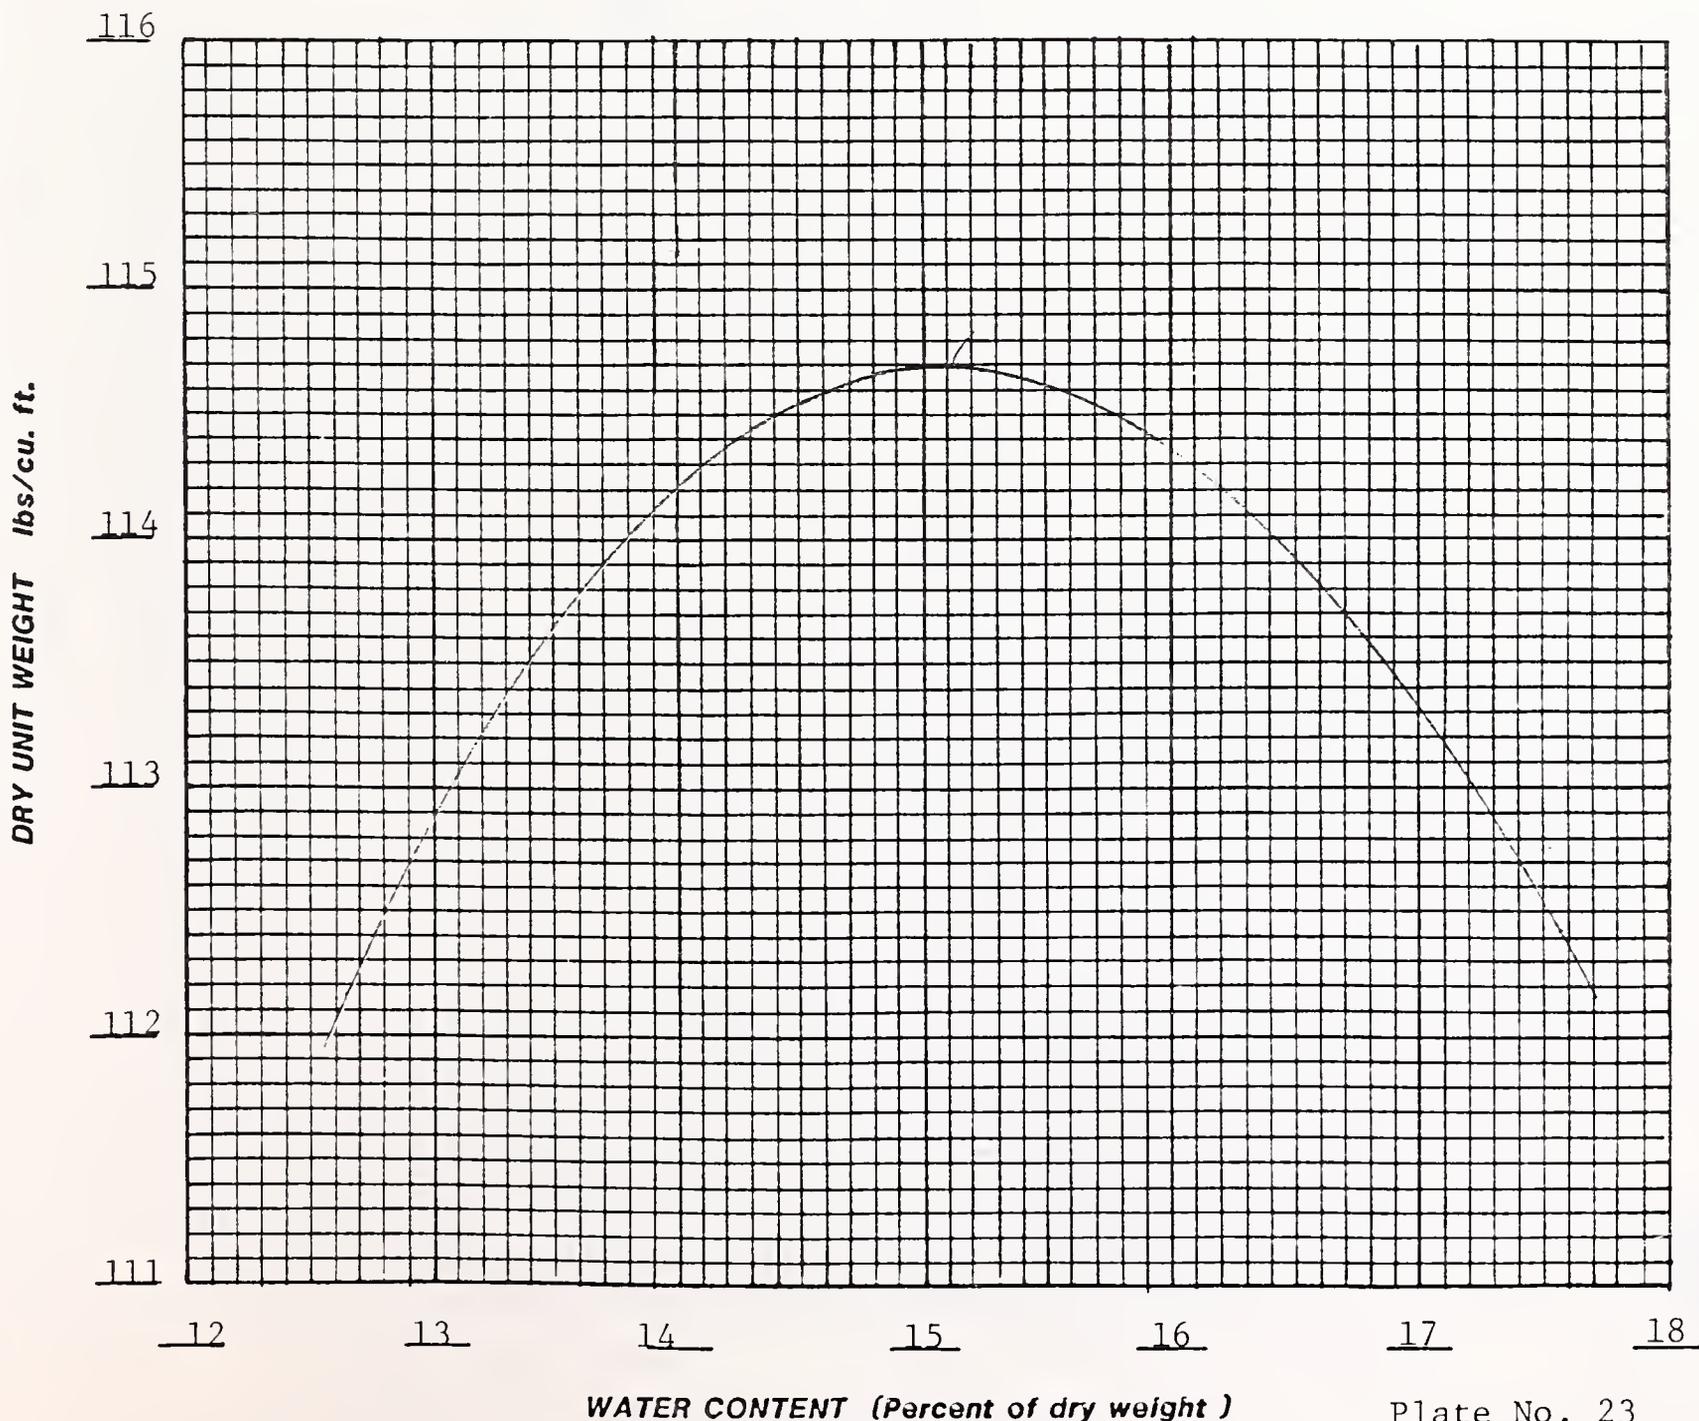
MOISTURE-DENSITY GRAPH

Optimum Moisture 15.1%

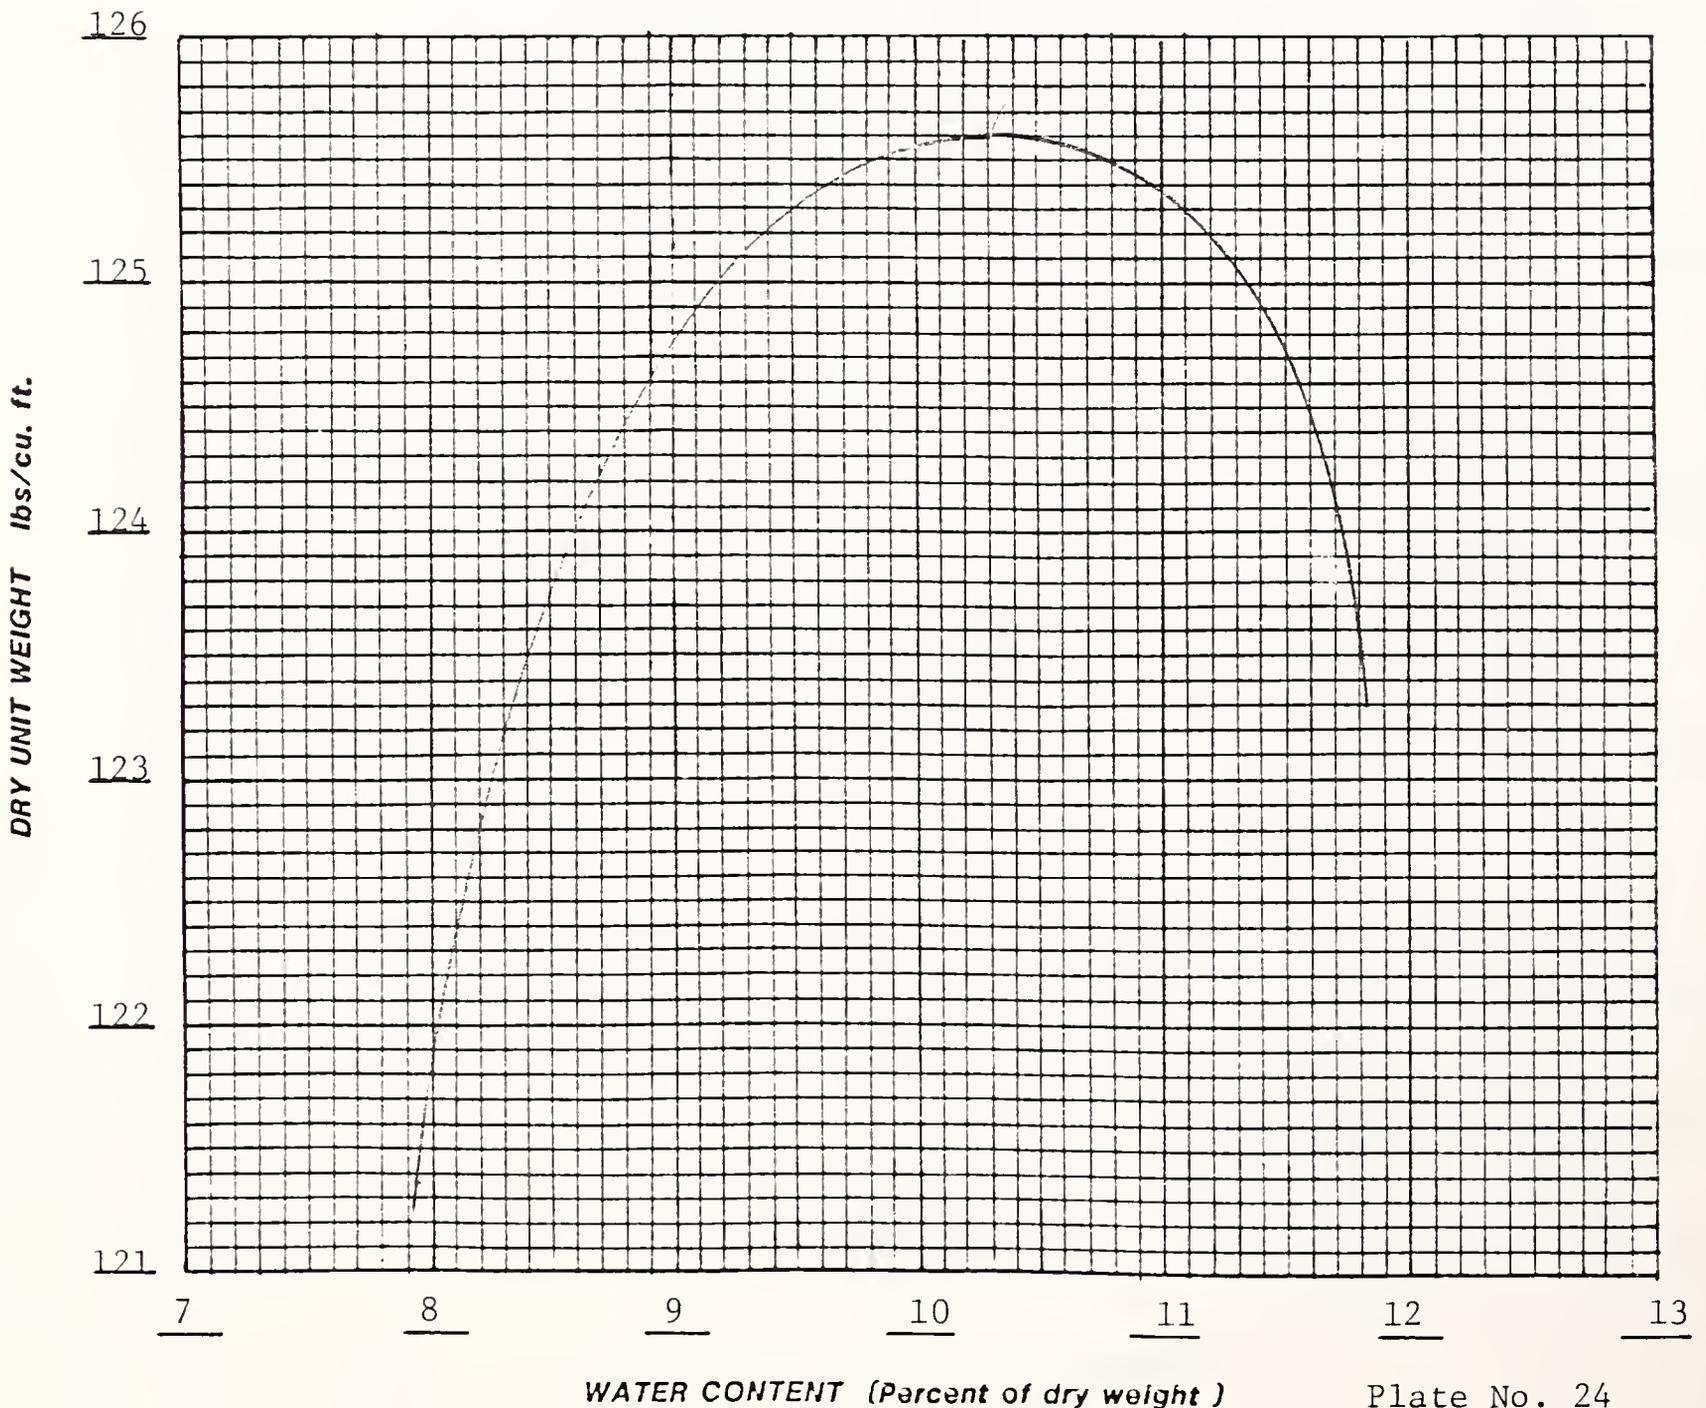
**MOISTURE-DENSITY GRAPH**

Optimum Moisture 10.3%

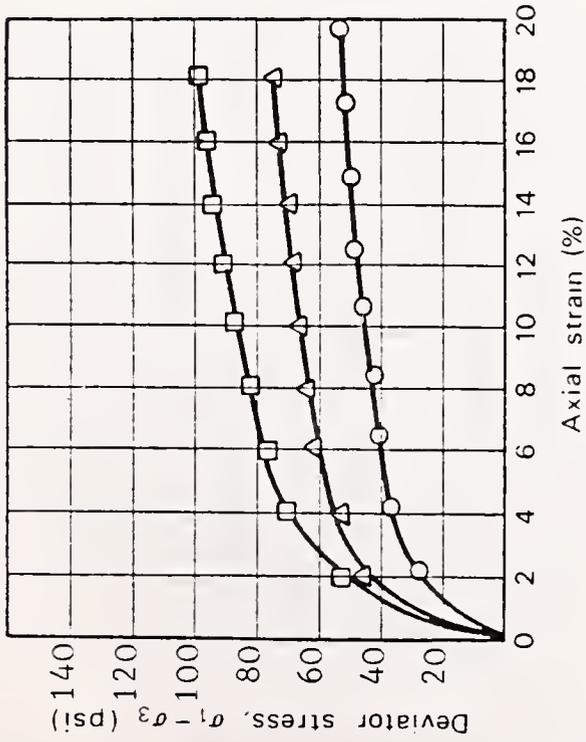
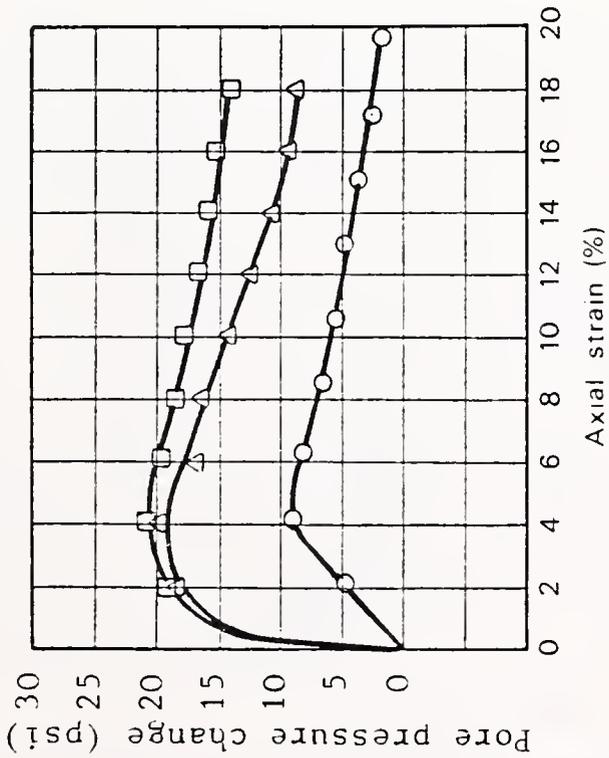
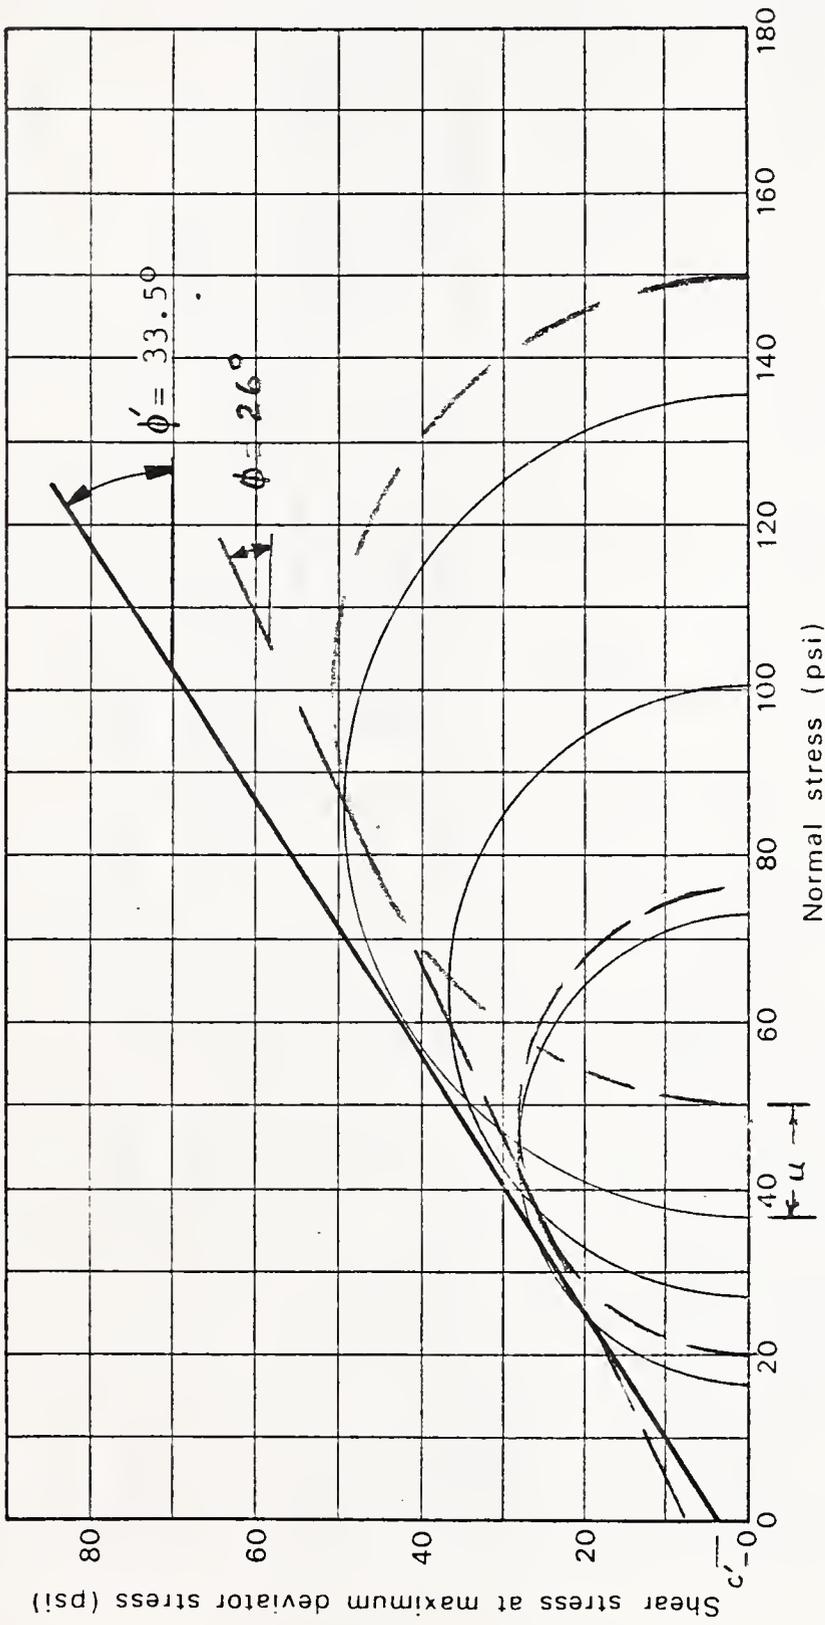
Test no. or symbol	Boring no. or depth	Sample data		Degree of saturation (%)	Confining pressure (psi)	Maximum deviator stress (psi)	Strength values at failure		Sample size, L/D (inches)	Strain rate (inches/minute)
		Dry density (pcf)	Moisture content (%)				Friction angle $\phi$ (degrees)	Cohesion (c/psi)		
O	6A	109.7	16.4	100	20	55.1	33.5	3.5	2.8/1.32	.0023
$\Delta$	64-65	109.7	16.4	100	35	73.5	33.5	3.5	5/2.5	.0025
$\square$	20-21	109.7	16.4	100	50	100.2	33.5	3.5	5/2.5	.0025
