# MIDDLE CREEK DAM

## GEOTECHNICAL INVESTIGATION

MIDDLE CREEK DAM  
GEOTECHNICAL INVESTIGATION

February 1984  
8M087.113/0611H

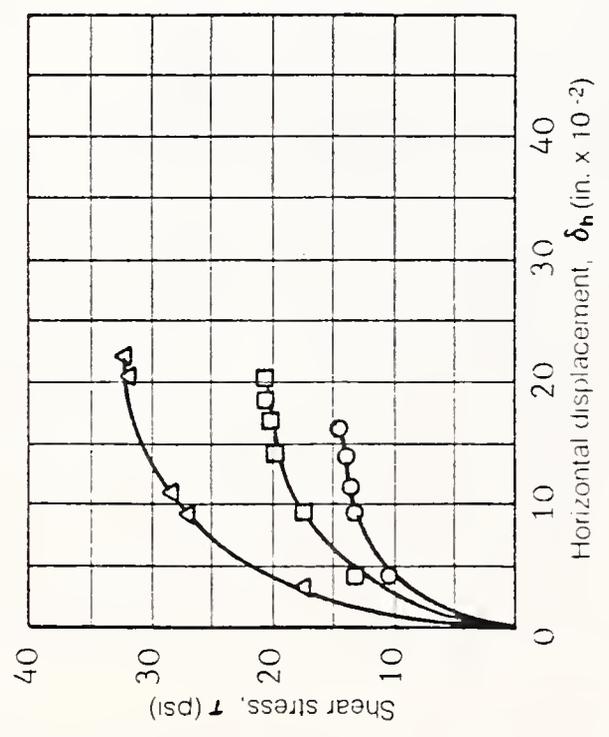
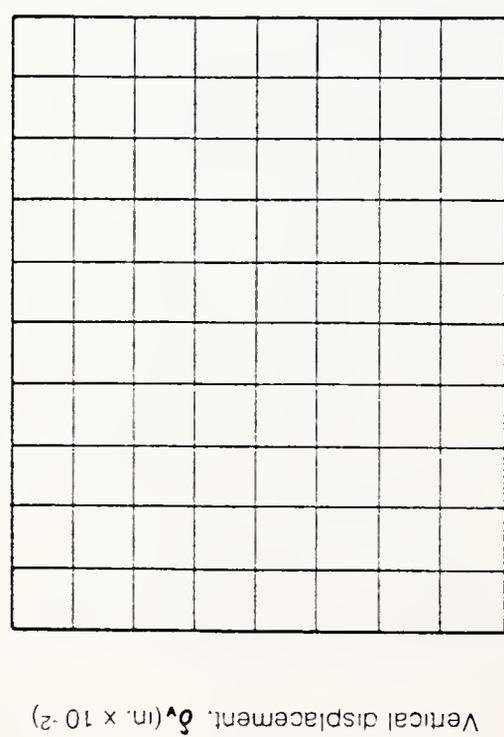
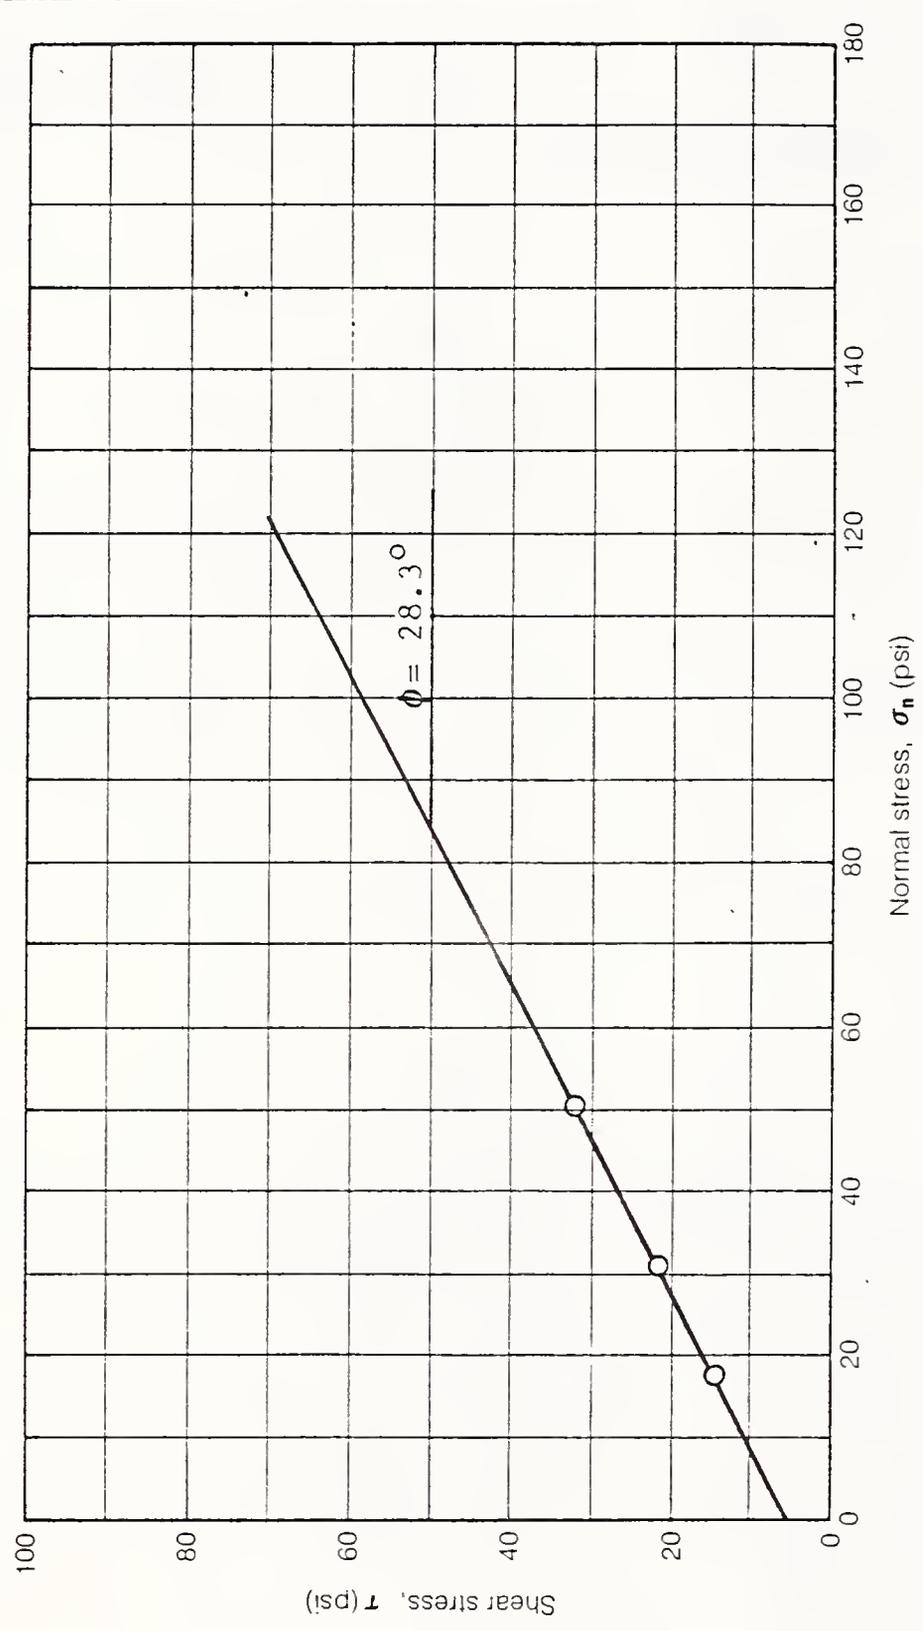
Plate NO. 26

HOLE NO. 7  
DEPTH: 87-88'  
(Foundation)

Vertical displacement,  $\delta_v$  (in. x 10<sup>-2</sup>)

Normal stress,  $\sigma_n$  (psi)

Test no. or symbol	Sample size (inches)	Sample data		Degree of saturation (%)	Normal stress $\sigma_n$ (psi)	Maximum shear stress $\tau$ (psi)	Strain rate (inches / minute)	Shear strength parameters	
		Dry density (pcf)	Moisture content (%)					Friction angle $\phi$ (degrees)	Cohesion (c / psi)
○	2	86.8	32.8	100	17.8	14.9	.0071	28.3	5.0
□	2	86.8	32.8	100	30.6	20.9	.0071		
Δ	2	86.8	32.8	100	49.6	32.7	.0071

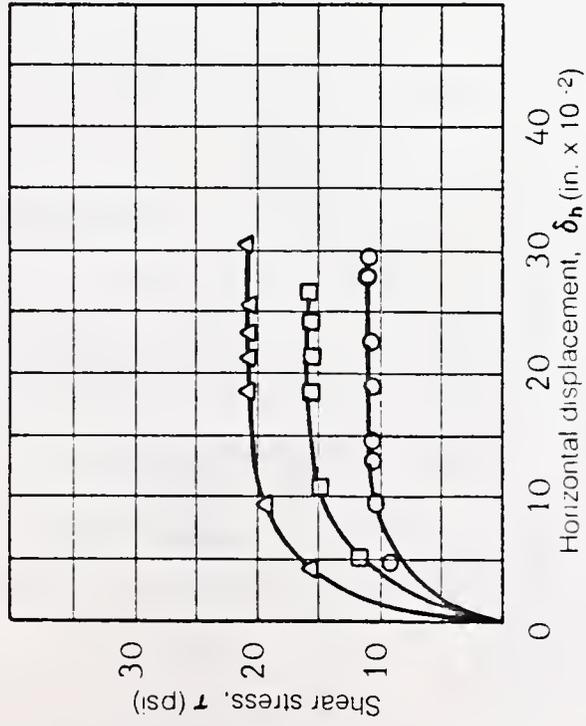
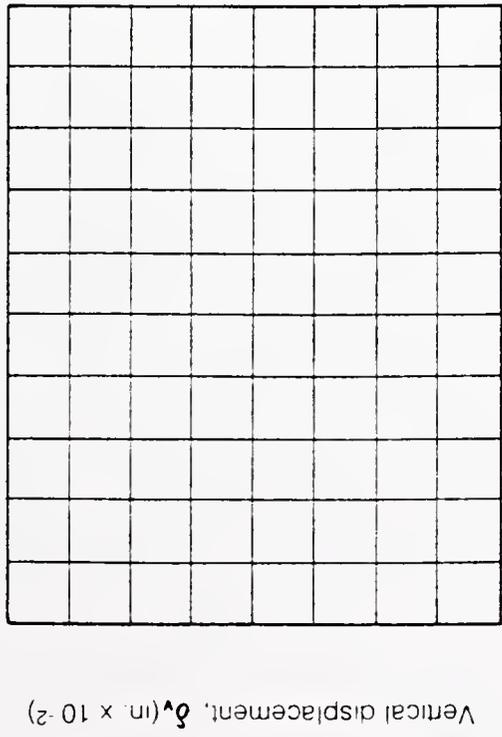
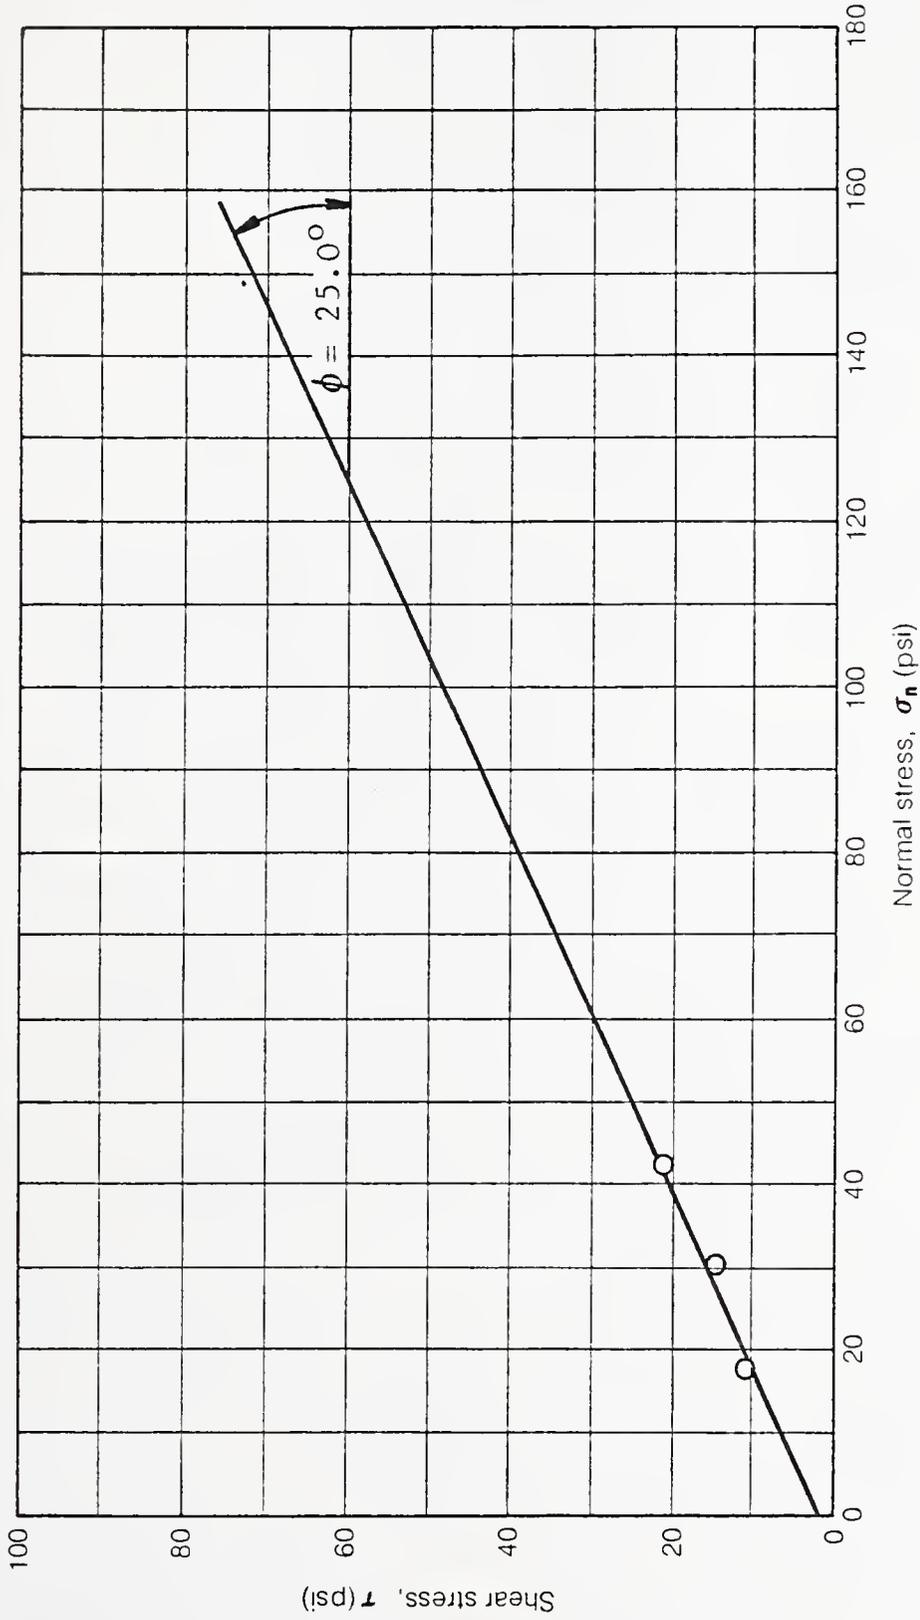
Test no. or symbol	Sample size (inches)	Sample data		Degree of saturation (%)	Normal stress $\sigma_n$ (psi)	Maximum shear stress $\tau$ (psi)	Strain rate (inches/minute)	Shear strength parameters	
		Dry density (pcf)	Moisture content (%)					Friction angle $\phi$ (degrees)	Cohesion (c / psi)
○	2	110.3	18.3	100	17.8	11.5	.0009	25.0	2.0
□	2	110.3	18.3	100	30.2	15.4	.0009		
△	2	110.3	18.3	100	42.4	21.0	.0009

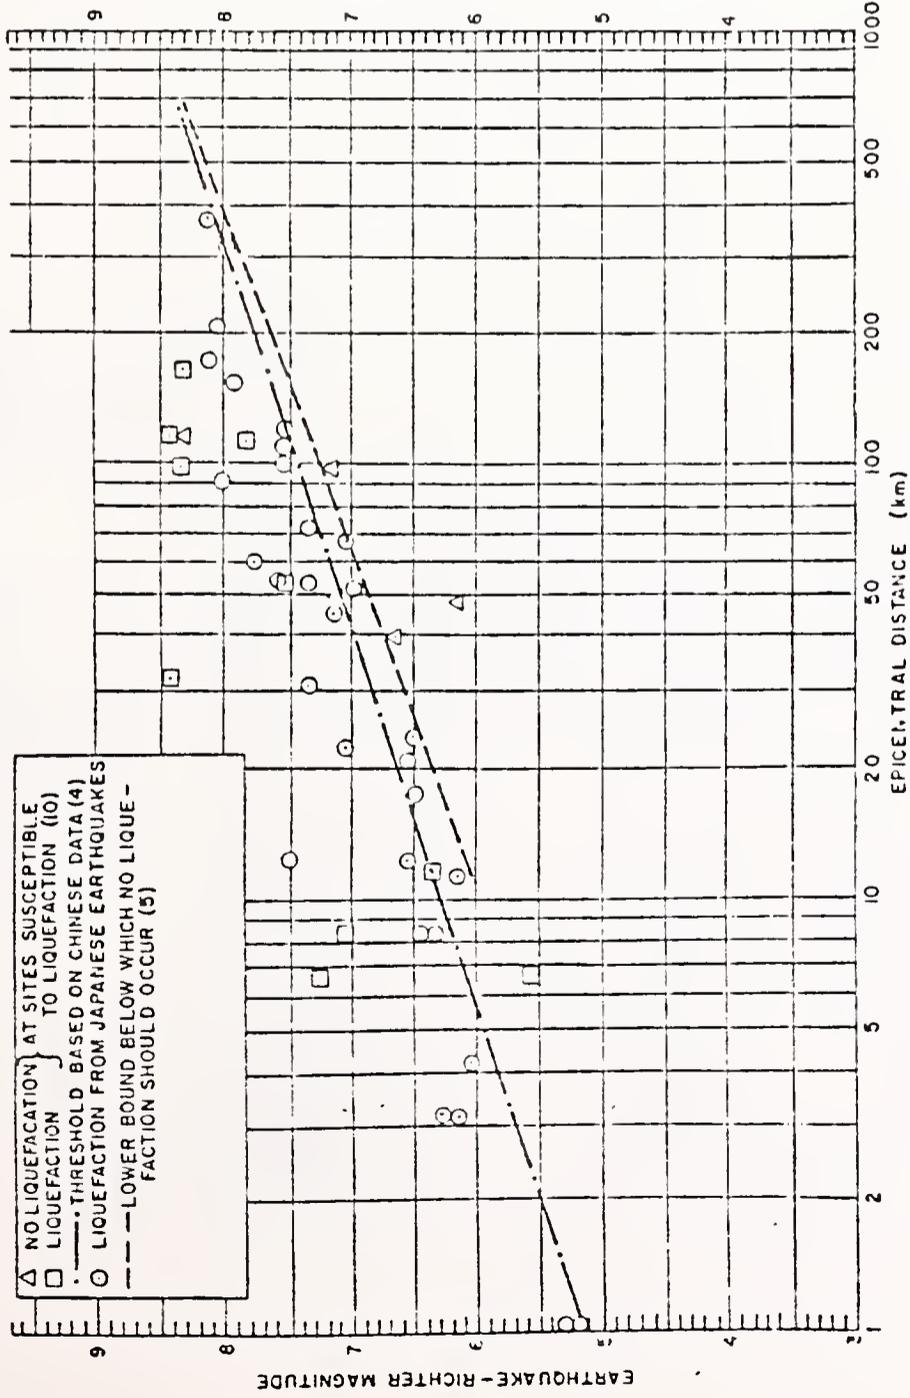
BUREAU OF RECLAMATION'S SEISMIC REEVALUATION OF EMBANKMENT DAMS CRITERIA

1. Liquefaction Criteria

2. If the embankment and foundation soils suffer a considerable loss in strength under cyclic loading, the above chart is used to determine the likelihood of liquefaction. If the chart indicates that liquefaction is a possibility, a liquefaction analysis is performed.
